WATERS OF THE U.S. TECHNICAL REPORT

I-69 OHIO RIVER CROSSING PROJECT
Evansville, IN and Henderson, KY

Prepared by:
PARSONS

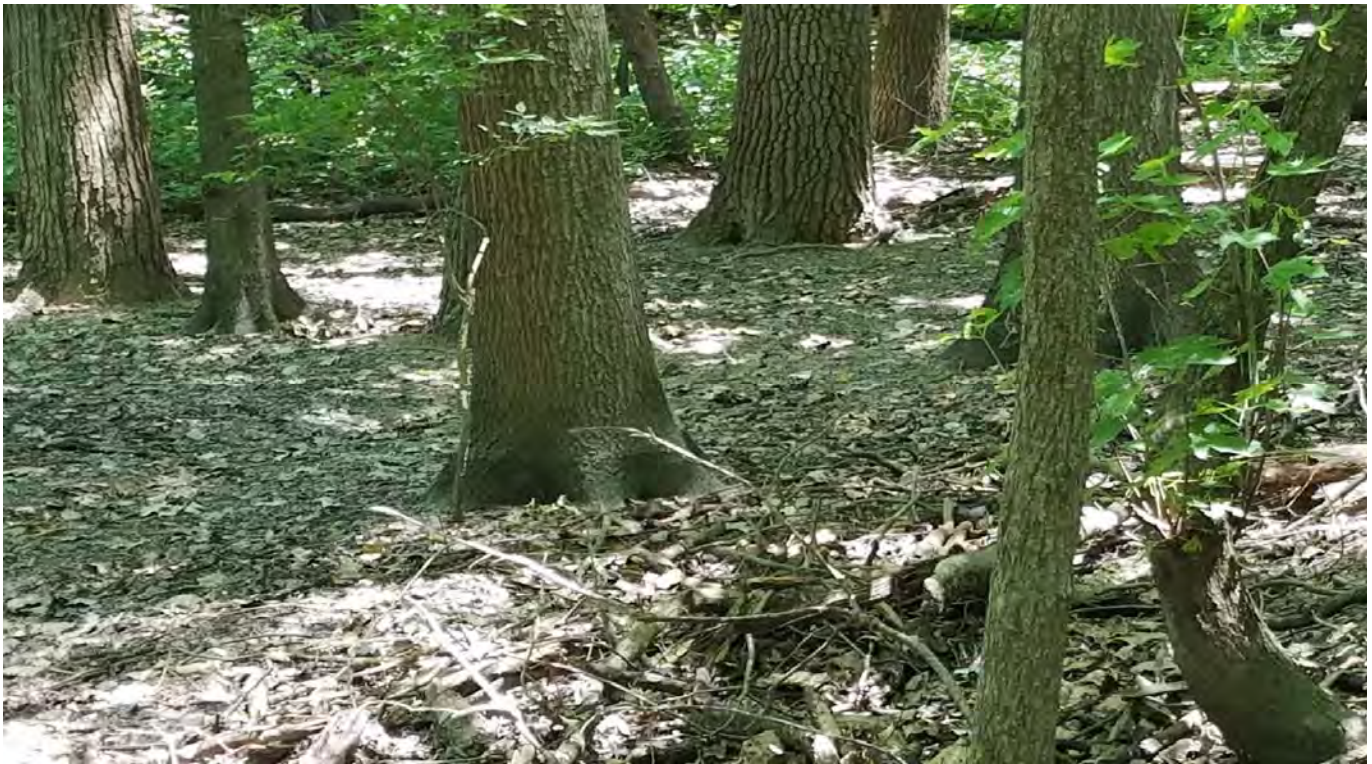
WTL-03 (06/23/2017)

Water-stained leaves and woody debris within wetland. Sparsely vegetated herbaceous stratum. Some water marks on trees show that the area does pond water periodically. Photo direction: South

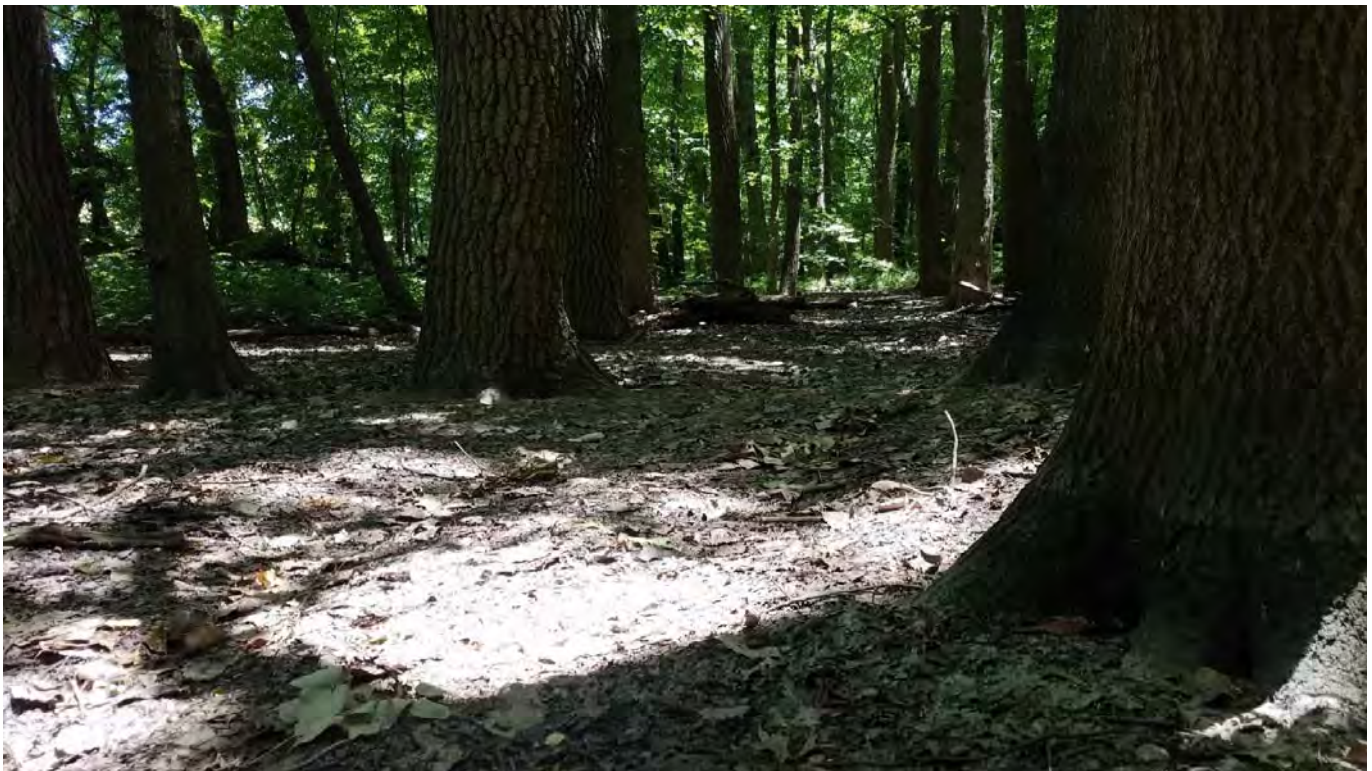
WTL-03 (06/23/2017)

Water marks on trees show that the area does pond water periodically.
Photo direction: South

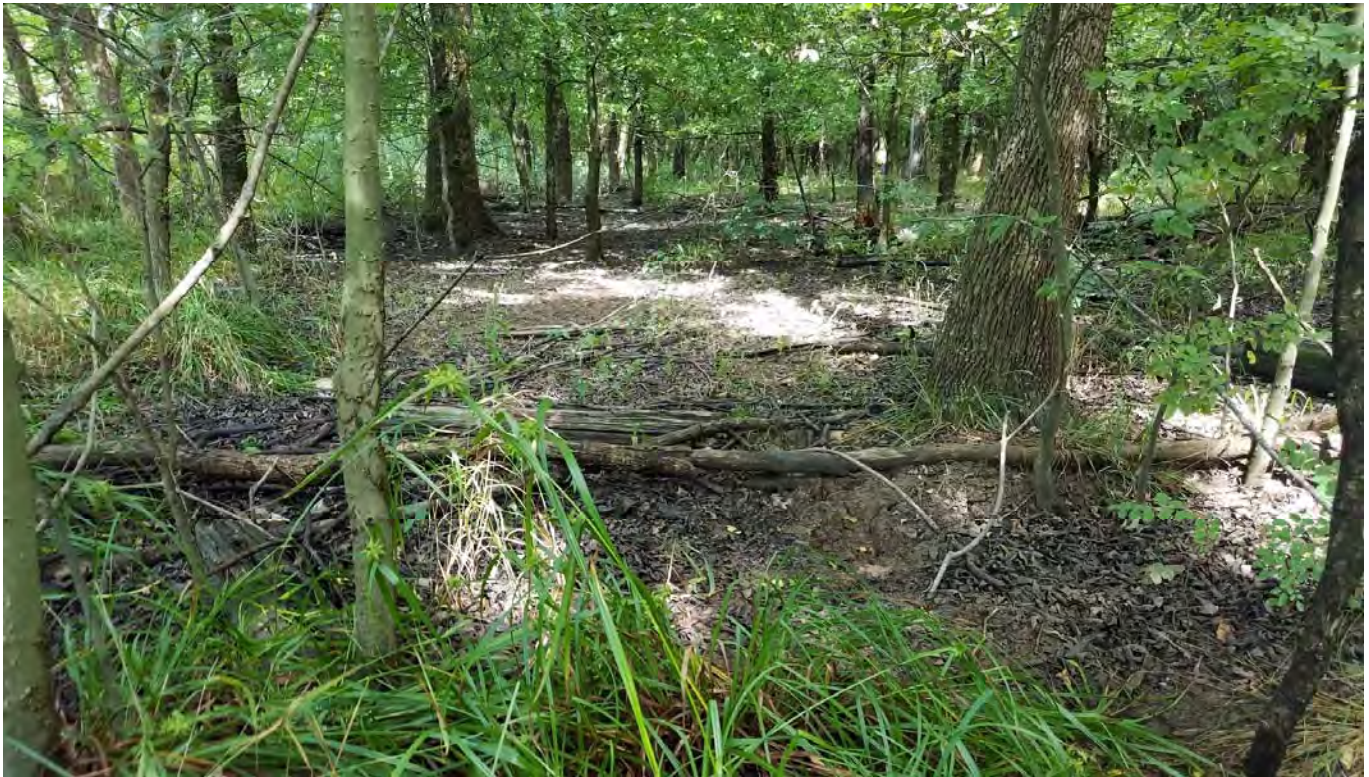
WTL-09 (07/07/2017)

Vegetation along western boundary of wetland. Water-stained leaves and tree debris within wetland. Sparsely vegetated herbaceous stratum. Photo direction: North

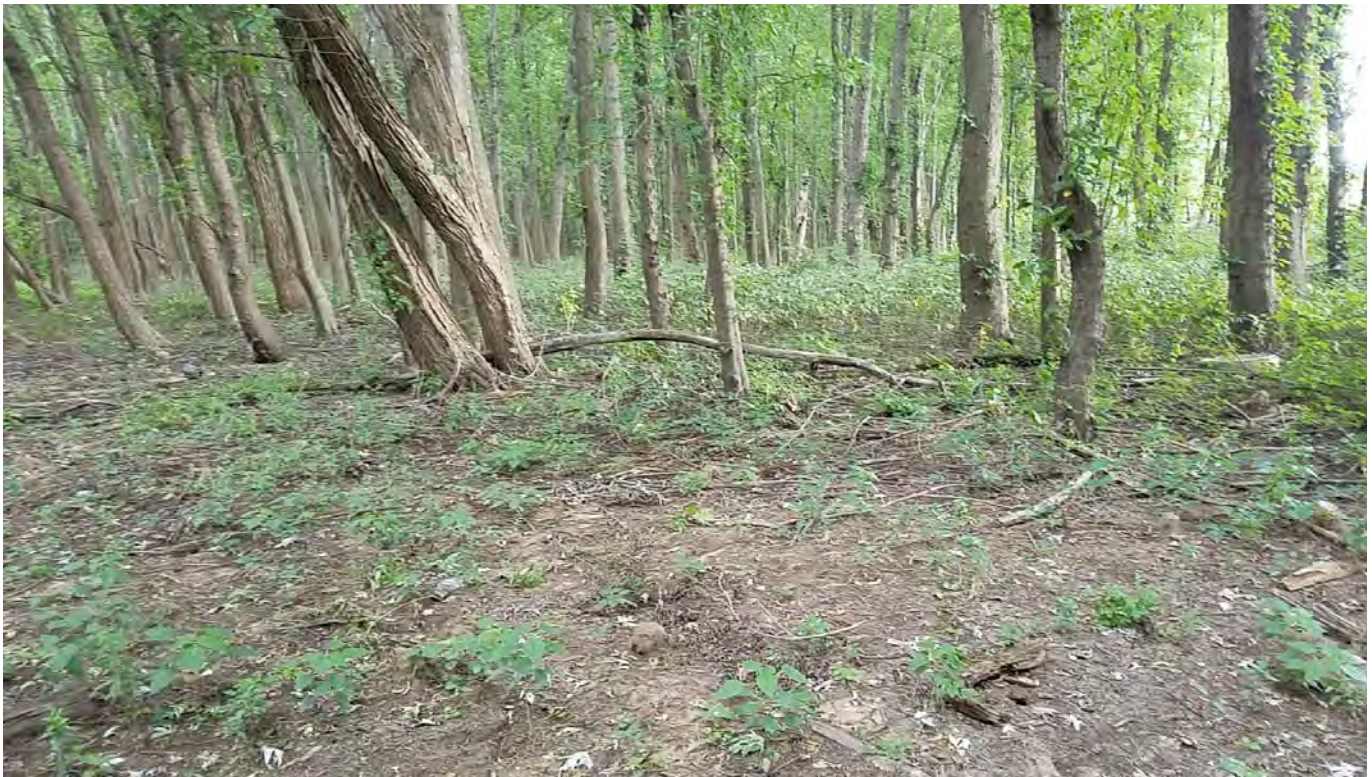
WTL-17 (09/08/2017)

Vegetation along northern boundary of wetland. Water-stained leaves, water marks, drift and debris within the wetland. Minimal herbaceous layer due to prolonged inundation. Photo direction: East

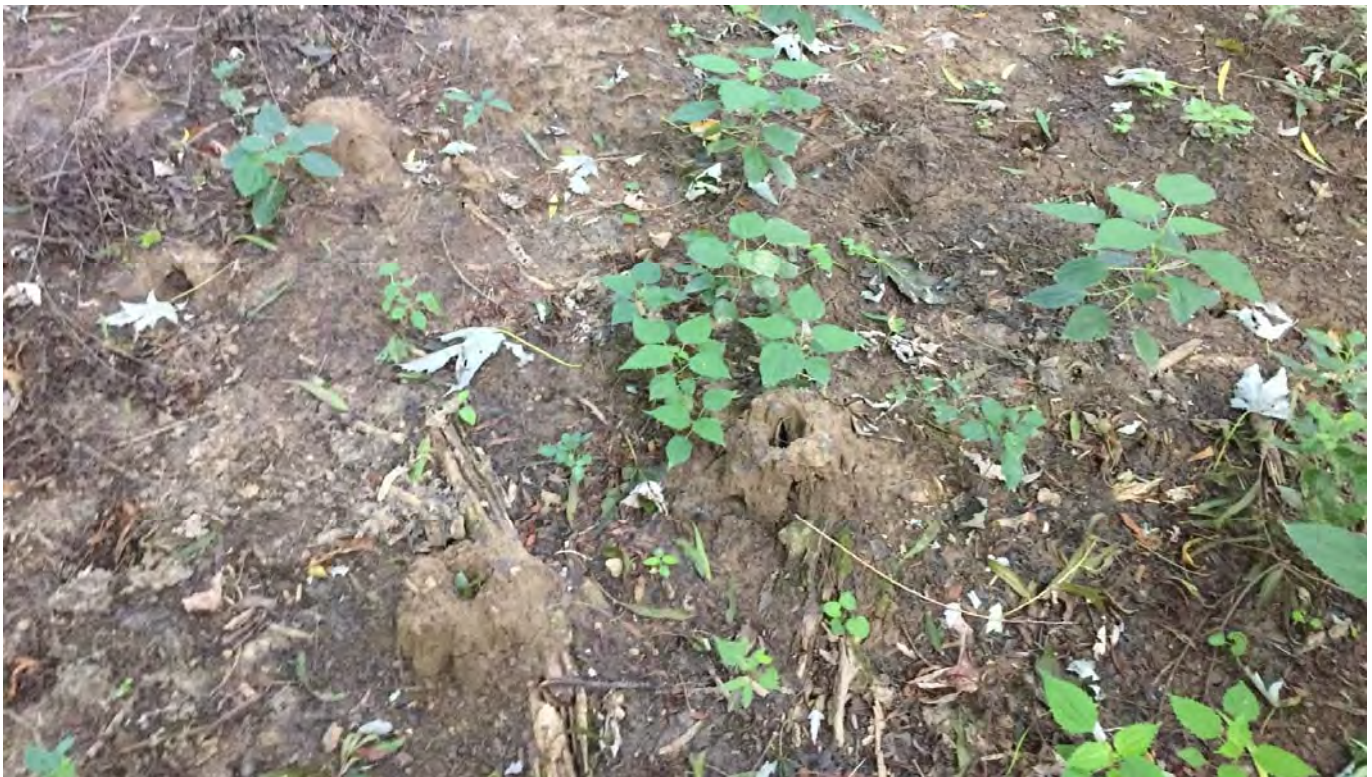
WTL-17 (09/08/2017)

Abundant crayfish burrows were present throughout the wetland. Photo direction: East

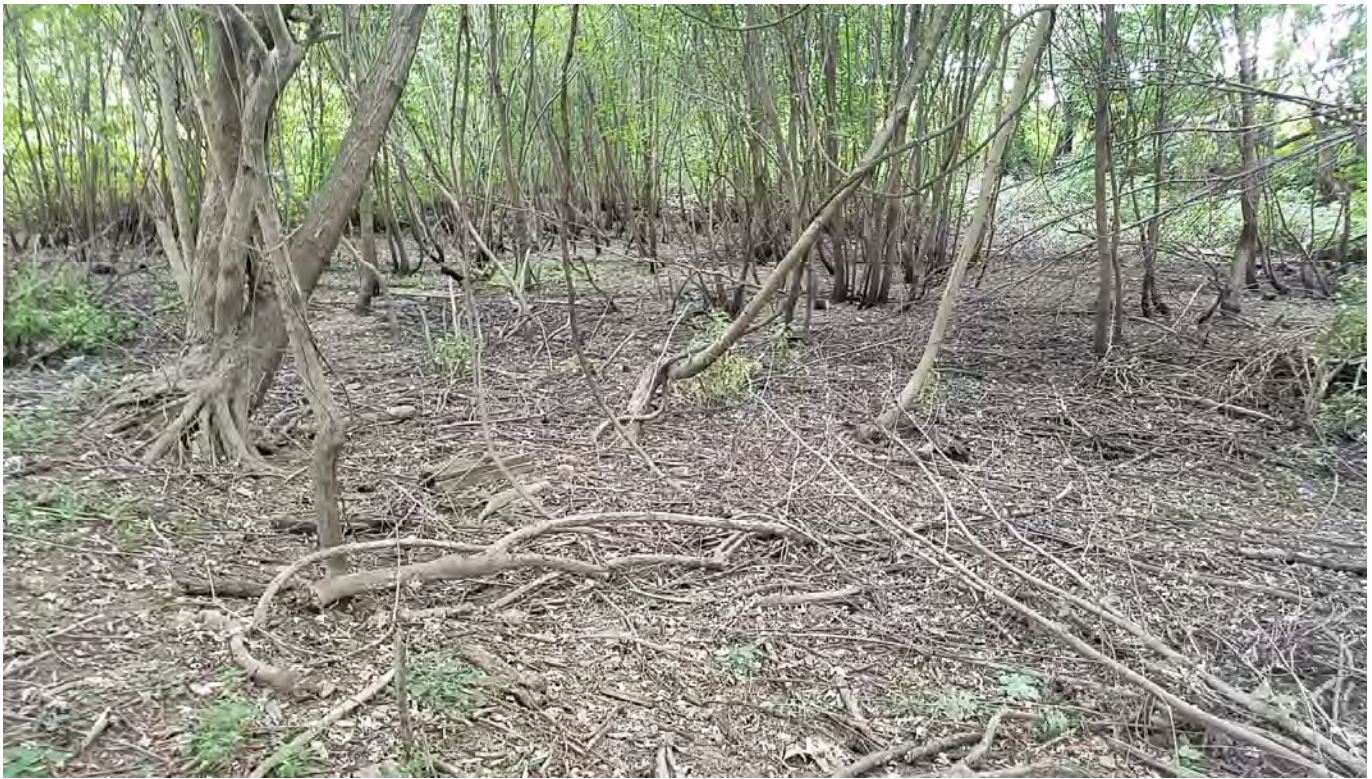
WTL-17 (09/08/2017)

Vegetation along northern boundary of wetland. Water-stained leaves and tree debris within wetland. Minimal herbaceous layer. Photo direction: East

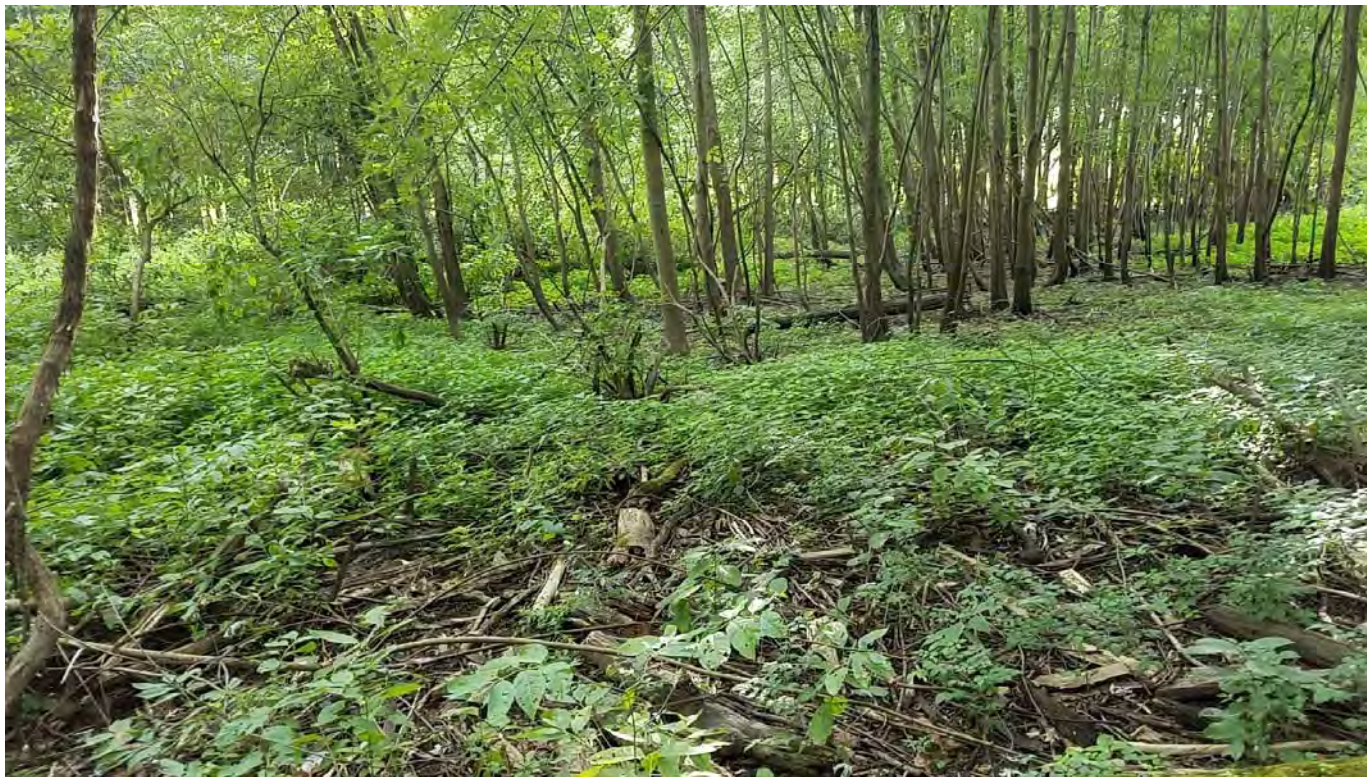
WTL-17 (09/08/2017)

Vegetation along northeastern boundary of wetland included a stand of wood nettle. Drift and debris was present throughout the wetland primarily due to Ohio River backwater flooding. Photo direction: West

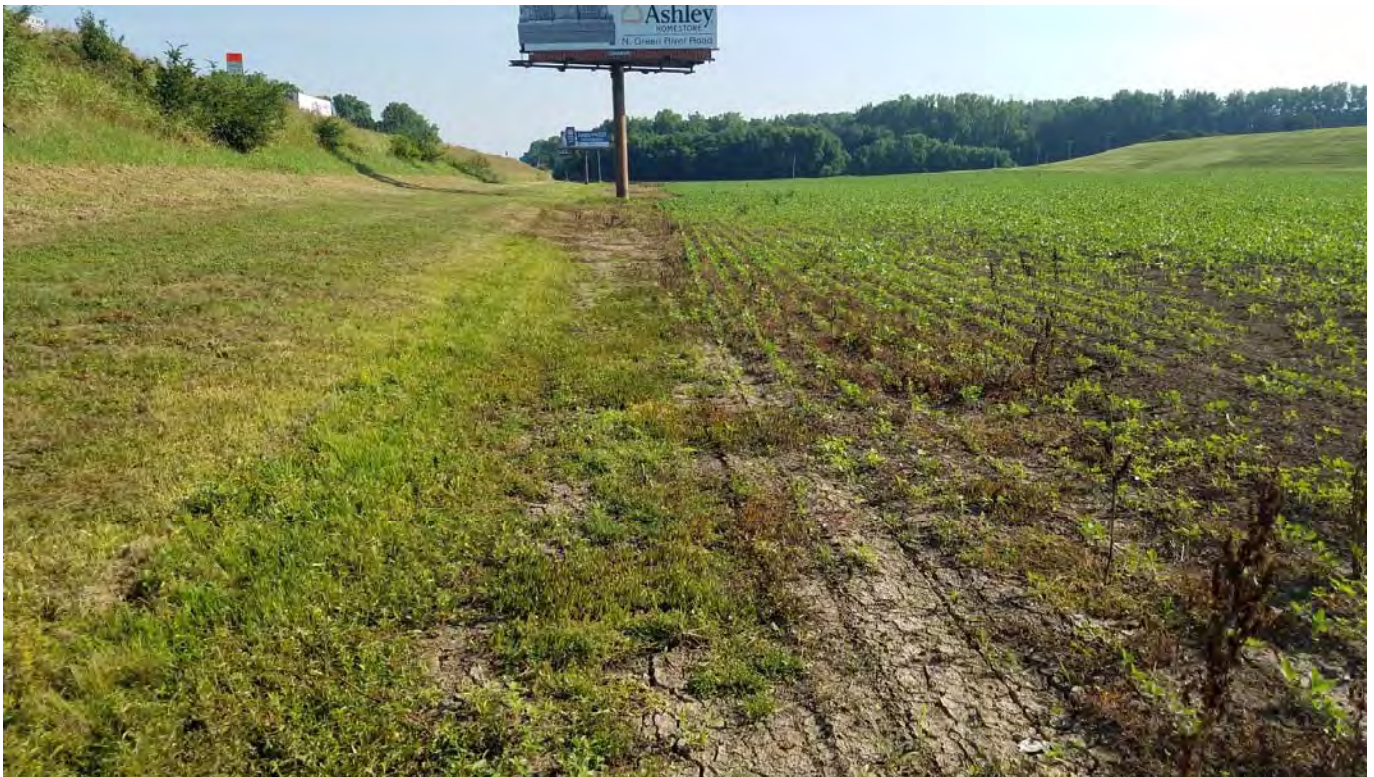
WTL-23 (07/12/2017)
 Narrow, partially farmed wetland along US-41. Surface soil cracks and crayfish burrows throughout wetland.
 Photo direction: South

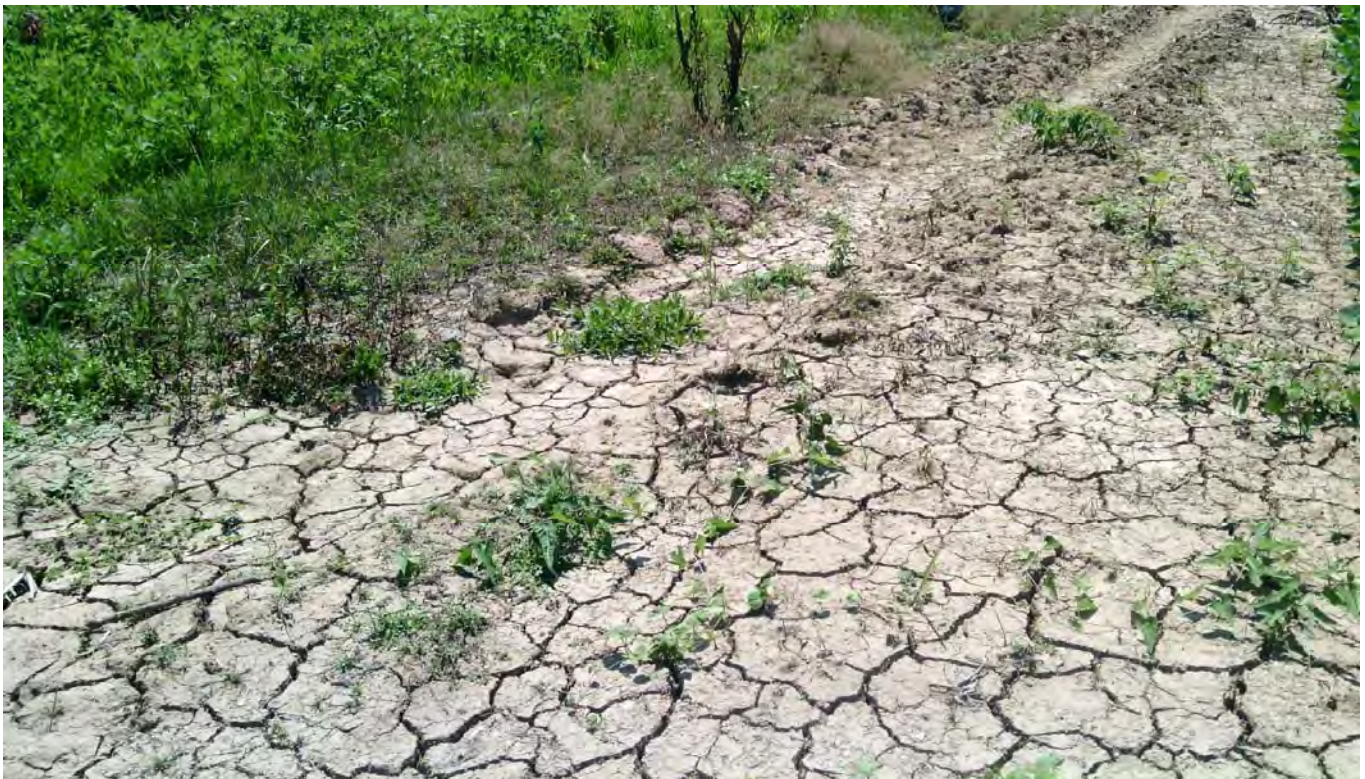
WTL-25 (07/12/2017)
 Surface soil cracks along western boundary.
 Photo direction: South

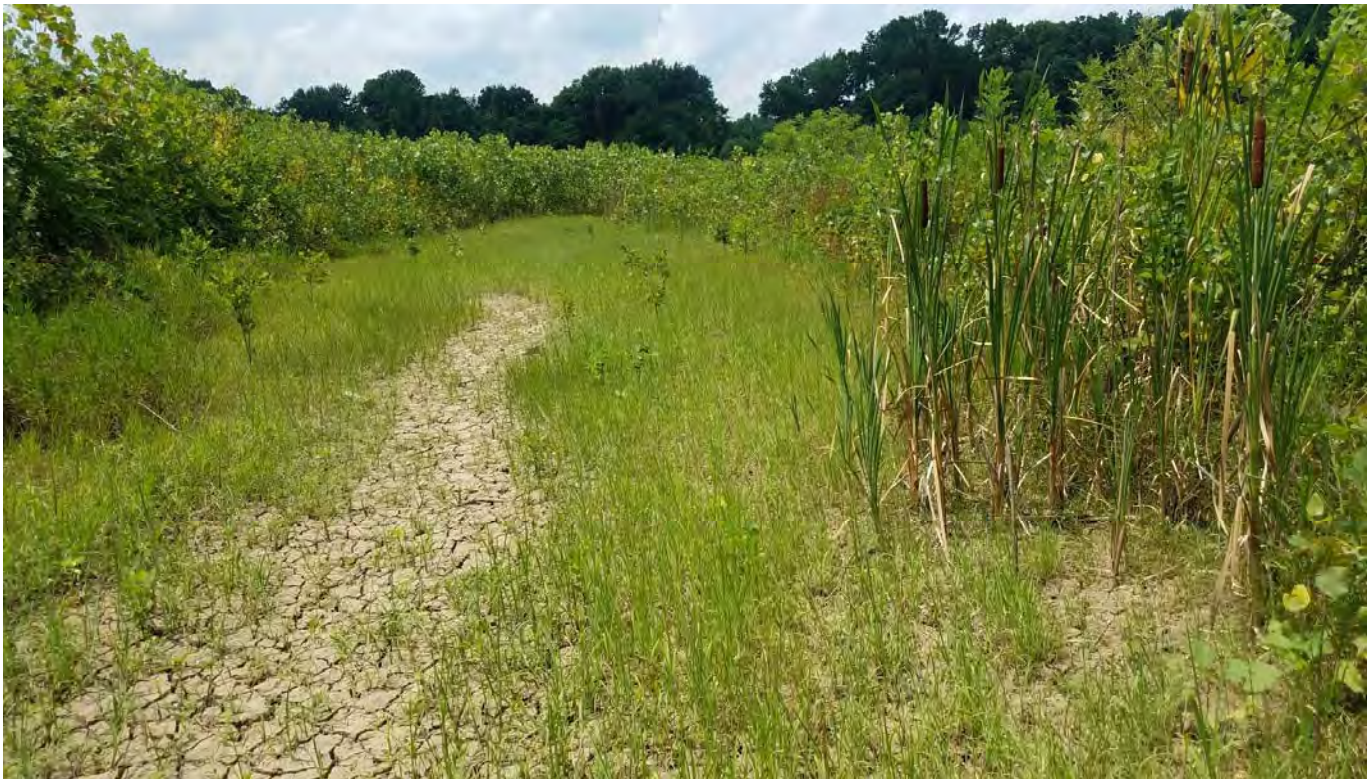
WTL-28 07/18/2017

Cattail (*Typha latifolia*) and desiccation soil cracks in wetland. Notice the succession of cottonwood (*Populus deltoides*) and green ash (*Fraxinus pennsylvanica*) in adjacent areas. Photo direction: West

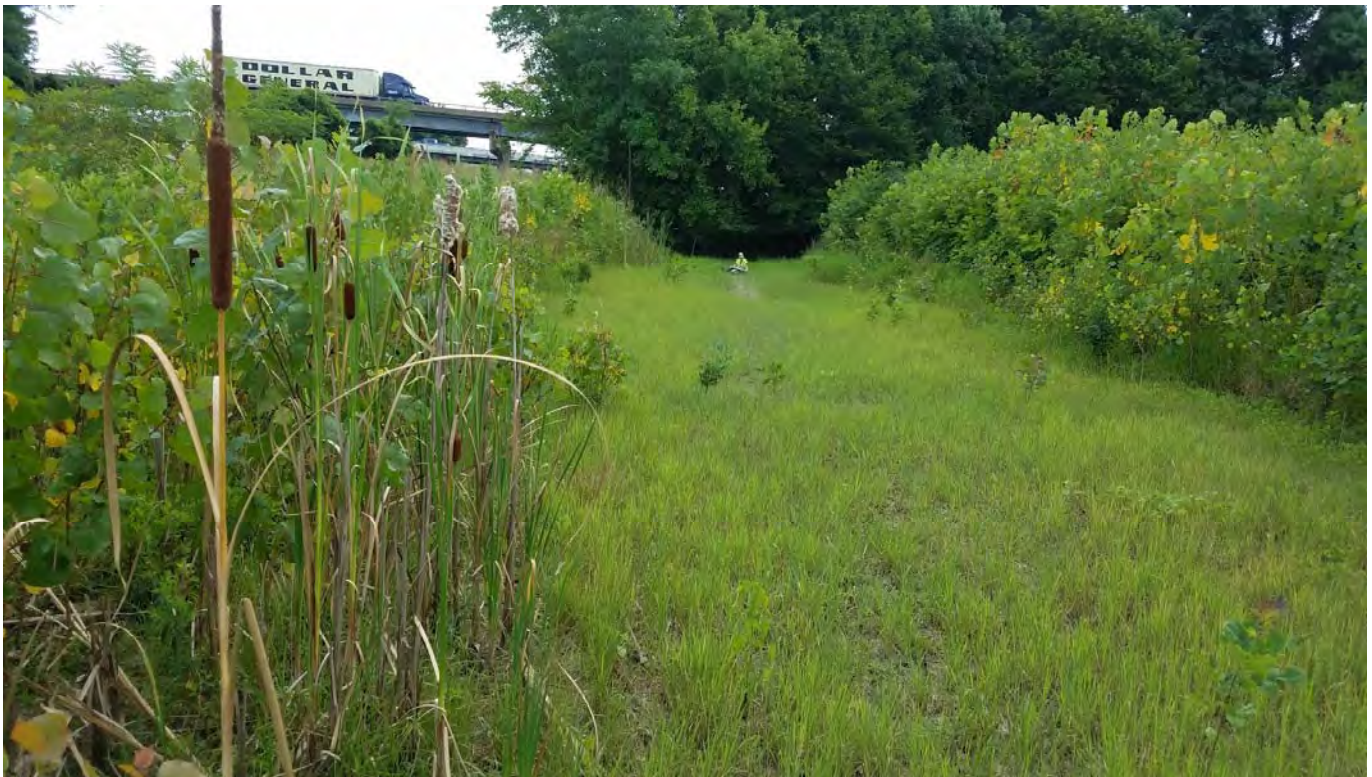
WTL-28 07/18/2017

Cattail (*Typha latifolia*) in wetland near US-41.
Photo direction: East

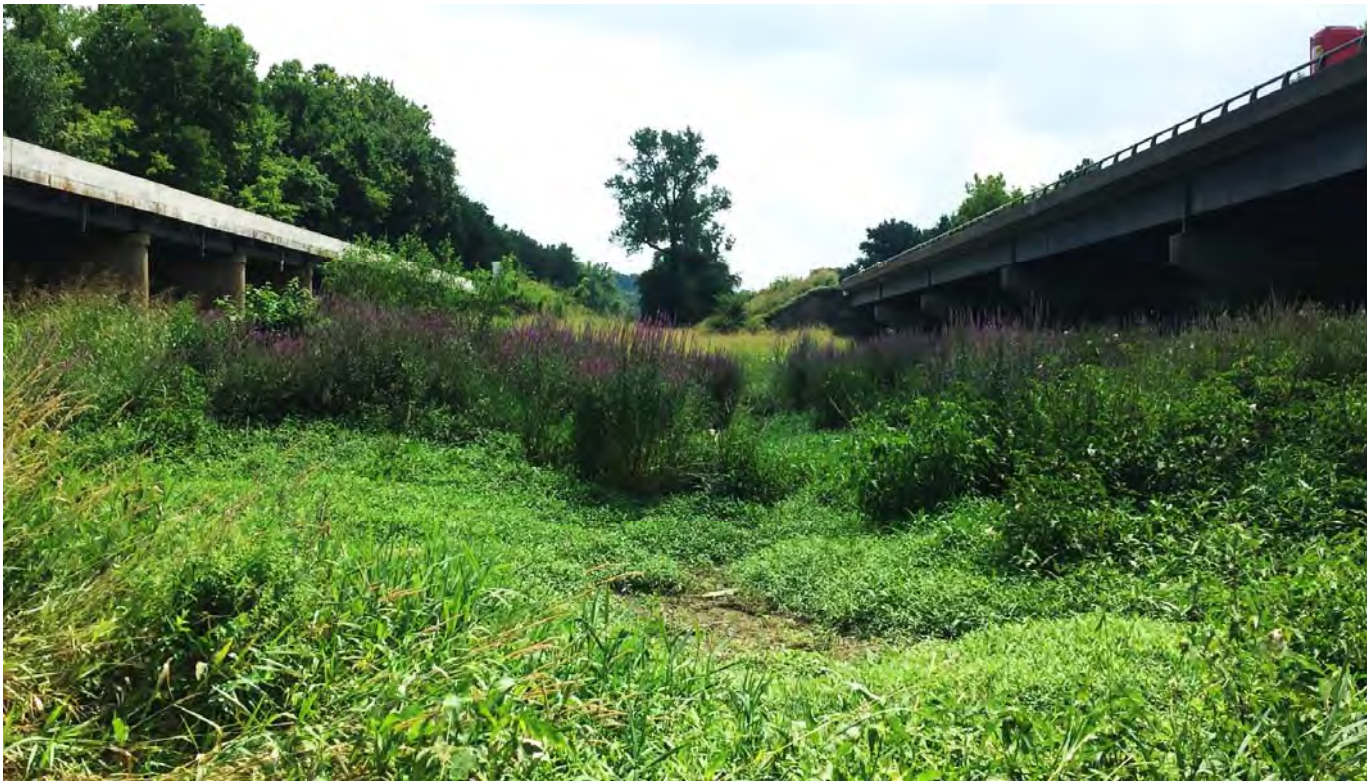
WTL-29 07/18/2017

PEM wetland vegetation under US-41. A dense stand of purple loosestrife (*Lythrum salicaria*) is present.

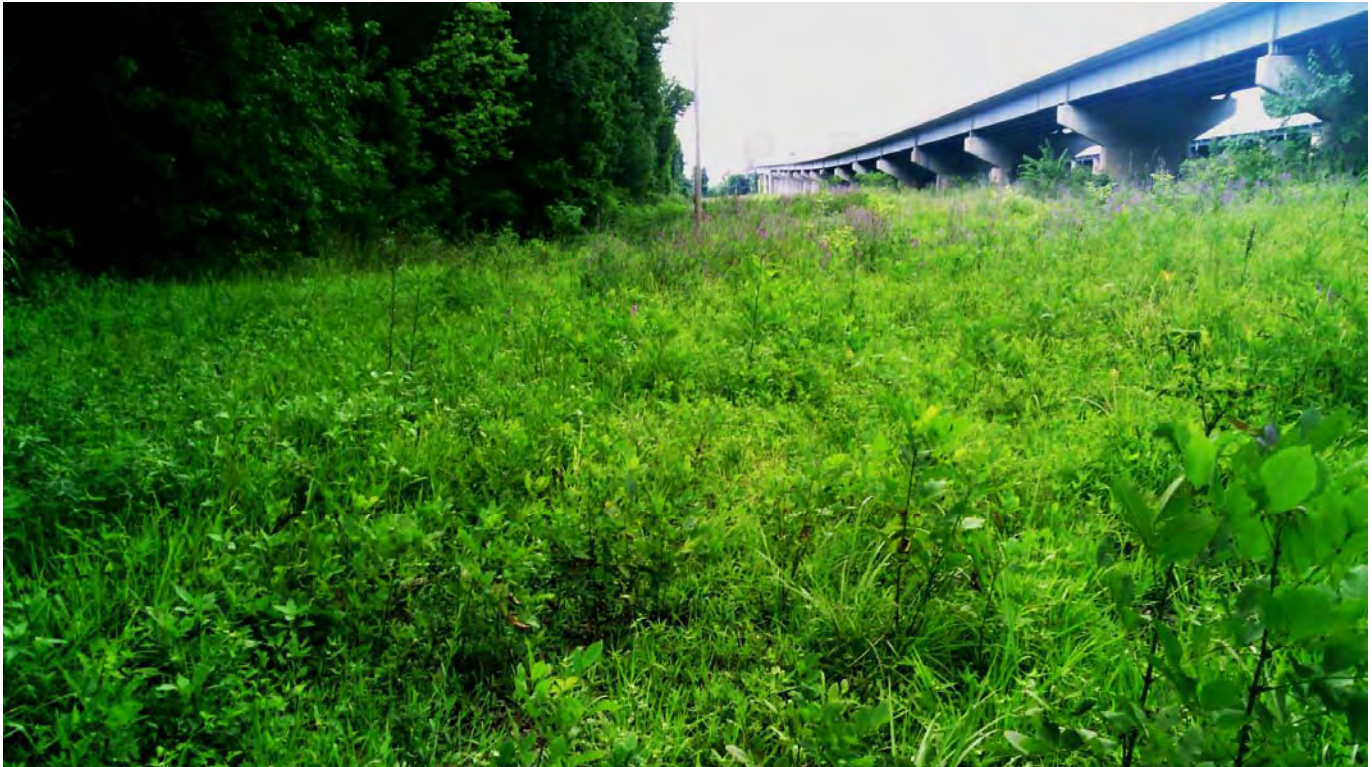
WTL-29 07/18/2017

PEM wetland vegetation west of US-41 with a dense stand of purple loosestrife (*Lythrum salicaria*) present in the background on the photograph. Photo direction: South

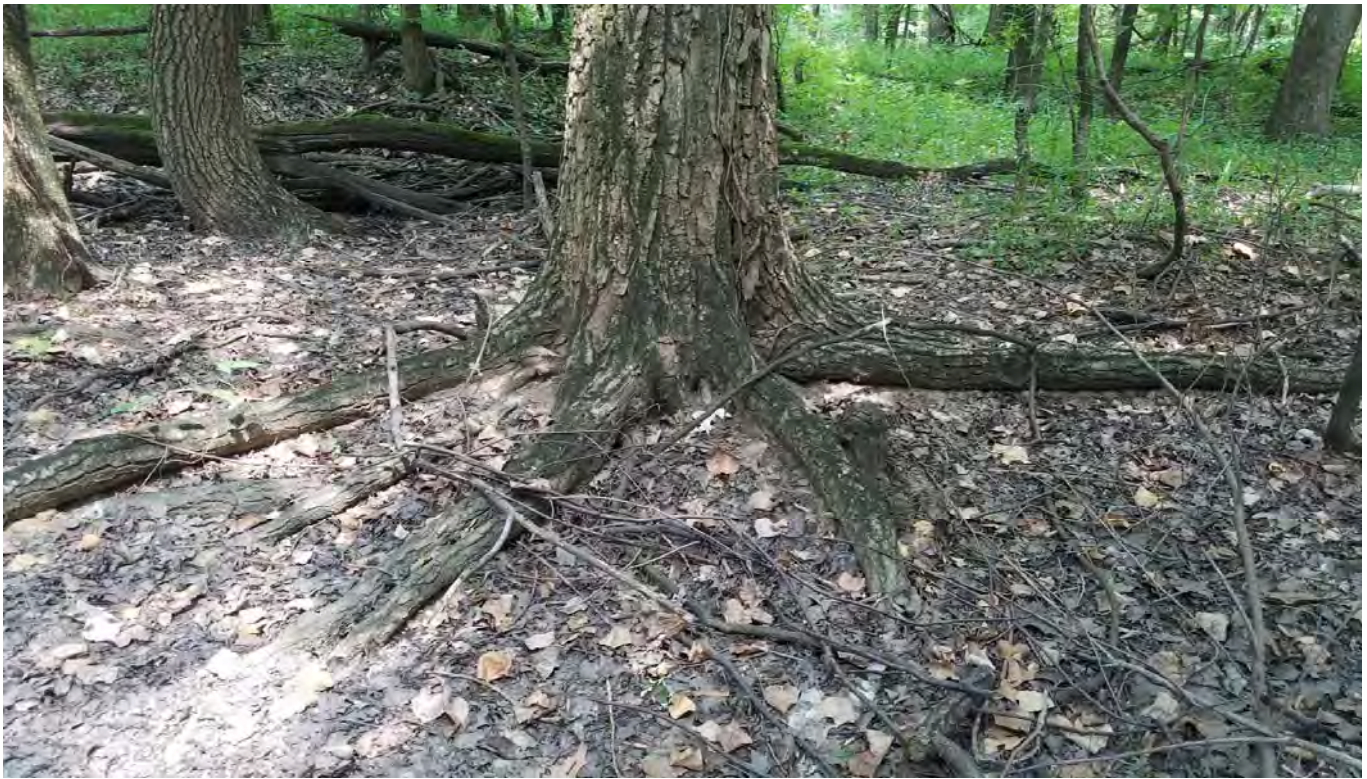
WTL-30

Water-stained leaves and tree debris within wetland. Sparsely vegetated herbaceous stratum.

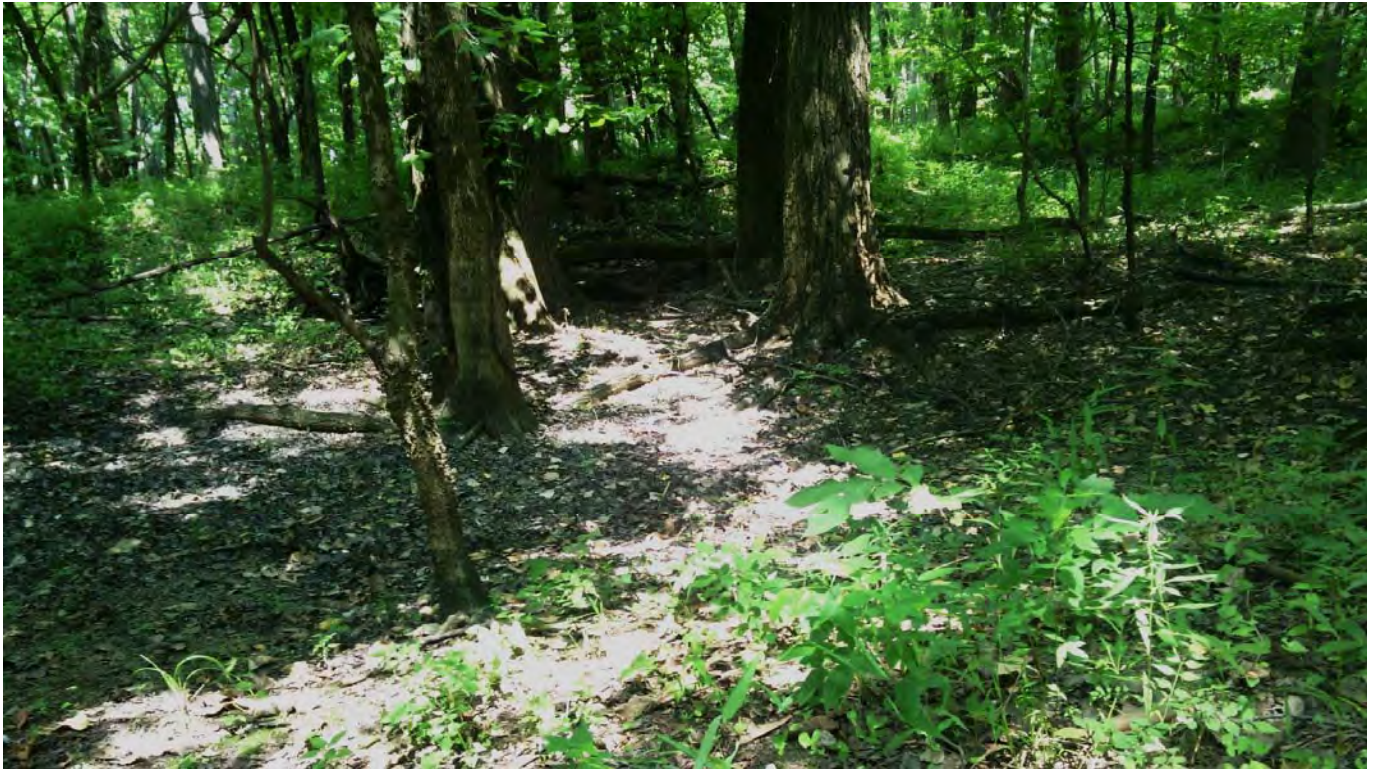
WTL-30

Water-stained leaves and tree debris within wetland. Sparsely vegetated herbaceous stratum.

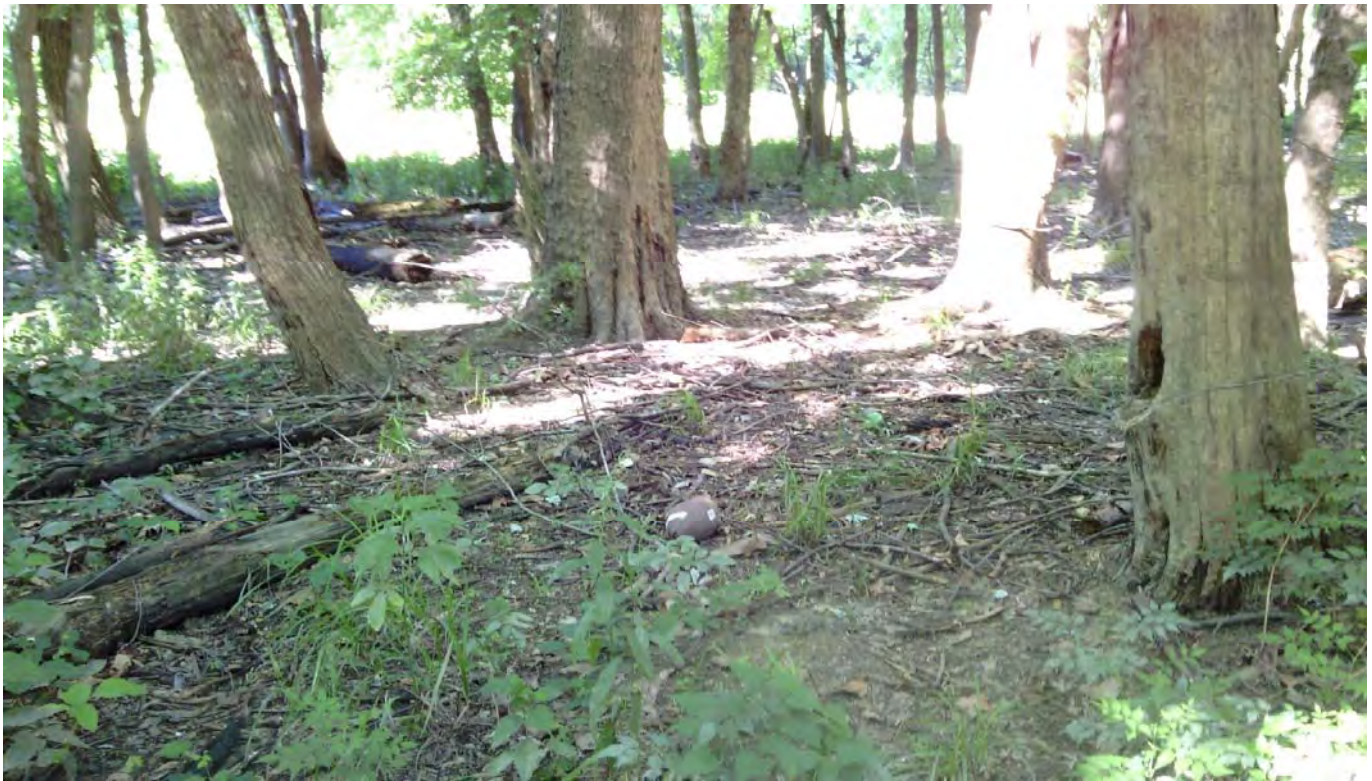
WTL-52 (06/27/17)

Vegetation along eastern boundary of wetland. Water-stained leaves and tree debris within wetland. Sparsely vegetated herbaceous layer. Photo direction: West

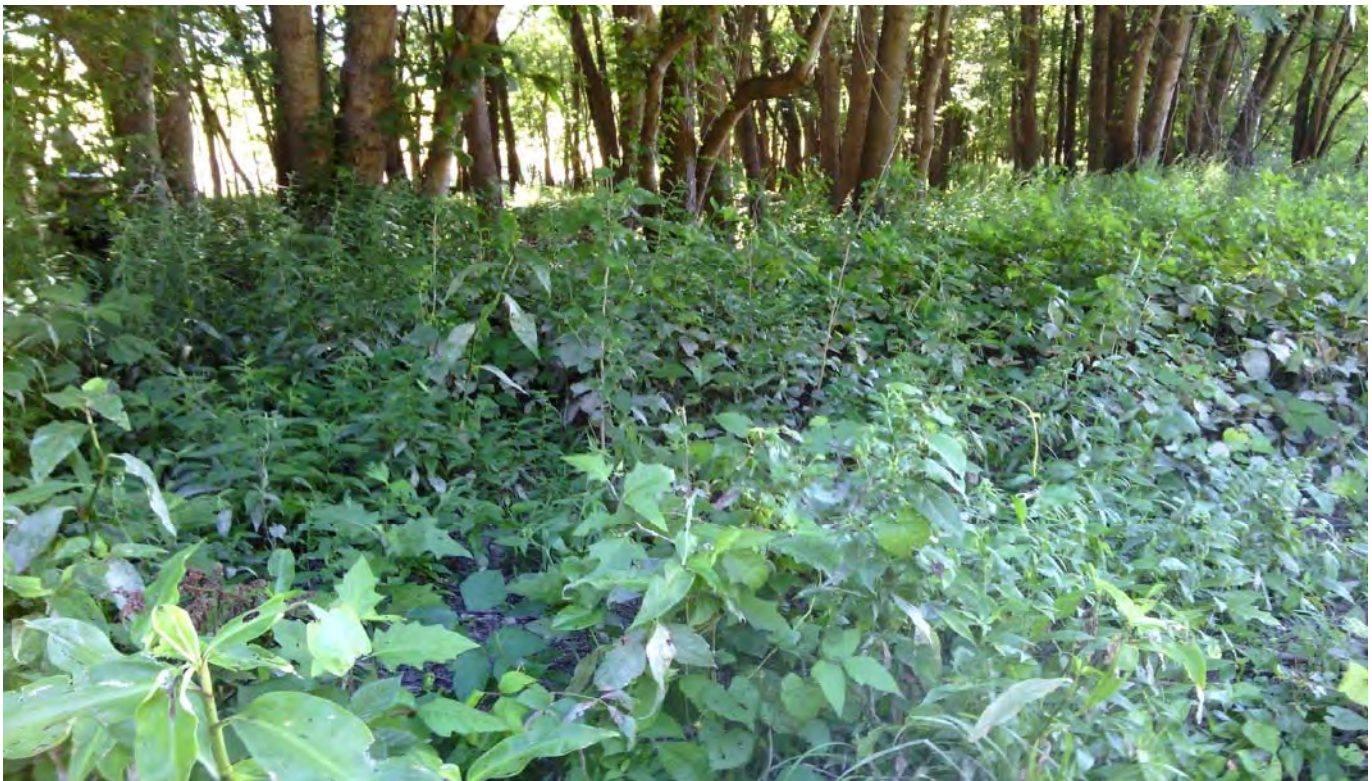
WTL-52 (06/27/17)

Vegetation along south western boundary of wetland.
Photo direction: North

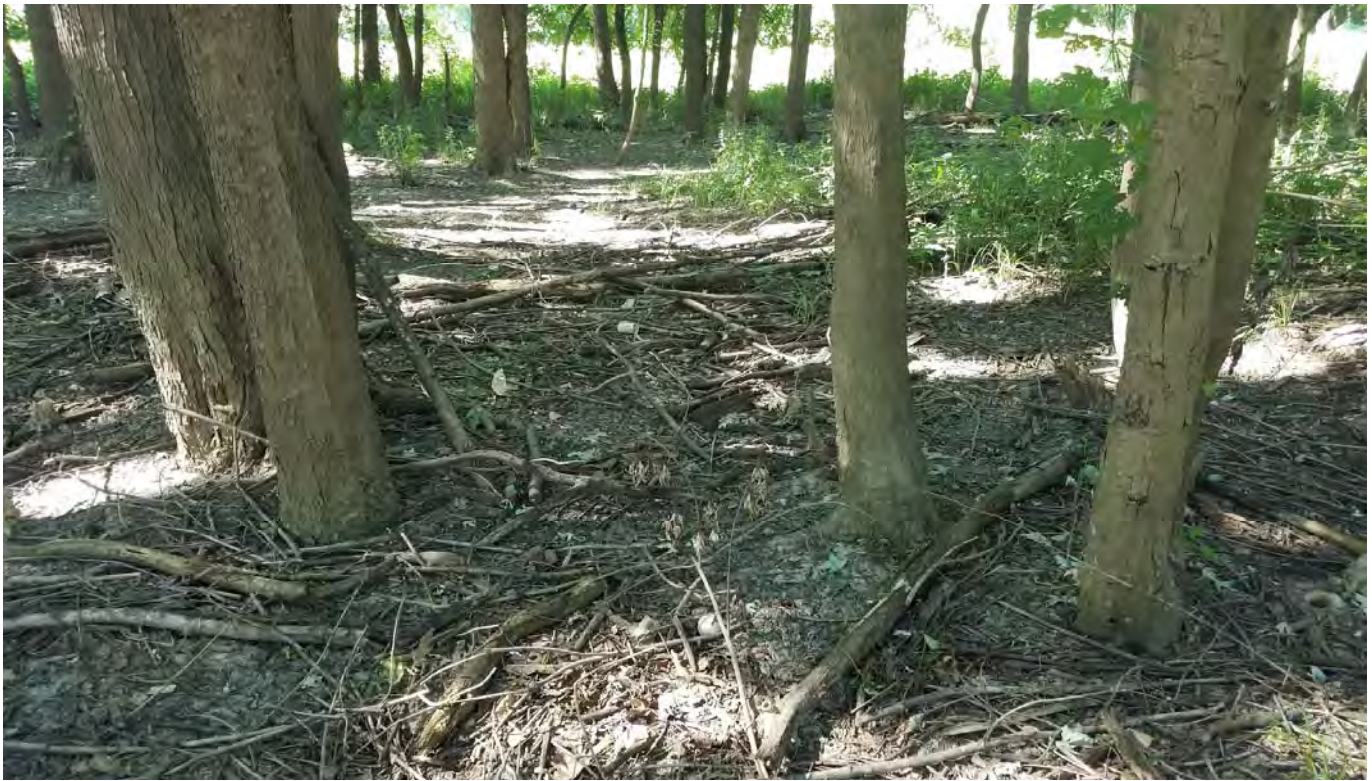
WTL-53 (06/27/17)

Vegetation along northern boundary of wetland. Water-stained leaves and woody debris within wetland. Sparsely vegetated herbaceous layer. Photo direction: North

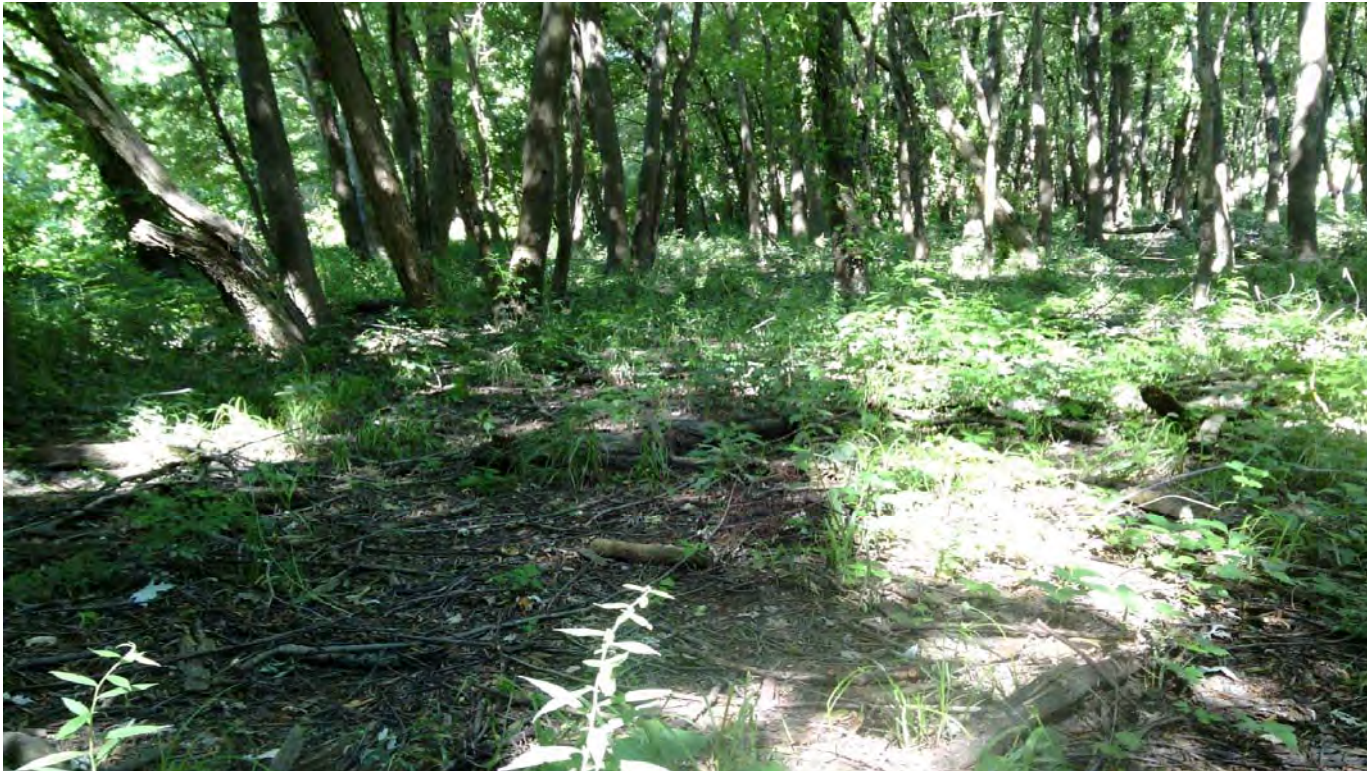
WTL-53 (06/27/17)

Vegetation along northern boundary of wetland.
Photo direction: South

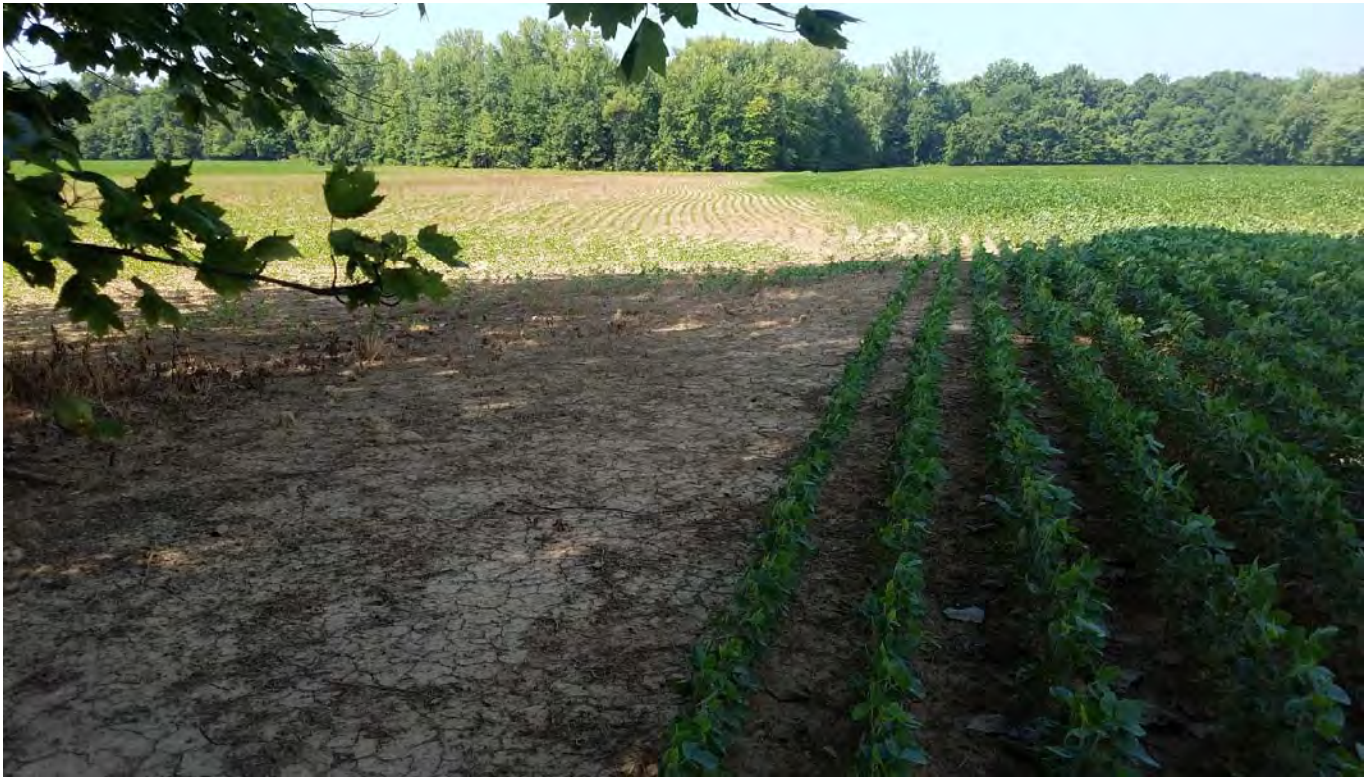
WTL-58 07/13/2017
 Farmed portion wetland with surface soil cracks.
 Photo direction: West

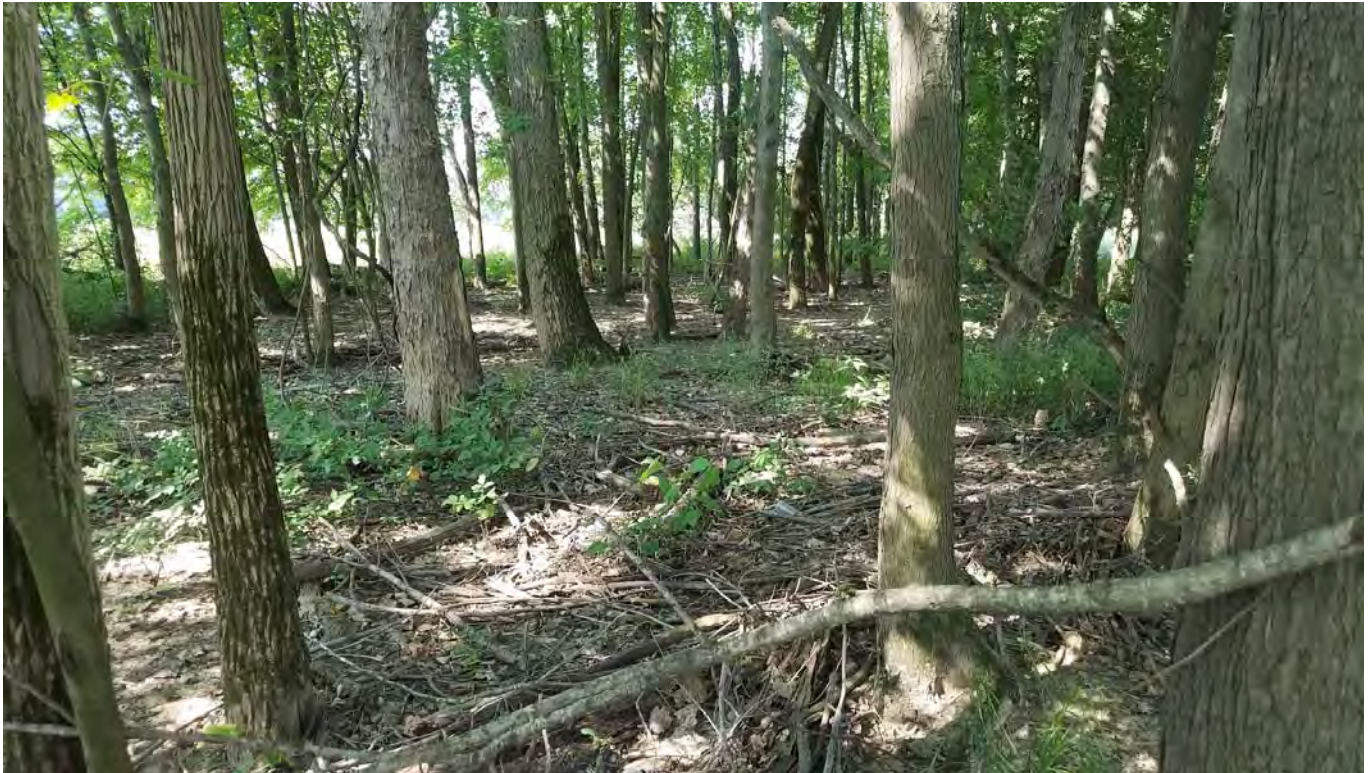
WTL-58 07/13/2017
 Bottomland hardwoods with a minimal understory in the wetland.
 Photo direction: South
