WATERS OF THE U.S. TECHNICAL REPORT

I-69 OHIO RIVER CROSSING PROJECT
Evansville, IN and Henderson, KY

Prepared by:
PARSONS

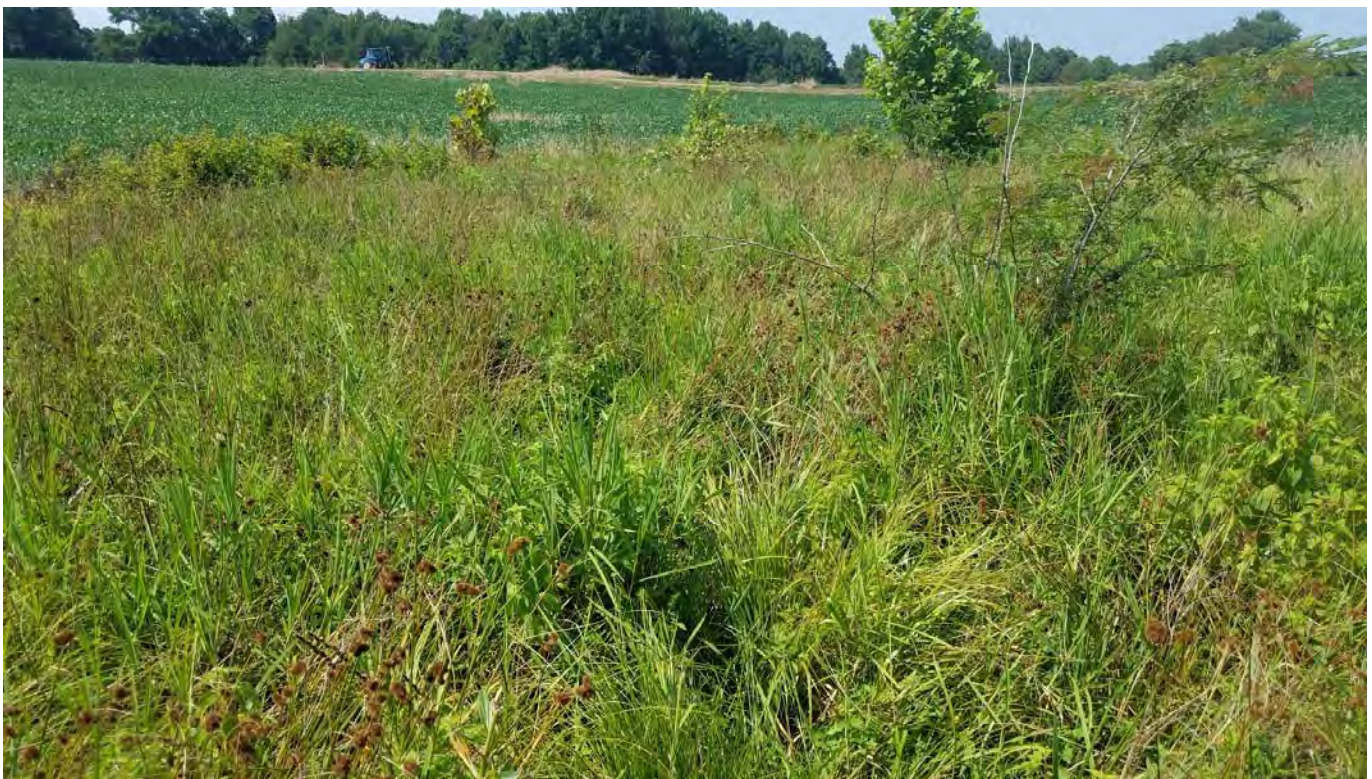
WTL-62 (07/19/2017)
 Typical wetland vegetation found in the wetland swale. Frequent use of herbicides limits woody succession.
 Photo direction: Northeast

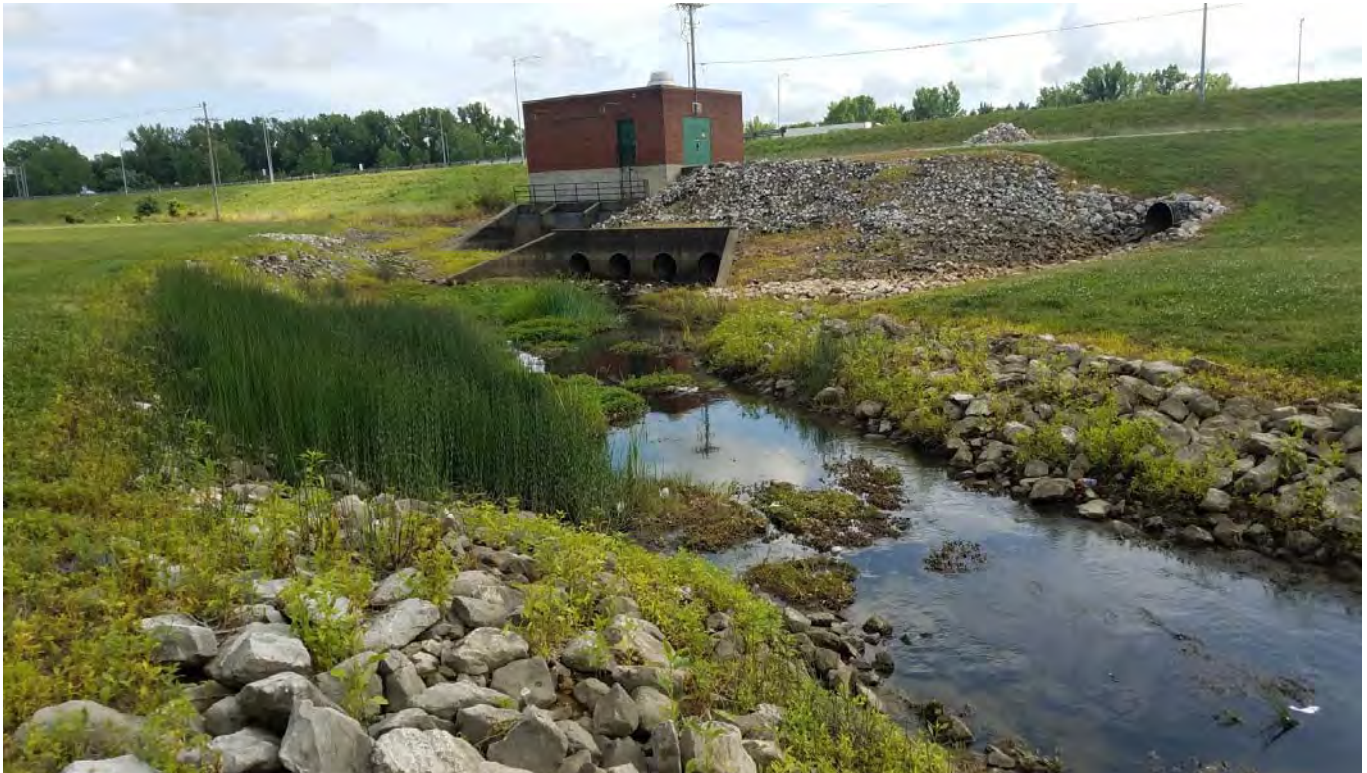
STR-07 Tributary to Eagle Creek (07/06/2017)
 Tributary to Eagle Creek with riparian vegetation. The stand of scouringrush (*Equisetum hyemale*) indicated that the stream rarely had prolonged bankfull conditions. Photo direction: Southeast
