WATERS OF THE U.S. TECHNICAL REPORT

I-69 OHIO RIVER CROSSING PROJECT
Evansville, IN and Henderson, KY

August 2019

Parsons

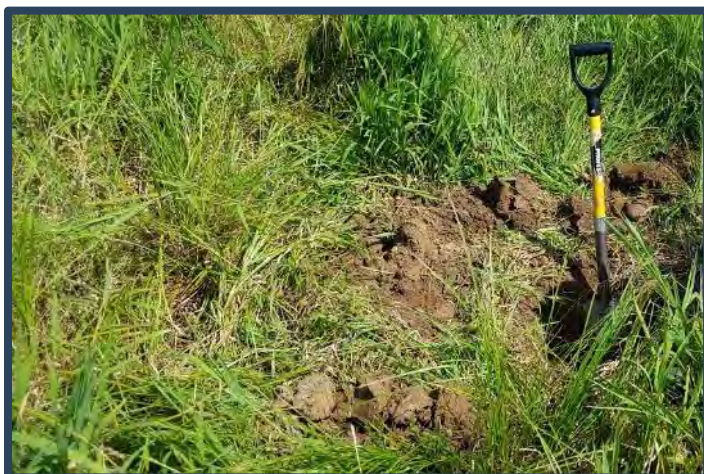
Photo 5: View of the soil profile observed at Wetland 1 (DP-1-IN). This location met the depleted matrix (F3) indicator (07/25/18).

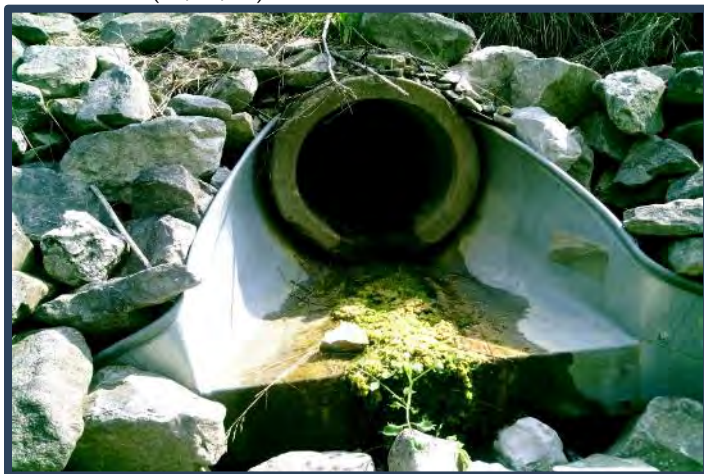
Photo 16: UNT-5 to Eagle Creek facing west (07/06/17)

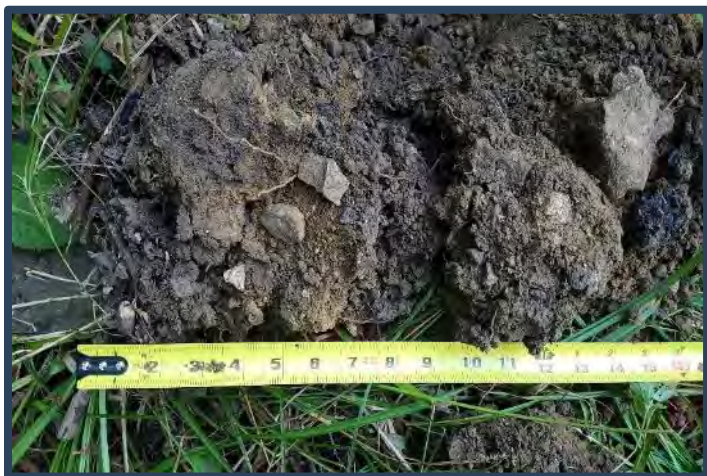
Photo 27: View of the soil profile observed at Wetland 2 (DP-2-IN). This location met the depleted matrix (F3) and the depleted below dark surface (A11) indicators (07/24).

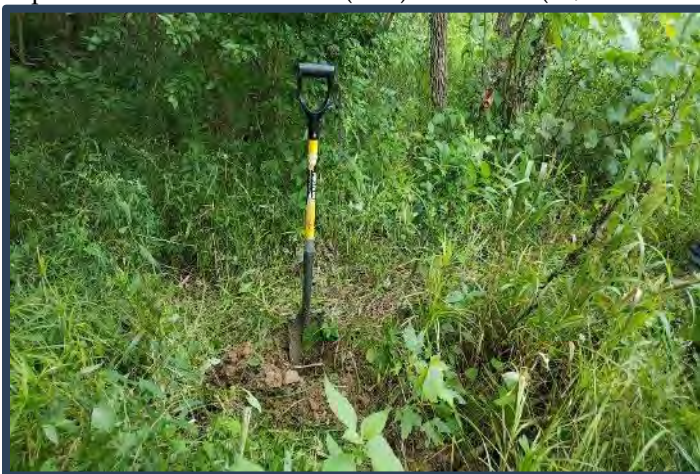
Photo 28: View of the soil profile observed at DP-2-OUT. This location did not meet any of the hydric soil indicators (07/24/18).

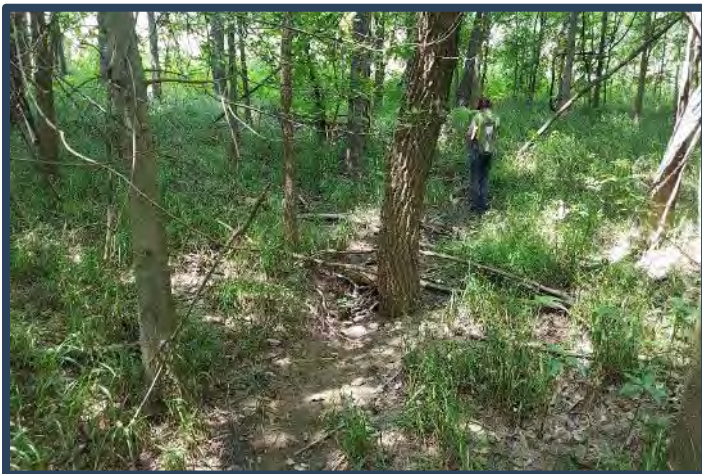
Photo 32: View of the soil profile observed at DP-3-4-OUT. This location did not meet any of the hydric soil indicators (07/24/18).

Data Point 3-4 OUT (DP-3-4-OUT) was dominated by *Maclura pomifera* (Osage-orange, FACU, 70%) and *Populus deltoides* (cottonwood, FAC, 30%) in the tree stratum. The sapling/shrub stratum was dominated by *Acer negundo* (boxelder, FAC, 15%). The herbaceous stratum was dominated by *Acer negundo* (boxelder, FAC, 4%). This point met the hydrophytic vegetation criterion. The soil profile did not meet the hydric soil criterion. No hydrology indicators were observed. Since only one of the three wetland criteria were met at DP-3-2-OUT, this point was determined to be upland. This data point helped establish the boundary of Wetland 3, which was determined based on changes in vegetation and hydrology.

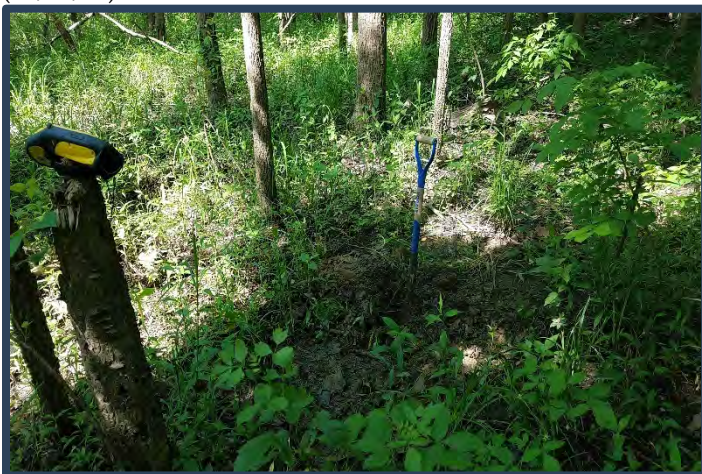
Photo 34: View of the soil profile observed at Wetland 3 (DP-3-4-IN). This location met the depleted matrix (F3) indicator. (07/24/18).

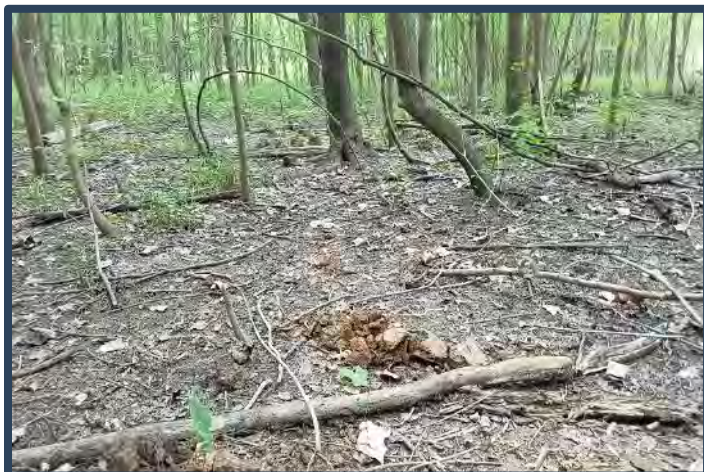
Photo 36: View of the soil profile observed at Wetland 3 (DP-3-2-IN). This location met the depleted matrix (F3) indicator (07/24/18).

Data Point 3-2 IN (DP-3-2-IN) was dominated by *Acer negundo* (boxelder, FAC, 70%) in the tree stratum. No vegetation was observed within the herbaceous stratum. This point met the hydrophytic vegetation criterion, because it passed the dominance test and the prevalence test. The soil profile met the hydric soil criterion, because it exhibited the Depleted Matrix [F3] indicator. Two primary indicators of hydrology (Drift Deposits [B3] and Water-Stained Leaves [B9]) and two secondary indicators of hydrology (Surface Soil Cracks [B6] and Crayfish Burrows [C8]) were observed. Since all three wetland criteria were met at DP-3-2-IN, this area was identified as Wetland 3.

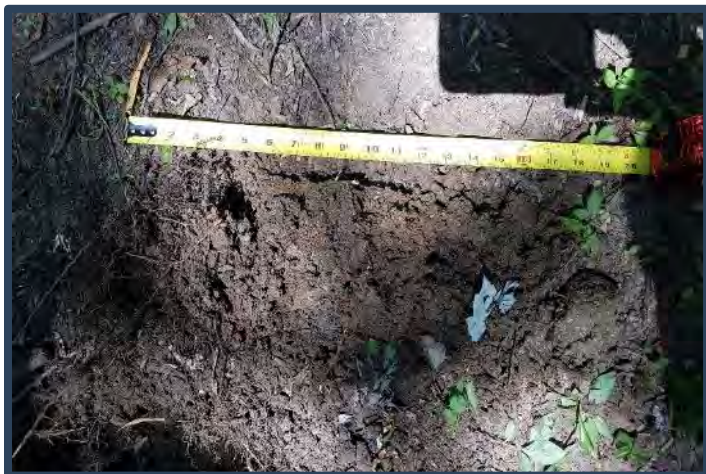
Photo 42: View of the soil profile observed at DP-3-3-OUT (07/24/18). No hydric soil indicators were observed.

Data Point 3-3 OUT (DP-3-3-OUT) was dominated by *Acer rubrum* (red maple, FAC, 90%) in the tree stratum. The herbaceous stratum was dominated by *Laportea canadensis* (Canadian wood-nettle, FACW, 40%). This point met the hydrophytic vegetation criterion, because it passed the dominance test and the prevalence test. No hydric soil indicators were observed. One secondary indicator of hydrology (FAC-Neutral Test [D5]) was observed. Since only one of the three wetland criteria were met at DP-3-3-OUT, this point was determined to be upland. This data point helped establish the boundary of Wetland 3, which was determined based on the changes in hydrology.

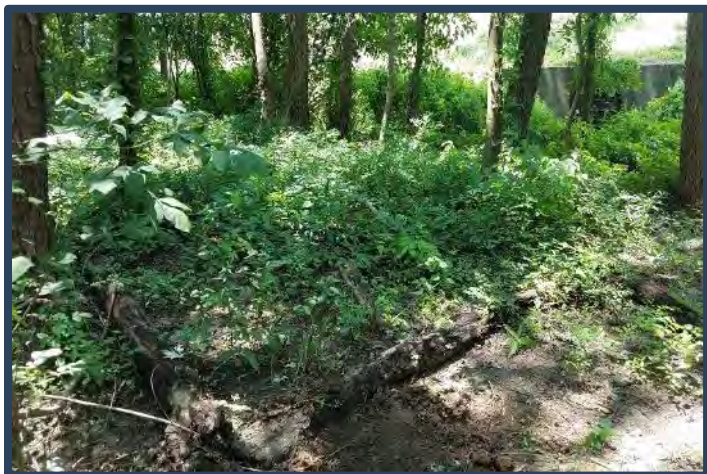
Photo 43: View of the soil profile observed at Wetland 3 (DP-3-1-IN). This location met the depleted matrix (F3) indicator (07/24/18).

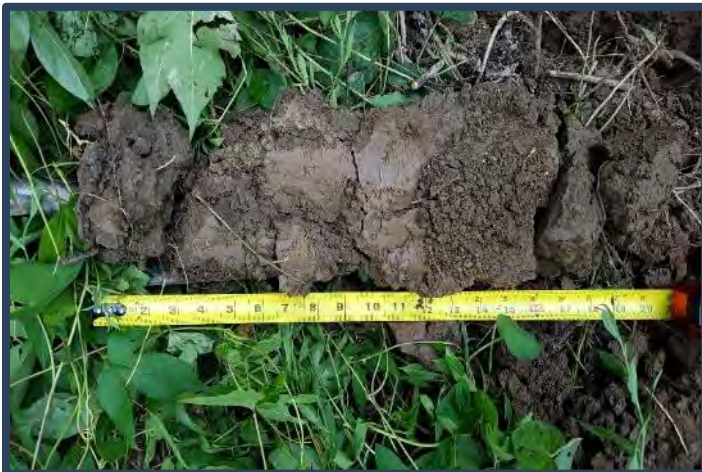
Photo 54: View of the soil profile observed at Wetland 3 (DP-3-1-IN). This location met the depleted matrix (F3) and depleted below dark surface (A11) indicators. Note the crayfish burrow, a wetland hydrology indicator (07/24/18).

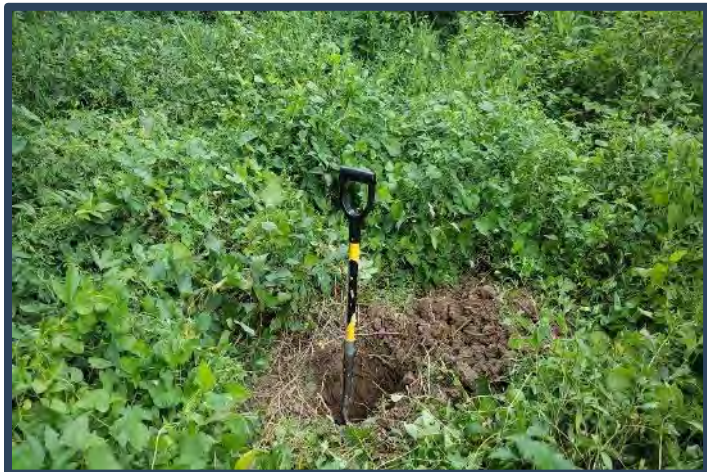
Photo 55: View of the soil profile observed at DP-3-1-OUT (07/24/18). No hydric soil indicators were observed.

Data Point 3-1 OUT (DP-3-1-OUT) was dominated by *Acer saccharinum* (silver maple, FACW, 30%) in the tree stratum. This data point was dominated by *Toxicodendron radicans* (eastern poison ivy, FAC, 60%) and *Convolvulus arvensis* (field bindweed, NI, 30%) in the herbaceous stratum. DP-3-1-OUT met the hydric vegetation criterion, because it passed the dominance test and the prevalence test. No hydric soil indicators were observed. One secondary indicator of hydrology (FAC-Neutral Test [D5]) was observed. Since only one of the three wetland criteria were met at DP-3-1-OUT, this point was determined to be upland. This data point helped establish the boundary of Wetland 3, which was determined based on changes in hydrology.

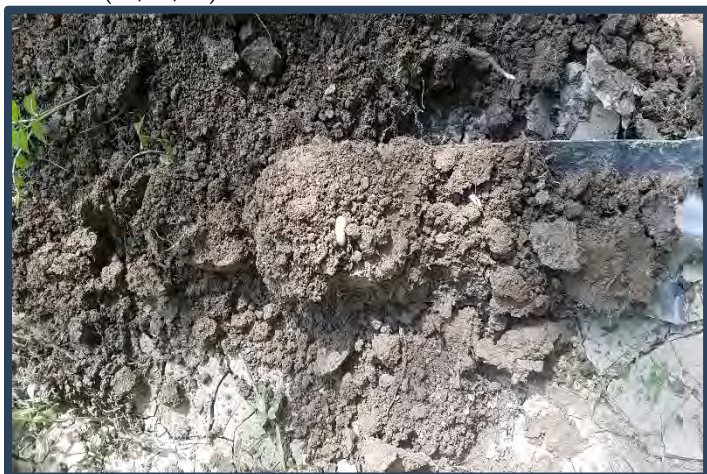
Photo 57: View of DP-4B-3-OUT with OW-1, a borrow pit, in the background, facing south (05/16/19).

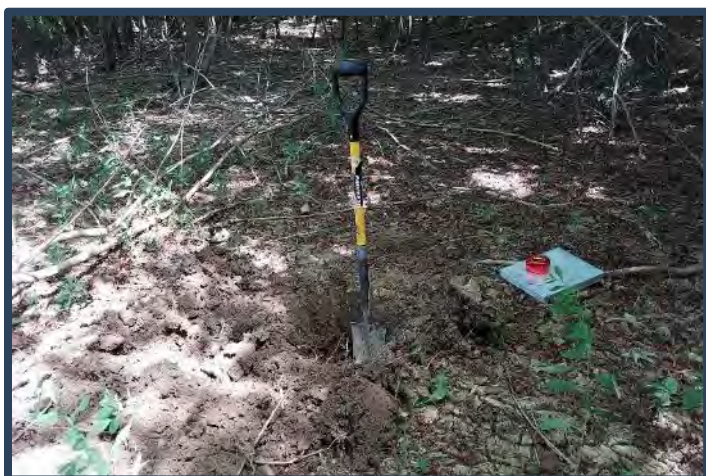
Photo 62: View of the soil profile observed at Wetland 4A (DP-4A-1-IN). This location met the depleted matrix (F3) indicator. Note the surface soil cracks (07/25/18).

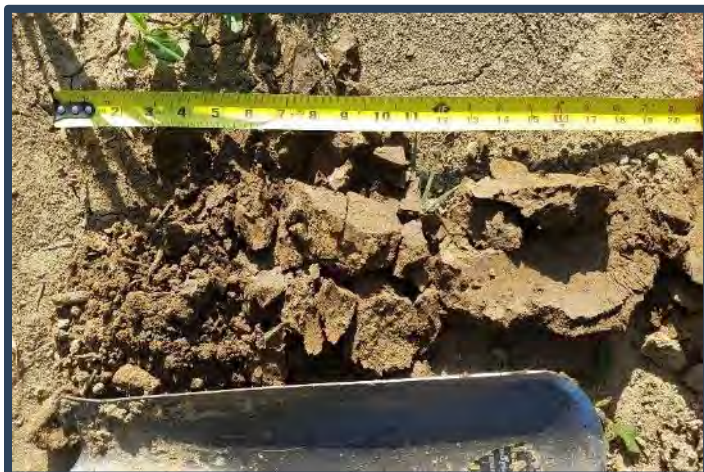
Photo 97: View of DP-5A-1-OUT facing south. This location was well drained (07/26/18).

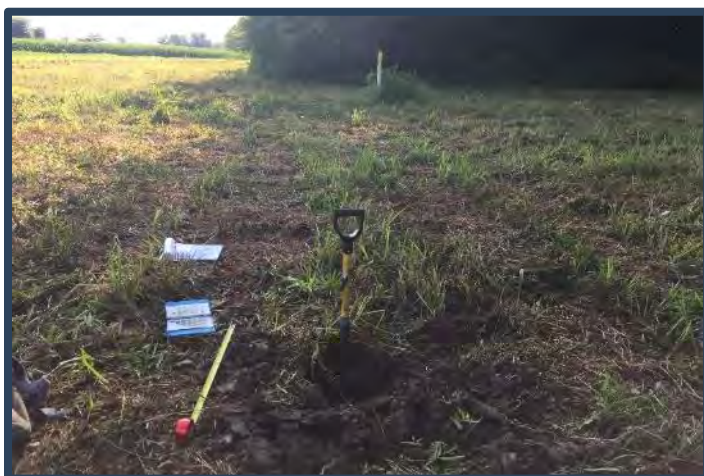
Photo 98: View of the soil profile observed at DP-5A-1-OUT (07/26/18). No hydric soil indicators were observed.

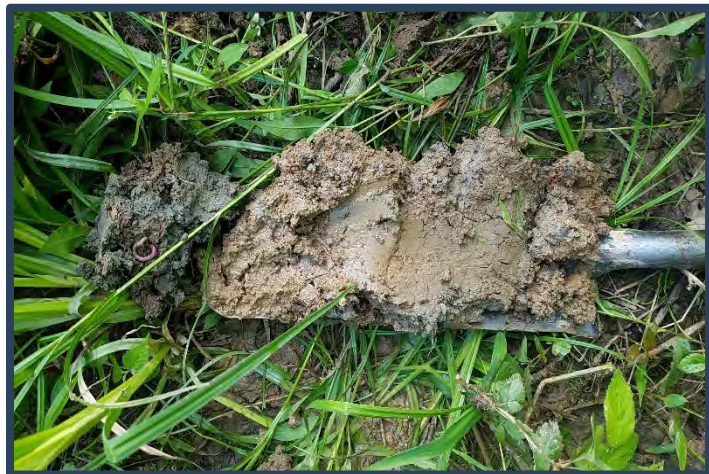
Photo 105: View of the soil profile observed at Wetland 5B (DP-5B-1-IN). This location met the depleted matrix (F3) and the depleted below dark matrix (A11) indicators (07/26/18).

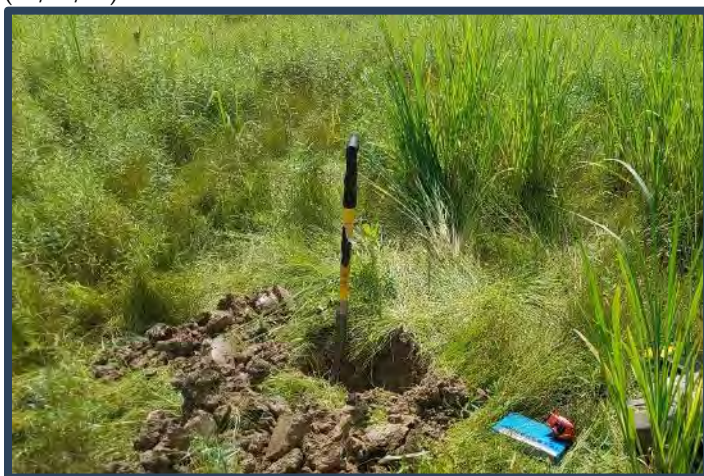
Photo 112: View of the soil profile observed at DP-5D-1-OUT (07/26/18). No hydric soil indicators were observed.

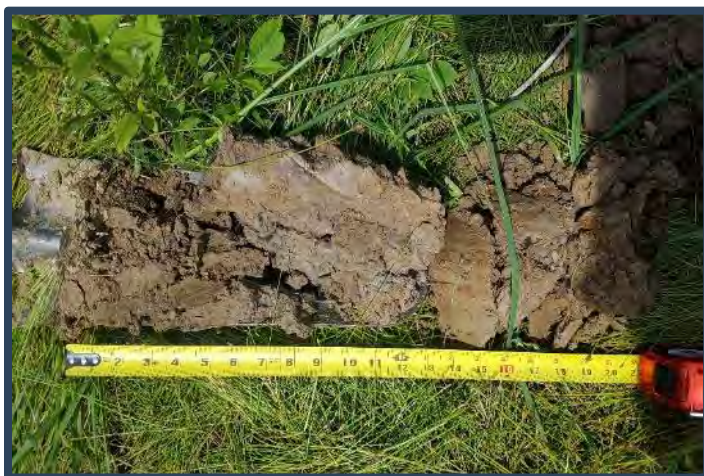
Photo 113: View of Wetland 5D (DP-5D-1-IN) facing west (07/26/18). This location met all three wetland criteria

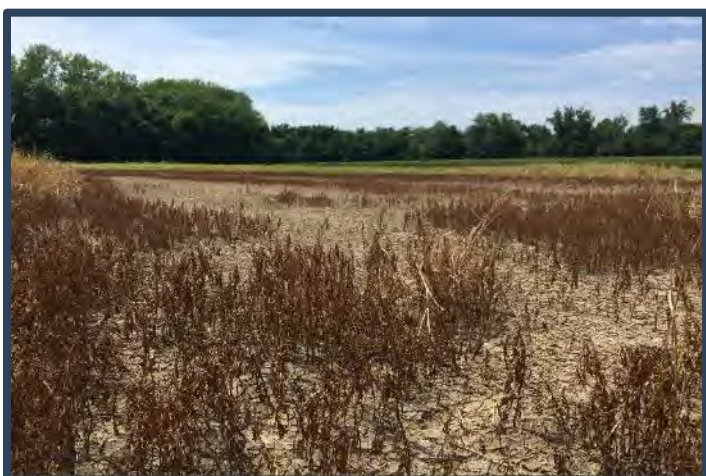
Photo 119: View of upland ridge at DP-5D-2-OUT between swales of Wetland 5D, facing west (05/17/19).

Data Point 5D-2 OUT (DP-5D-2-OUT) was positioned on a moderately well-drained ridge between two swales that are part of Wetland 5. This location had virtually no vegetation with only *Brassica rapa* (field mustard, NI, 1%) present in the herbaceous stratum. This point did not meet the hydrophytic vegetation criterion. No hydric soil indicators were observed. One secondary indicators of hydrology (Surface Soil Cracks [B6]) was observed. Since none of the three wetland criteria were met at DP-5D-2-OUT, this point was determined to be upland. This data point helped establish the boundary of Wetland 5D, which was determined based on changes in elevation and hydrology.

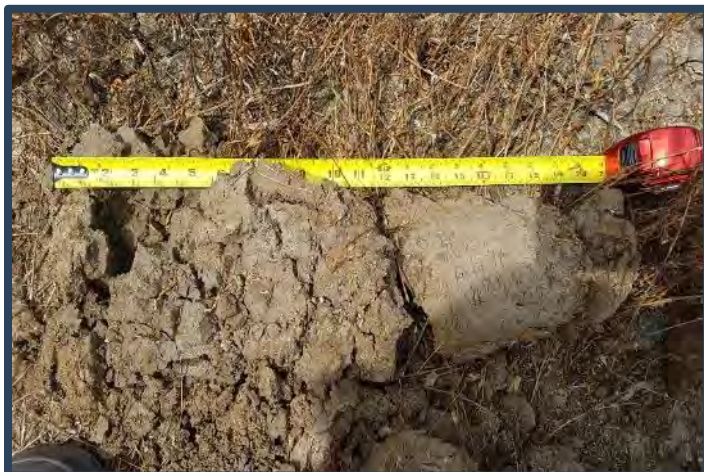
Photo 120: View of Wetland 5D facing northwest. Note surface soil cracks and herbicide impact on vegetation (07/26/18).

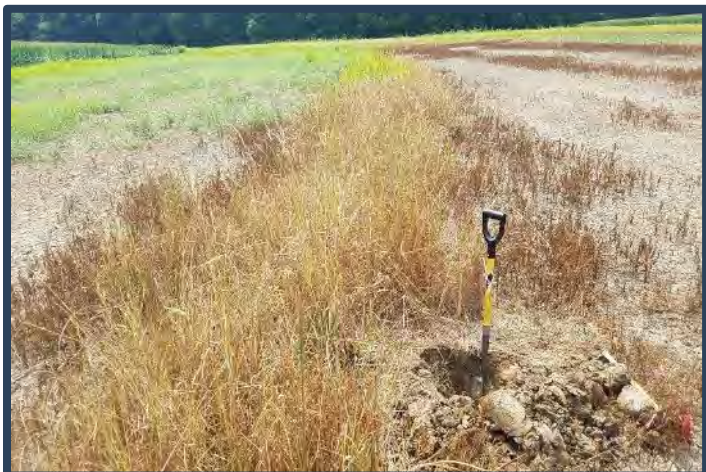
Photo 121: View of the soil profile observed at Wetland 5D (DP-5D-2-IN). This location met the depleted matrix (F3) indicator (07/26/18).

Data Point 5D-2 IN (DP-5D-2-IN) was evaluated, because it exhibited hydrophytic vegetation. The herbaceous stratum was dominated by *Echinochloa muricata* (rough barnyard grass, FACW, 80%). This point met the hydrophytic vegetation criterion, because it passed the rapid test, dominance test, and the prevalence test. The soil profile met the hydric soil criterion, because it exhibited the Depleted Matrix (F3) indicator. One primary indicator of hydrology (Algal Mat or Crust [B4]) and five secondary indicators of hydrology (Surface Soil Cracks [B6], Drainage Patterns [B10], Crayfish Burrows [C8], Geomorphic Position [D2], and FAC-Neutral Test [D5]) were observed. Since all three wetland criteria were met at DP-5D-2-IN, this area was identified as Wetland 5D.

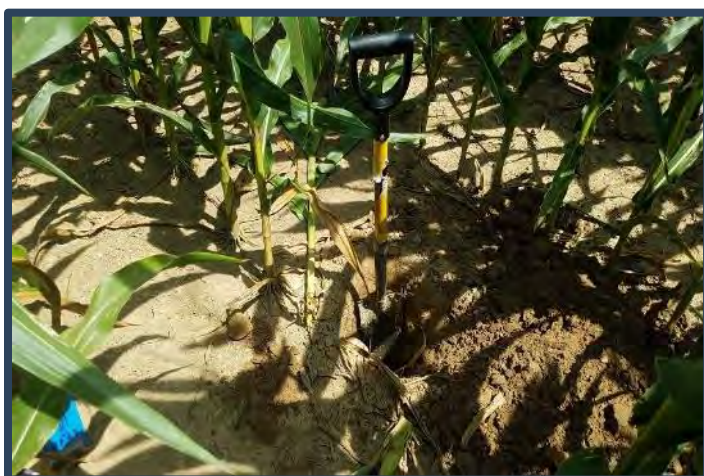
Photo 124: View of the soil profile observed at DP-5D-2-OUT (07/26/18).

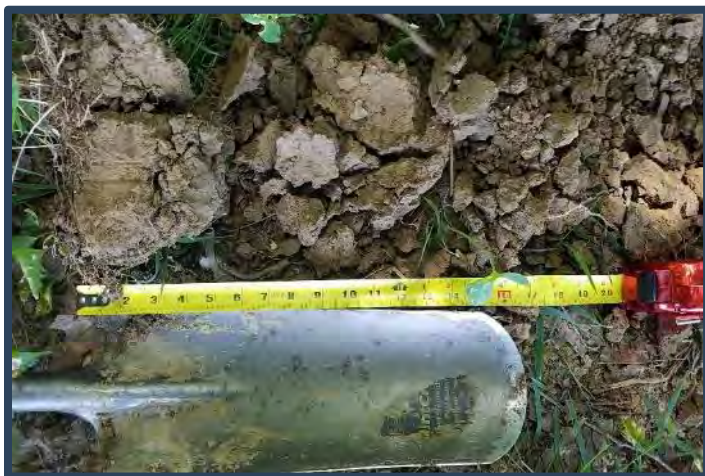
Photo 129: View of DP-6-1-OUT facing east. This location was well-drained and did not have hydric soils (07/26/18).

Data Point 6-1 OUT (DP-6-1-OUT) was adjacent to an agricultural field and a utility right-of-way. The area was on a higher stream terrace that appears to be moderately well drained. The tree stratum was dominated by *Acer rubrum* (red maple, FAC, 40%) and *Ulmus americana* (American elm, FACW, 30%). The herbaceous stratum was dominated by *Chasmanthium latifolium* (Indian wood-oats, FACU, 50%) and *Campsis radicans* (trumpet-creeper, FAC, 20%). This point met the hydrophytic vegetation criterion, because it passed the dominance test. No hydric soil indicators were observed. One secondary indicator of hydrology (Surface Soil Cracks [B6]) was observed. Since only one of the three wetland criteria was met at DP-6-1-OUT, this point was determined to be upland. This data point helped establish the boundary of Wetland 6, which was determined based on changes in hydrology.

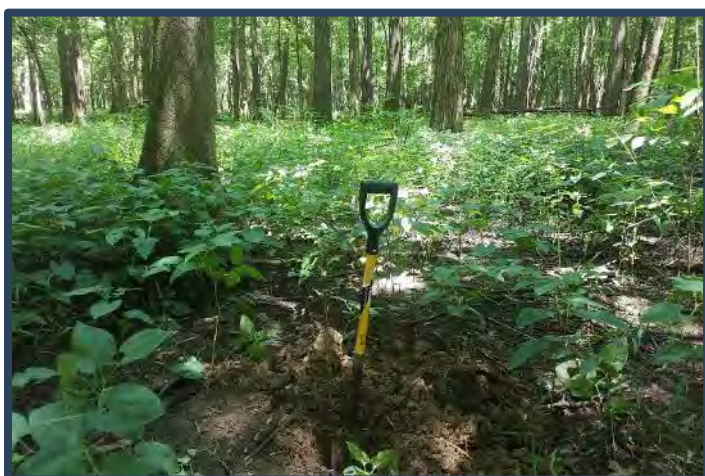
Photo 131: View of the soil profile observed at Wetland 6 (DP-6-1-IN). This location met the depleted matrix (F3) indicator (07/26/18).

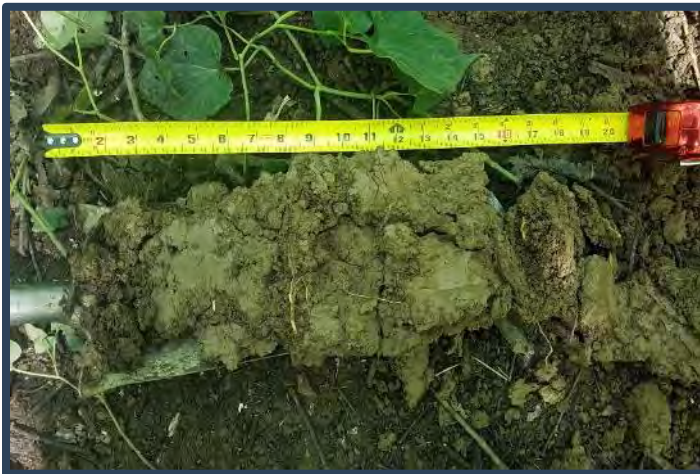
Photo 132: View of Wetland 6 (DP-6-2-IN) facing east (07/26/18). This location met all three wetland criteria.

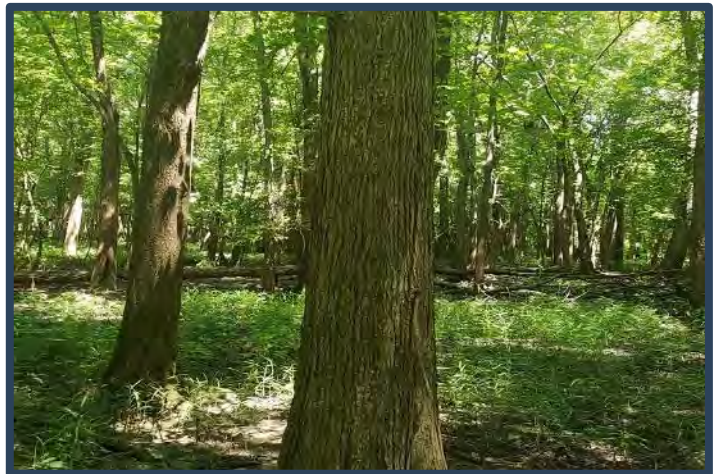
Photo 133: View of the soil profile observed at Wetland 6 (DP-6-2-IN). This location met the depleted matrix (F3) and the depleted below dark surface (A11) indicators (07/26/18).

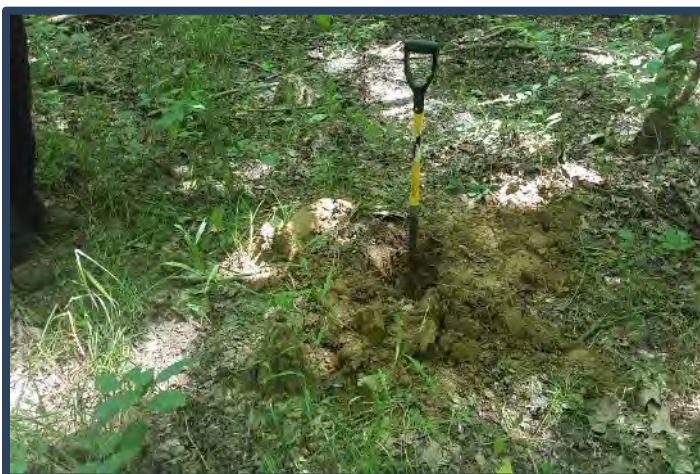
Photo 136: View of the soil profile observed at Wetland 6 (DP-6-3-IN). This location met the depleted matrix (F3) and depleted below dark surface (A11) indicator (07/26/18).

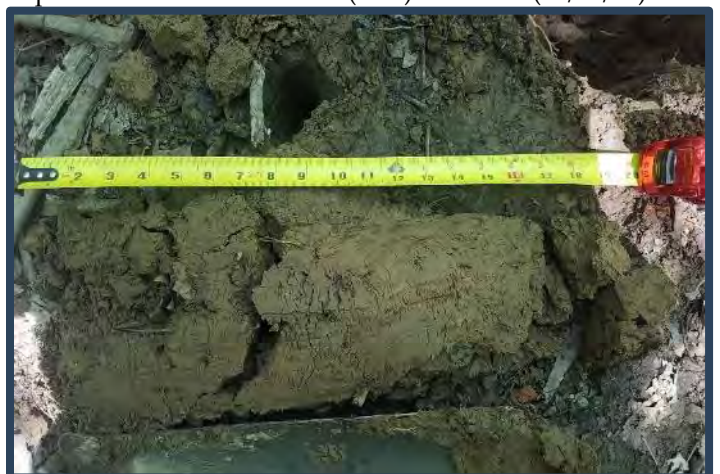
Photo 137: View of Wetland 6 (DP-6-3-IN) facing north. This location met all three wetland criteria (07/26/18).

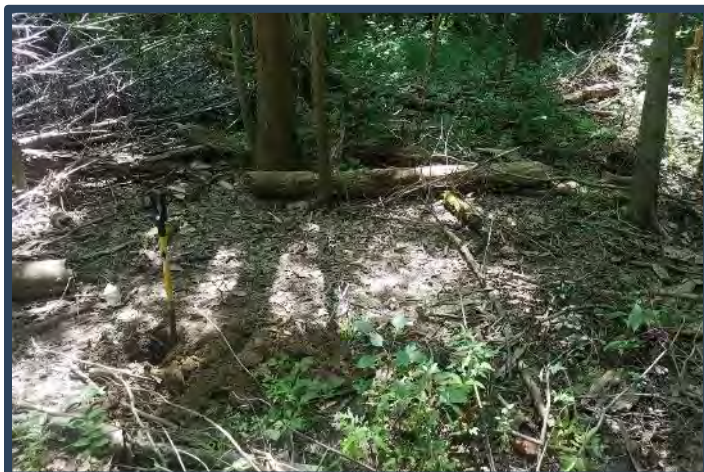
Photo 138: View of the soil profile observed at Wetland 6 (DP-6-4-IN). This location met the depleted matrix (F3) indicator (07/26/18).

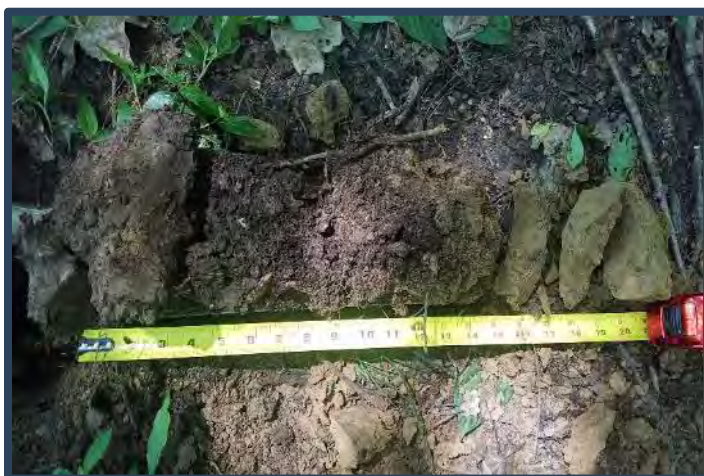
Photo 140: View of DP-6-4-OUT facing east (07/26/18). Only the hydric soil criterion was met at this location.

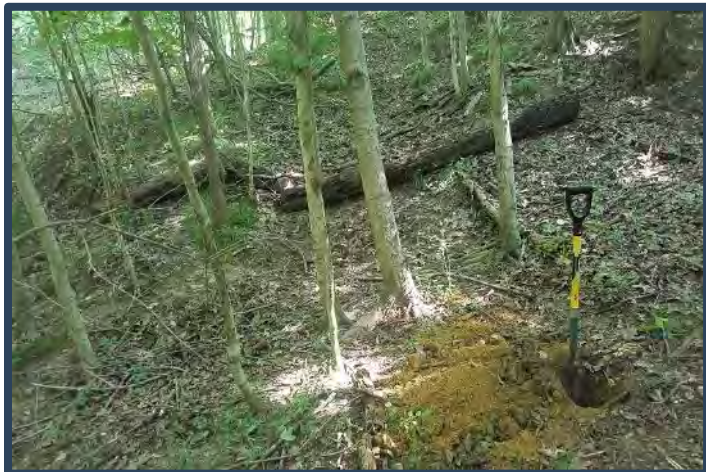
Photo 162: View of the soil profile observed at DP-7-OUT. This well-drained soil is not hydric (07/26/18).

Data Point 7 OUT (DP-7-OUT) was taken on a hillslope above an old farm pond. The soils at this data point appear to be well drained. This location was dominated by *Acer rubrum* (red maple, FAC, 98%) in the tree stratum. The herbaceous stratum was primarily bare, but dominated by *Toxicodendron radicans* (eastern poison ivy, FAC, 5%). This point met the hydrophytic vegetation criterion, because it passed the dominance test and prevalence test. No hydric soil indicators were observed. One secondary hydrology indicator (Geomorphic Position [D2]) was observed. Since only one of the three wetland criteria were met at DP-7-OUT, this point was determined to be upland. This data point helped establish the boundary of Wetland 7, which was determined based on changes in hydrology.

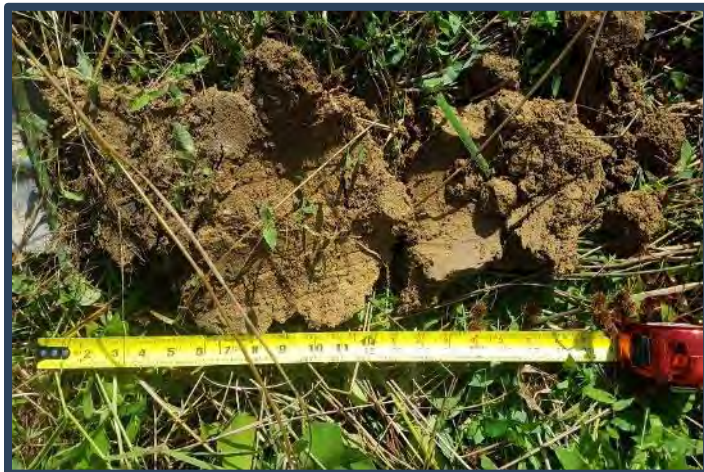
Photo 175: View of DP-8-OUT facing west. This location did not meet all three wetland criteria (07/26/18).

Data Point 8 OUT (DP-8-OUT) lies within an agricultural field and appeared to be well drained. This location was dominated by *Glycine max* (soybeans, NI, 90%) in the herbaceous stratum. This point did not meet hydrophytic vegetation criterion. No hydric soil or hydrology indicators were observed. Since none of the three wetland criteria were met at DP-8-OUT, this point was determined to be upland. This data point helped establish the boundary of Wetland 8, which was determined based on changes in vegetation and hydrology.

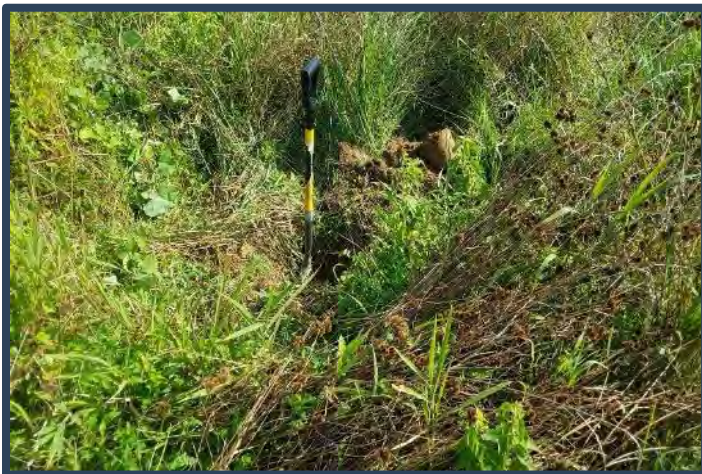
Photo 176: View of the soil profile observed at Wetland 8 (DP-8-IN). This location met the depleted matrix (F3) indicator (07/26/18).

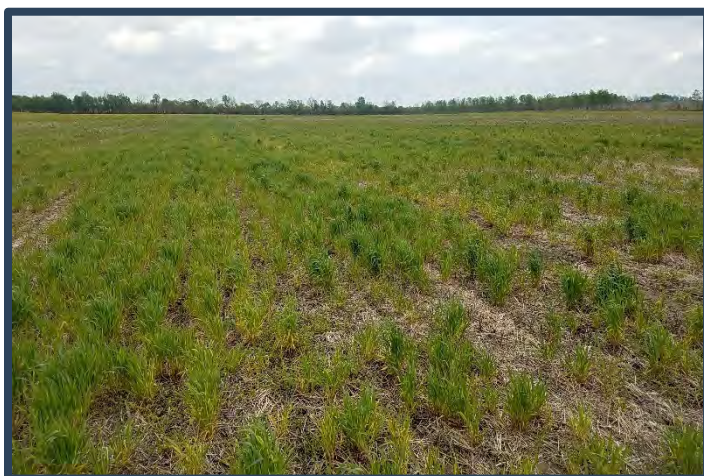
Photo 218: Broken agricultural drainage tiles present in fields near North Fork Canoe Creek (04/24/19).

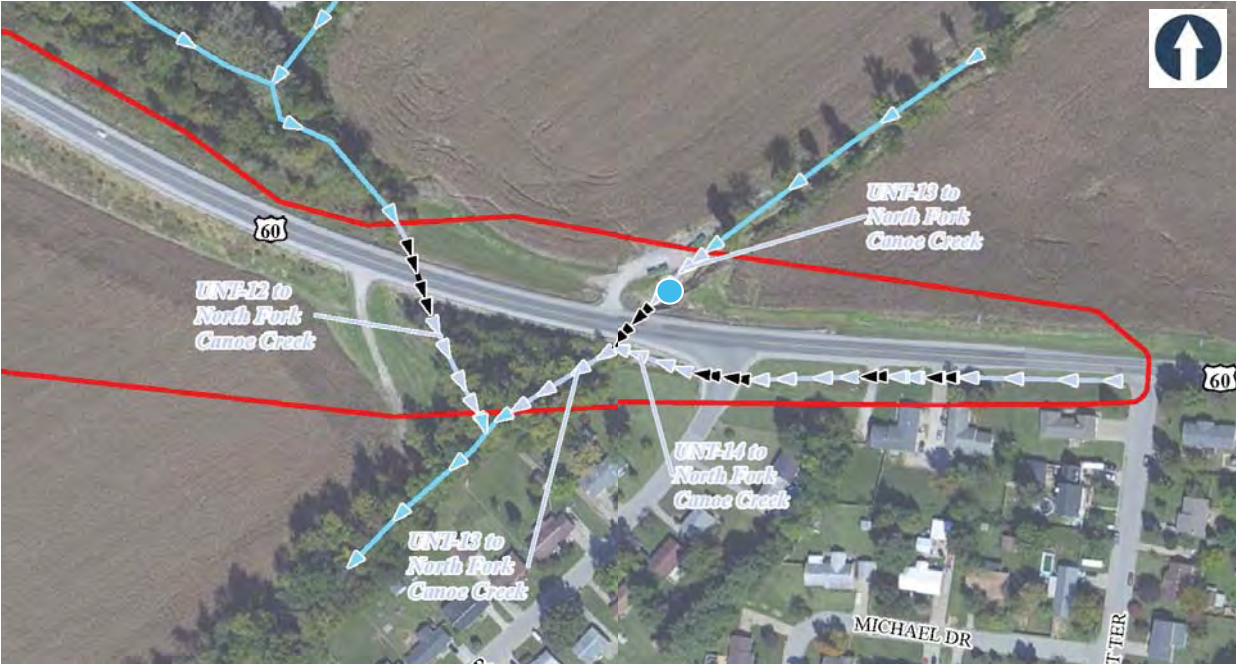
Stream Drawing:

There are some shallow pools throughout the channel. Crayfish burrows and frogs were observed. Trash/debris was present within the channel. Approximately 114 feet of this channel are within the right-of-way and 61 feet of channel will be within a culvert. The Hwy 60 culvert would be extended to the southwest.

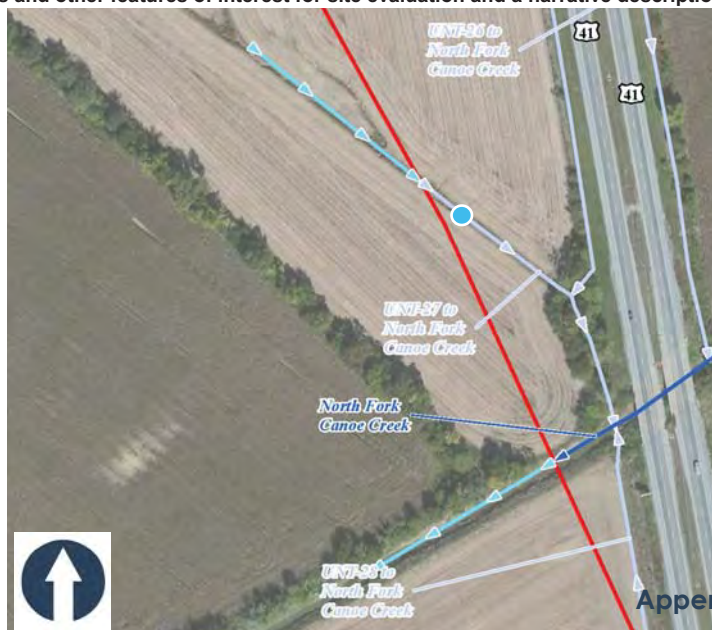
This is an agricultural stream/ditch west of US 41. The channel is dry with cracked soils. The direct channel impacts will be calculated when the I-69 south interchange design is completed.
