# OHIO RIVER CROSSING

## Freshwater Mussel Survey Report

I-69 Ohio River Crossing Project  
Evansville, IN and Henderson, KY

December 8, 2018

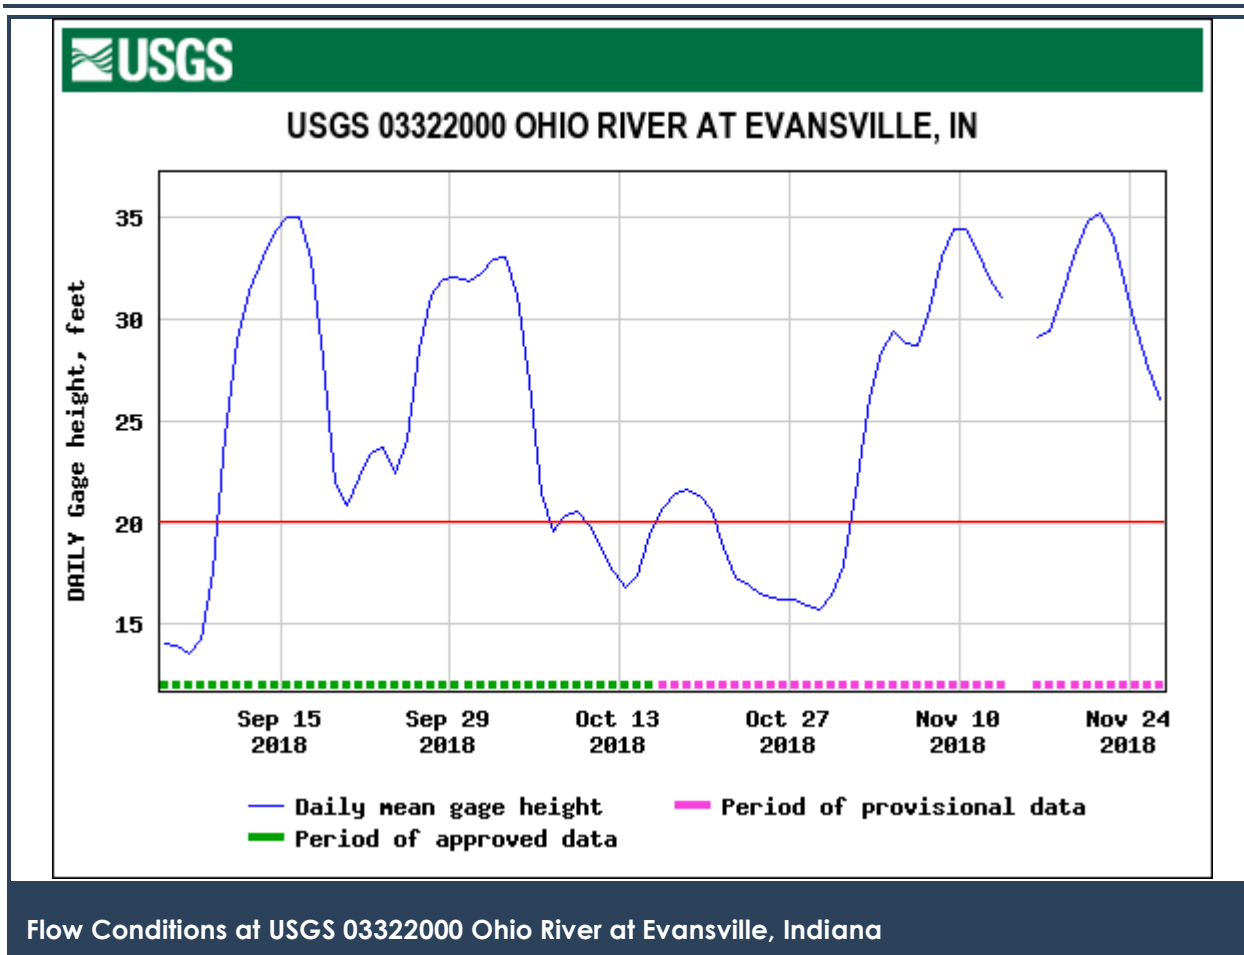
River discharges were unusually high in September and October of 2018 as a result of the remnants of two hurricanes moving through the watershed. Flow conditions were unsuitable for surveying for extended periods prior to mobilization by the survey team (Figure 3.1-1). Gauge height of less than 6m/20ft were suitable for diving, leaving the two survey windows (October 9-15, October 27-31) as the only times for completing safe and accurate dive surveys. Dive operations were suspended on October 13 as a catfish fishing tournament was ongoing, resulting in overcrowding of recreational boats within the Survey Area. Dive crews first mobilized on September 9-10<sup>th</sup> but cancelled field plans due to rain from Hurricane Florence (Figure 3.1-2). At gauge heights of greater than 6m/20 ft, flows were too fast for divers to remain on the substrate without being pushed downstream. At gauge heights of ~6m/20 ft, depths were approximately 3m/10 ft higher than those collected during the side-scan sonar substrate determination (MCDI 2017). This caused significant challenges to diving operations, limiting bottom time, decreasing efficiency, and reducing ability to stay on the river bottom during extreme high flows. On October 30, 2018, a dive boat moored to a barge collecting core samples in the center of the channel to eliminate the necessity of anchoring, but velocities were too great for divers to remain on the river bottom.

Figure 3.1-1 Flow Conditions at USGS 03322000 Ohio River at Evansville, Indiana

River conditions made sampling a logistical challenge throughout the months of September and October, two months that, statistically speaking, are ideal for mussel surveys (Figure 4.1-1). Frequent prolonged periods of high flow resulted in velocities that made it impractical for divers to remain at depth on the substrate. Surveys were conducted in the only windows of opportunity provided during this period. Turbidity was high due to multiple basin-wide rain events prior to surveying but was not expected to have impacted efficacy of searching relative to normal conditions, as high catch per unit effort (CPUE) was recorded in multiple cells from multiple divers.

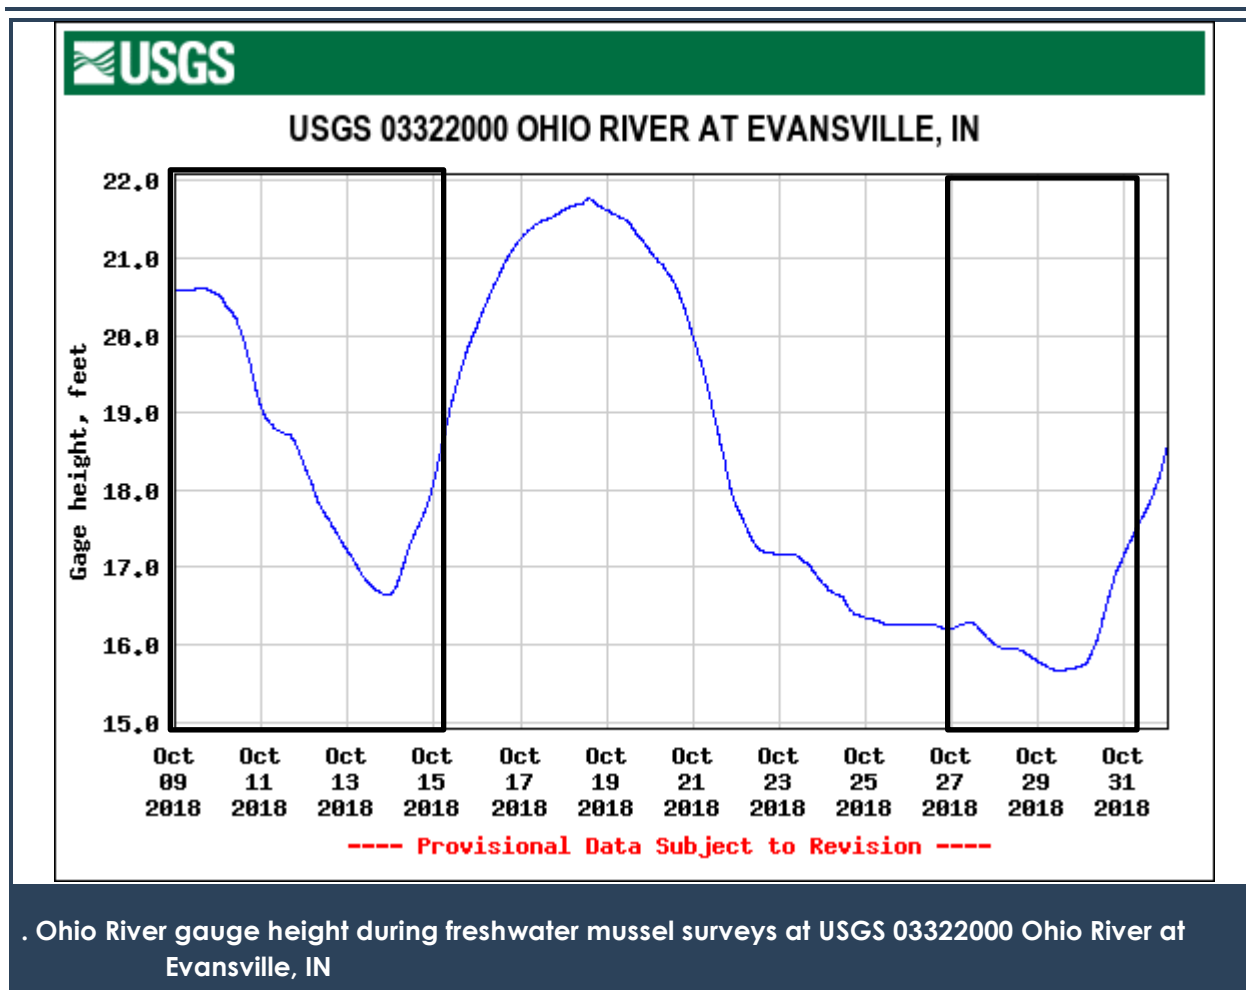
Water quality parameters were taken daily (except 10/27 & 10/28 when equipment was not yet onsite) as seen in Table 3.1-1. Turbidity was noticeably high, as both survey periods followed major rain events. Divers conducted the surveys in complete darkness that could not be ameliorated by dive lights and relied on tactile searching to locate mussels.

**Figure 3.1-2 Ohio River gauge height during freshwater mussel surveys at USGS 03322000 Ohio River at Evansville, IN**

Sampling was skewed towards shallow depths, as realized depths were significantly (~2.4m/8-3.6m/12ft) deeper than ideal conditions (Figure 3.1-2 & 3.2.1-1). Cells towards the thalweg of the river proved problematic as boats were often unable to anchor and maintain position or the combination of unstable substrate and high velocity made it impractical for divers to survey. Additionally, these cells were often in the shipping channel, which made anchoring of the boats for the necessary duration (i.e., > 30 minutes) difficult due to the frequency of barge traffic in the area. Cells were sampled in each depth category except the deepest (11m/35ft-14m/45ft), which only contained 2 cells. Negative values for depth indicated the cells were above water during acoustic surveying. All cells were under water during the mussel survey. Bathymetric data can be viewed in Figure A-8.

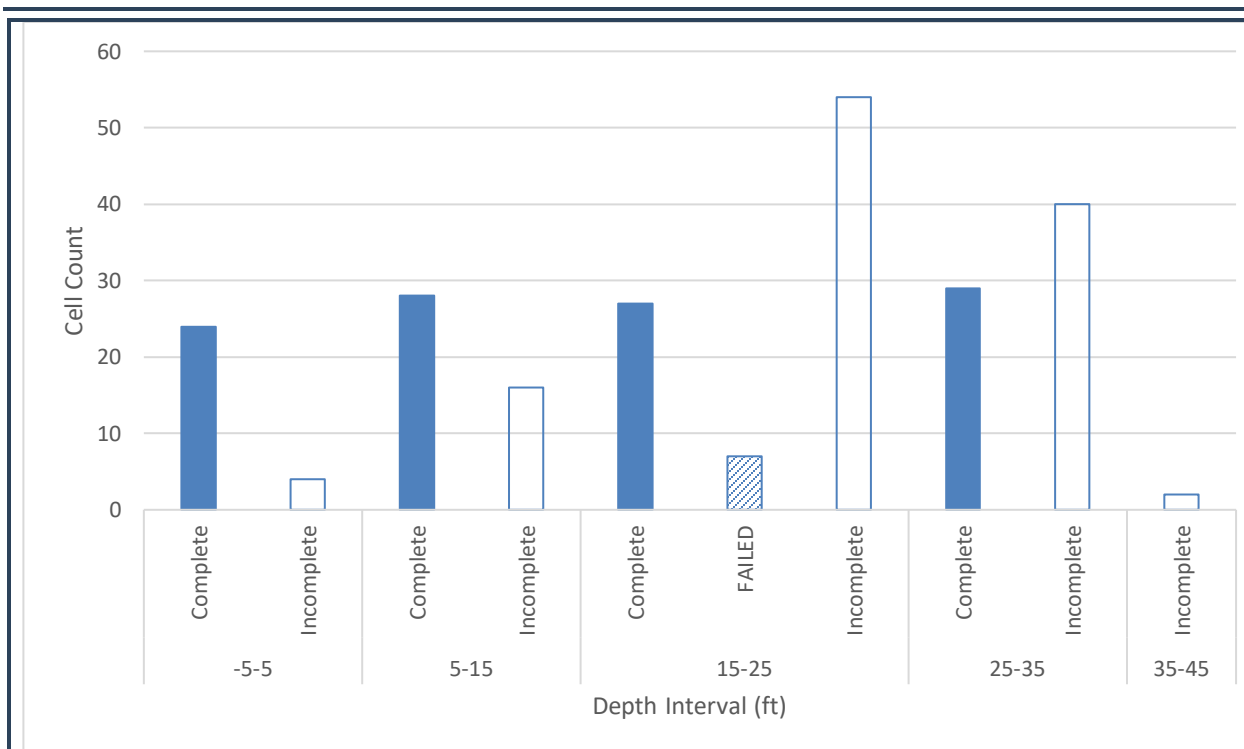
**Figure 3.2.1-1. Depth of completed, failed, and unsampled survey cells**

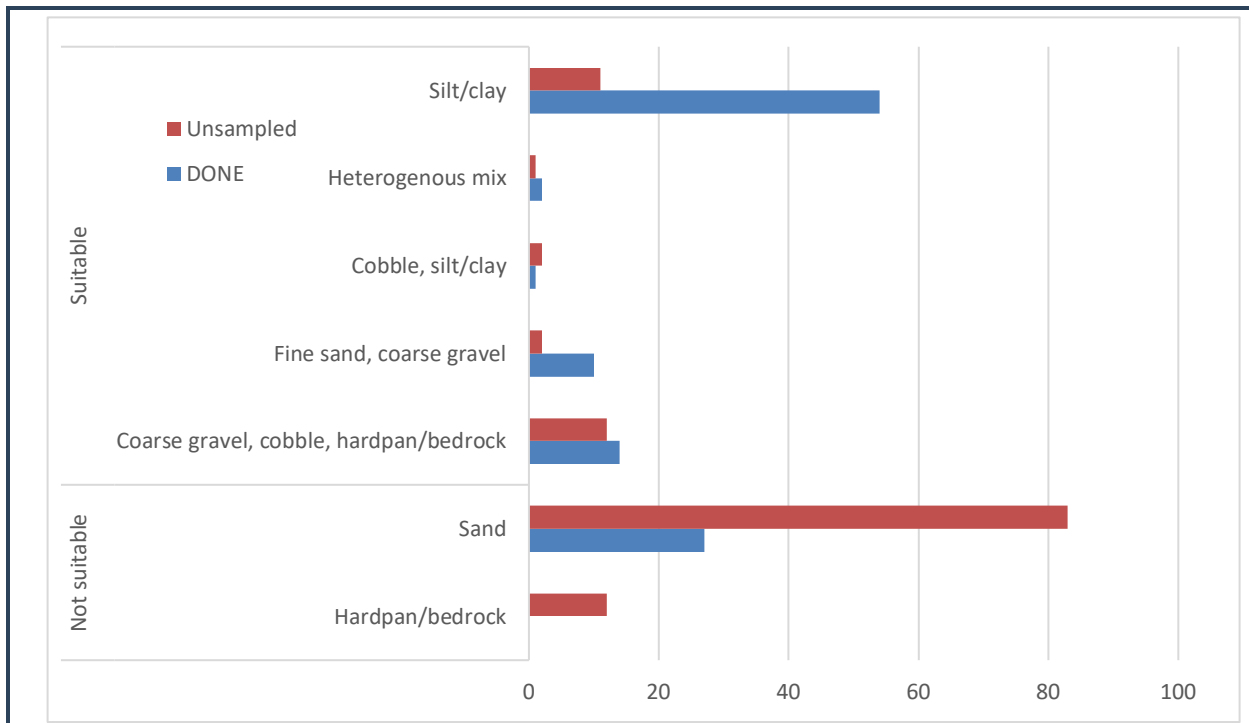
While still attempting for suitable spatial coverage of all cells, priority was placed on suitable substrate cells. As a result, 74 percent (81/109) of the suitable substrate cells were sampled, while 22 percent (27/122) of the unsuitable cells were sampled (Figure 3.2.2-1). Attempts were made during sampling to cover each substrate type as determined by the side-scan sonar. Hardpan/bedrock cells were unsampleable due to increased depths preventing divers from being able to stay on the river bottom for surveying. When the survey plan was prepared the water depths were based on depths taken during side-scan sonar efforts, approximately 10ft shallower.

**Figure 3.2.2-1 Total complete and unsampled cells for each acoustic substrate class**

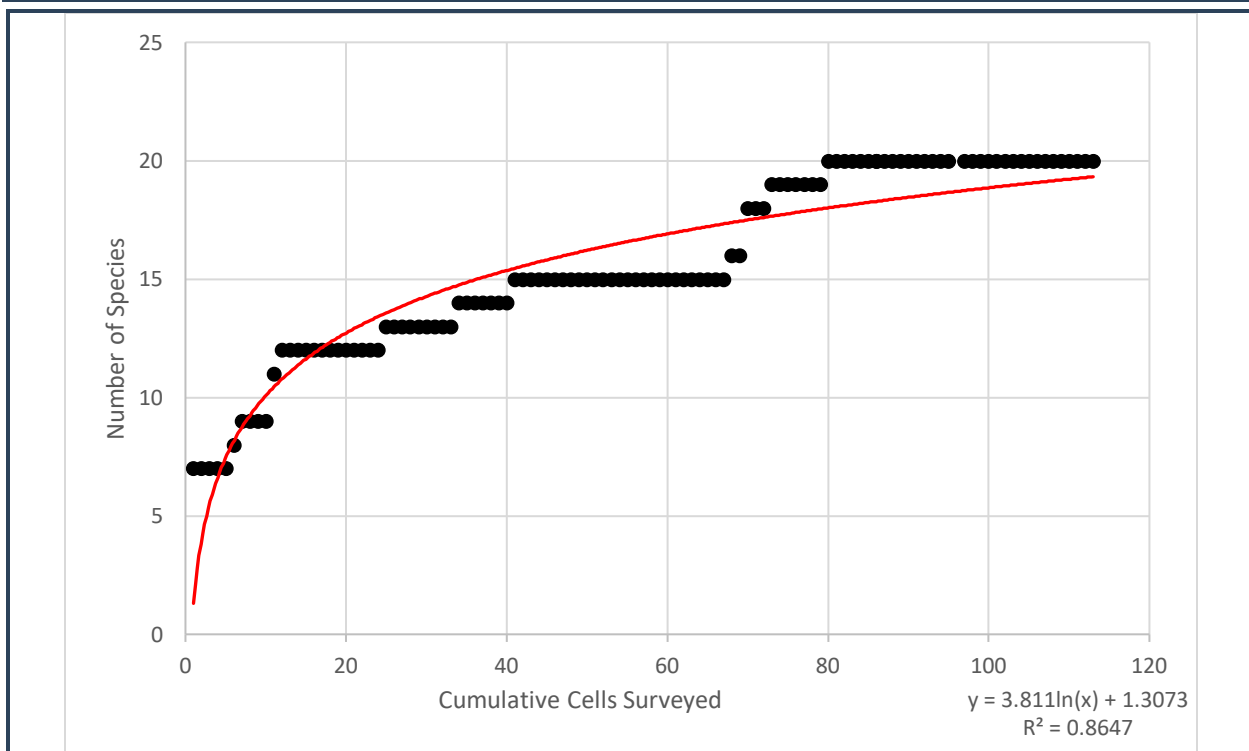
**Figure 3.3-1. Species accumulation curve showing the cumulative number of species recorded as a function of sampling effort**

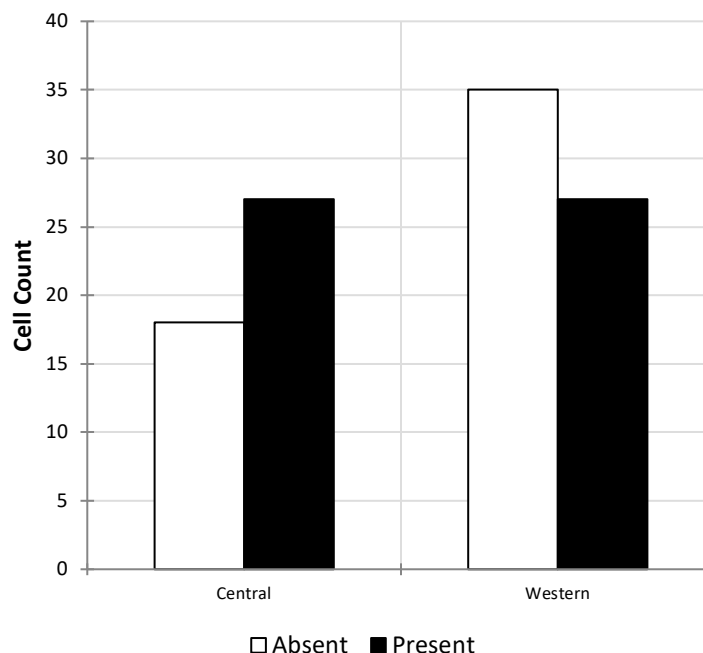
Live mussels were absent at lower frequencies in the Central Corridor (27 present, 18 absent) than in the Western Corridor (27 present, 35 absent) as shown in Figure 3.3.1-1. The frequency distributions for presence/absence in cells did not differ at the 0.05 level but approached statistical significance ( $X^2 = 2.82$ ,  $p = 0.09$ ,  $df = 3$ ). In addition to a higher ratio of presence/absence, catch per unit effort (CPUE, mussels per hour search time) was higher in cells in the Central Corridor (mean = 19.6) compared to the Western Corridor (mean = 2.3) (Table 3.3.1-1). The project overall had an average CPUE of 9.5 mussels per hour. The spatial distribution of CPUE and live mussel count data among survey cells is illustrated in Figures A-9 & A-10 and Figures A-11 & A-12, respectively. Average MacArthur diversity (MacArthur 1972) and species richness were also greater in the Central Corridor compared to the Western Corridor (Table 3.3.1-1). The spatial distribution of richness among survey cells is presented in Figures A-13 & A-14.

**Figure 3.3.1-1 Count of survey cells where live mussels were found (present) and not found (absent) for the Central and Western corridors**

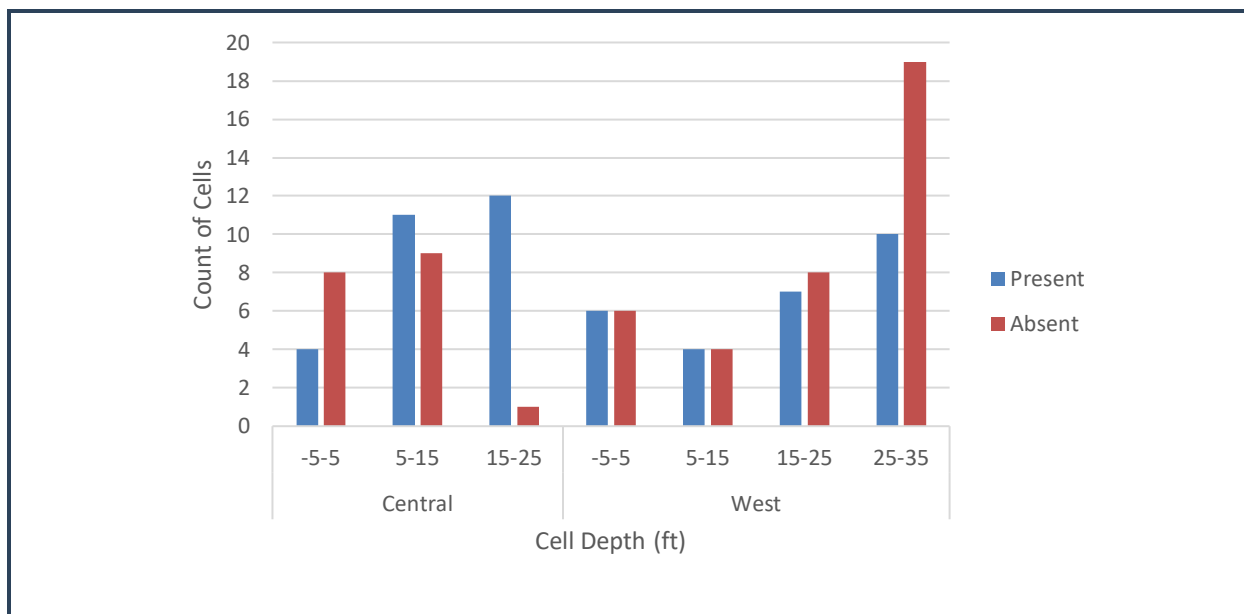
Mussel presence/absence was fairly consistent across depth ranges. Mussels were absent in higher proportions in two depth ranges, the -1.5m/-5ft to 1.5m/5ft range on the Central Corridor and the 25-35ft range on the Western Corridor (Figure 3.3.2-1). As shown in Table 3.3.2-1, the mean CPUE was low (<5 mussels per hour) in all depth categories, except for the 4.6m/15ft to 7.6m/25ft category on the Central Corridor, where the diverse and abundant mussel bed was located. Average MacArthur Diversity Index was similar across all depth categories, with a maximum of 2.33 in the shallow (-1.5m/-5ft to 1.5m/5ft) range on the Central Corridor, and a minimum of 1.63 in the shallow range on the Western Corridor. Average species richness by cell was greatest (5.25) in the 4.6m/15ft to 7.6m/25ft range on the Central Corridor.

**Figure 3.3.2-1 Count of survey cells where live mussels were found (present) and not found (absent) by cell depth for the Central and West Corridors**

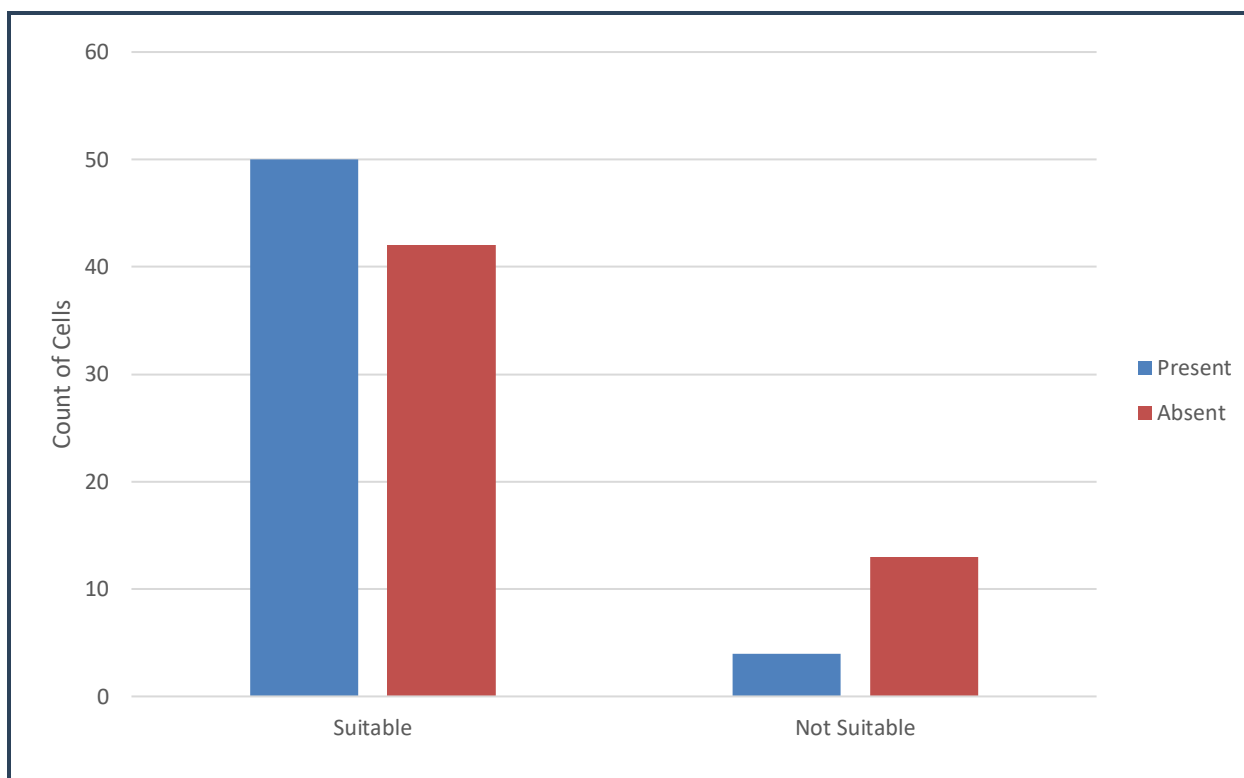
Live mussels were present in the majority of suitable substrate (50 of 92), while only present in 4 of the 17 sampled unsuitable habitats (Figure 3.3.3-1). When isolating individual substrate groups, live mussels were more frequently present than absent in the suitable sand, silt/clay, and coarse gravel, cobble, hardpan/bedrock categories (Figure 3.3.3-2). This analysis separated sand substrates into those with intruding 'suitable' substrate types and those that were 100% sand. Suitable sand cells (minority suitable substrate) had a higher ratio of presence to absence than that of unsuitable sand (isolated sand) cells (Figure 3.3.3-2). There were no mussels found in the heterogeneous mixture or cobble/silt/clay habitat classes. As shown in Table 3.3.3-1, the mean CPUE per cell was far greater in the coarse gravel/cobble/hardpan/bedrock acoustic class (49.59 mussels/hr). The mean species richness (4.92) was also greatest for the coarse gravel/cobble/hardpan/bedrock acoustic class. Total species richness was greatest for the coarse gravel/cobble/hardpan/bedrock acoustic class as well (Figure 3.3.3-2).

**Figure 3.3.3-1. Number of survey cells where live mussels were found (present) and not found (absent) for potentially suitable and non-suitable habitat**

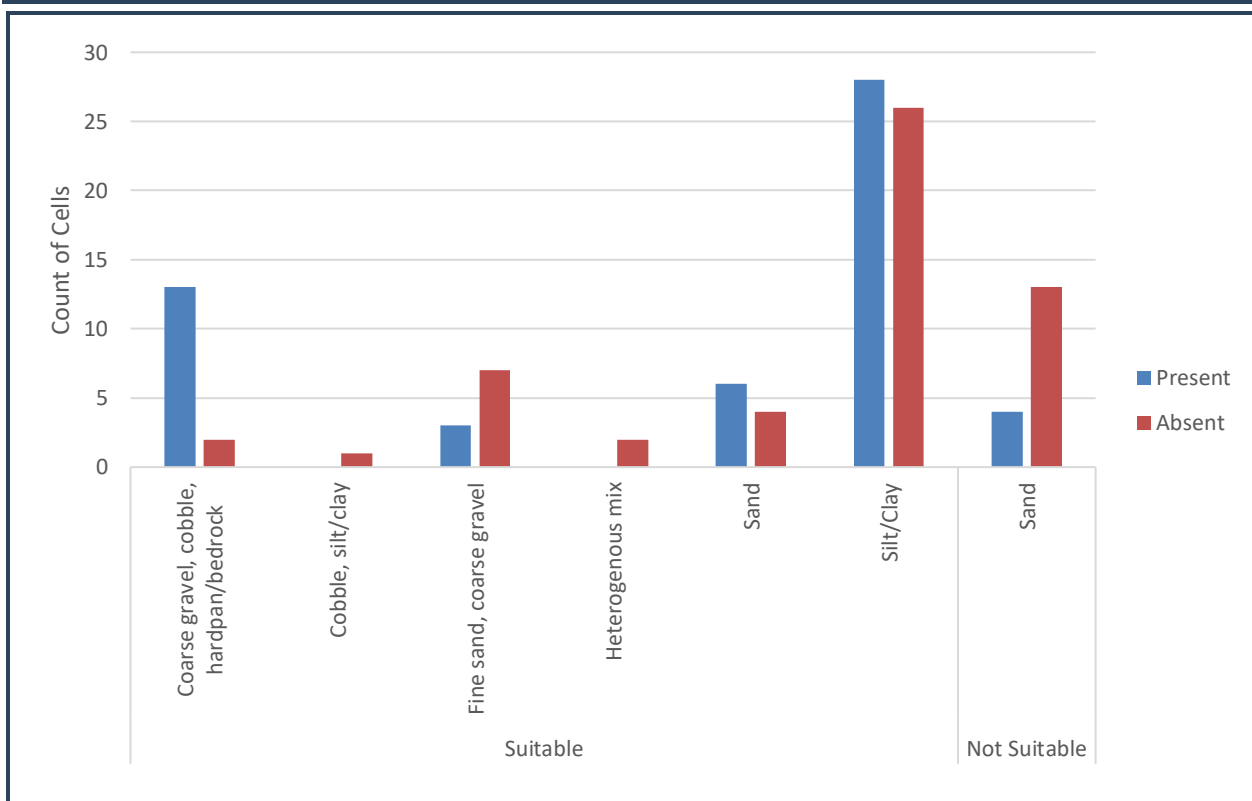
**Figure 3.3.3-2. Number of survey cells where live mussels were found (present) and not found (absent) for each acoustic substrate class**

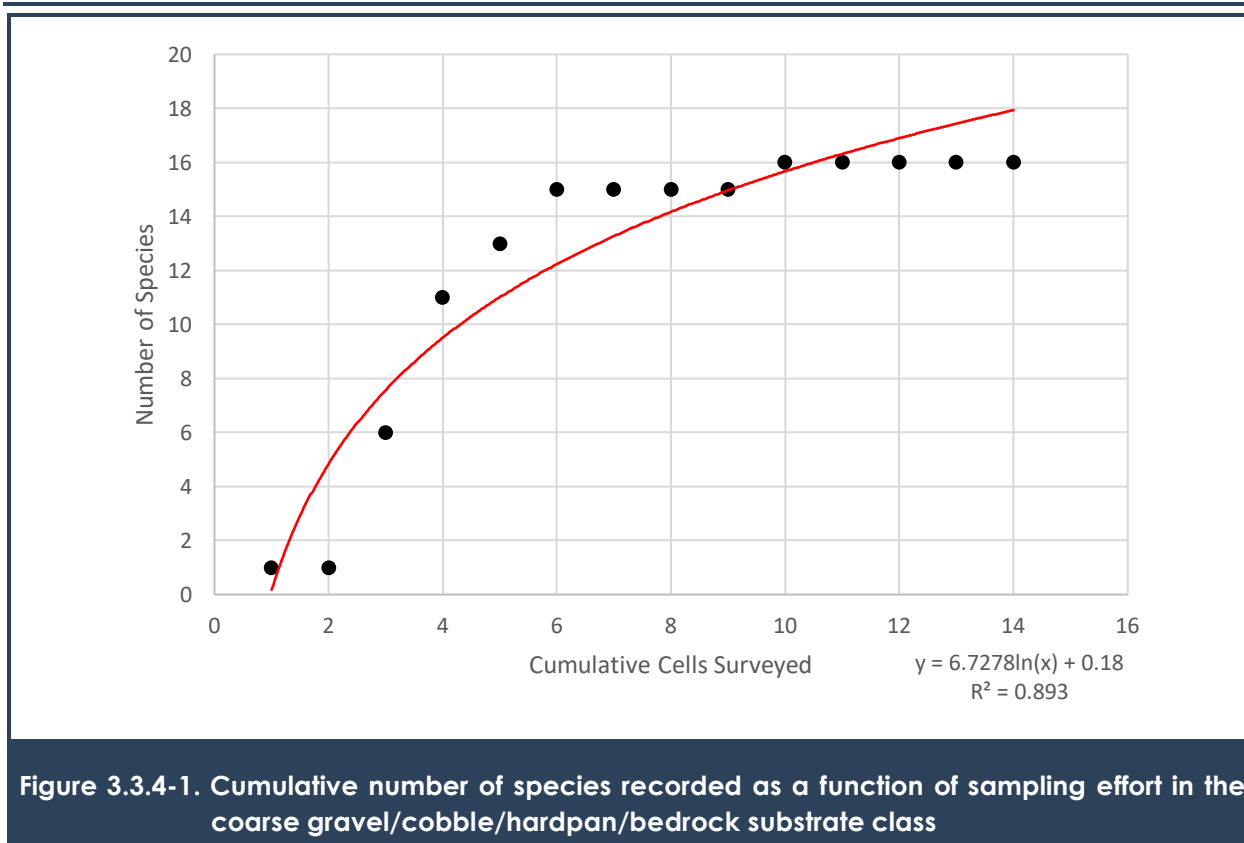
The coarse gravel/cobble/hardpan/bedrock substrate class was revealed to contain a significant mussel bed. This area had a high CPUE (49.59 mussels/hr), mean species richness per cell (4.92), and yielded a total live mussel count of 310 from the fifteen surveyed cells. The species accumulation curve (Figure 3.3.4-1) suggests survey efforts somewhat approached the asymptote, finding a richness of 16 species in the mussel bed, with a suggested richness of 22 based on a logarithmic curve equation (ignoring nonrandom sampling) (Figure 3.3.4-1).

The mussel bed in the Central Corridor yielded 310 individuals and 16 species of the total 452 individuals and 20 species found during the entire survey. The species accumulation curve suggests a potential six missing species from the mussel bed community data. This area contained 8 of the 11 live *Fusconaia subrotunda*, a Kentucky species of Special Concern.

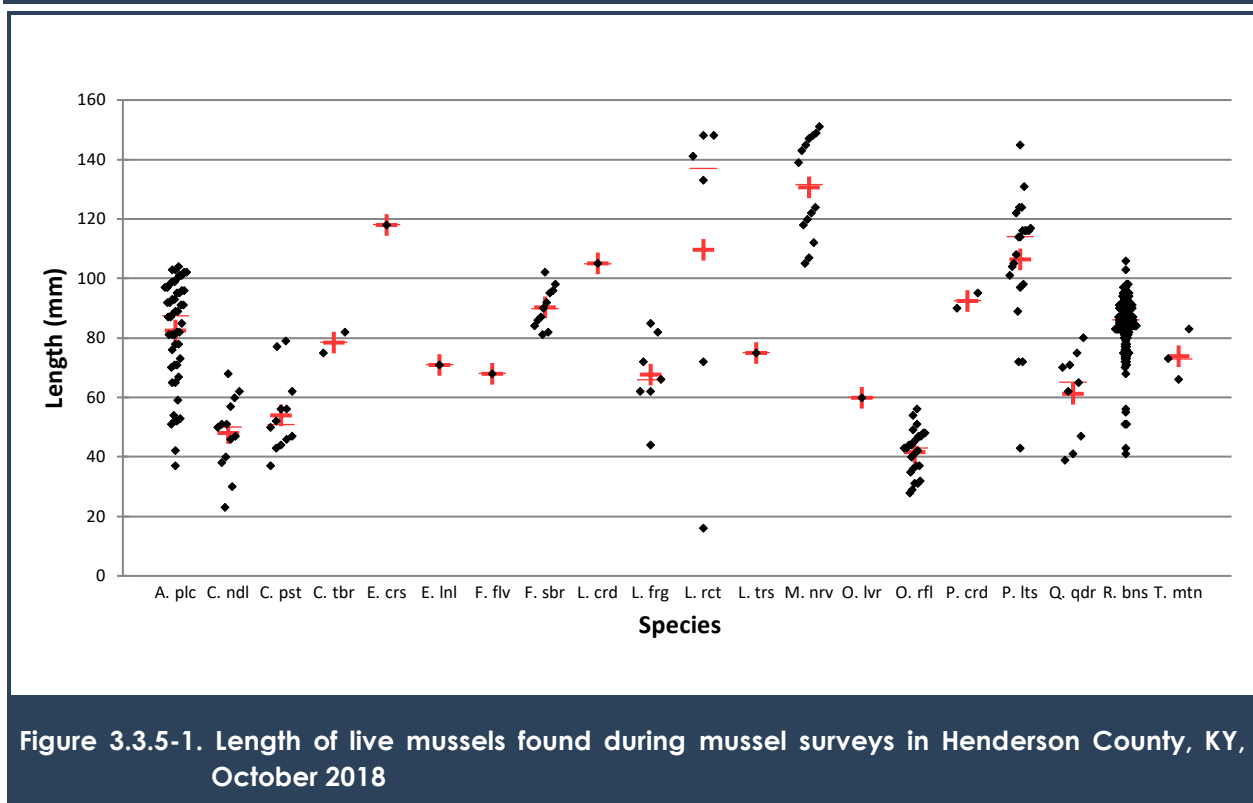
Figure 3.3.5-1 displays the length data from all mussels collected during the survey. Numerous species (*Amblema plicata*, *Cyclonaias nodulata*, *Cyclonaias pustulosa*, *Leptodea fragilis*, *Obliquaria reflexa*, *Potamilus alatus*, and *Reginaias ebenus*) were collected over a wide range of size classes, which can be interpreted as age classes. Numerous other species collected were noted only as large/older individuals (*Cyclonaias tuberculata*, *Elliptio crassidens*, *Ellipsaria lineolata*, *Megalonaias nervosa*, and *Lampsilis cardium*).

**Figure 3.3.5-1. Length of live mussels found during mussel surveys in Henderson County, KY, October 2018**

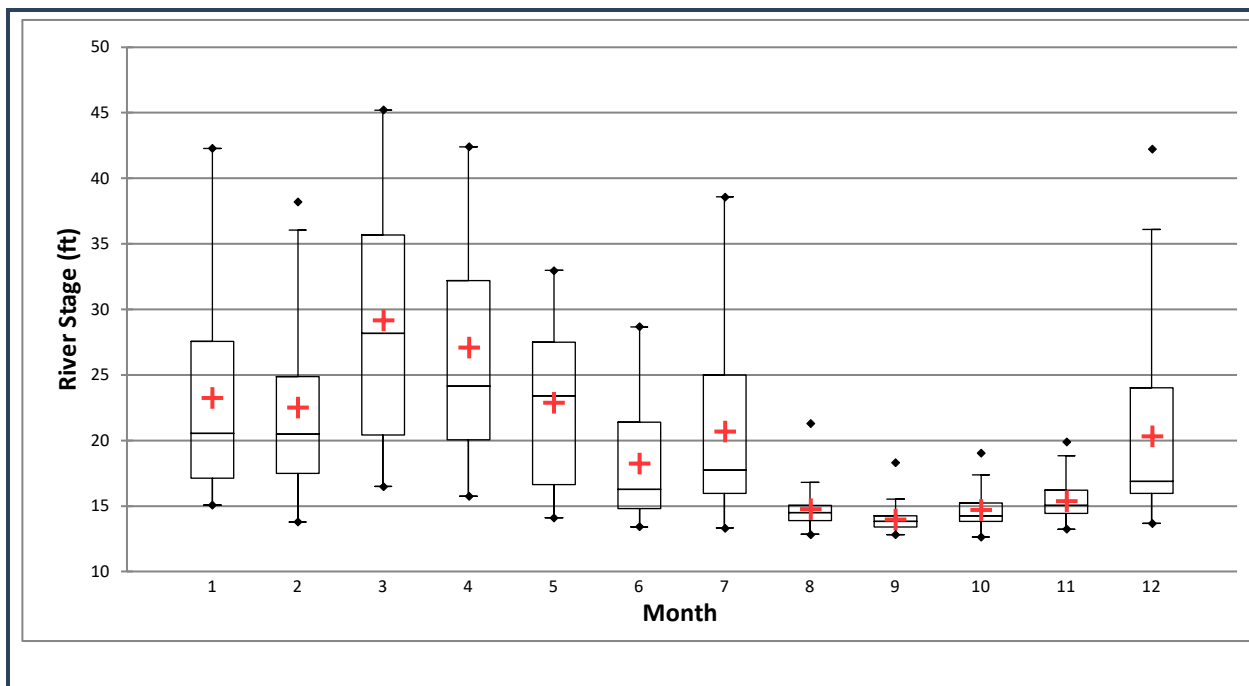
Figure 4.1-1. Historical (2014-2017) river stage measured at USGS gauge 03322000 Ohio River at Evansville, IN

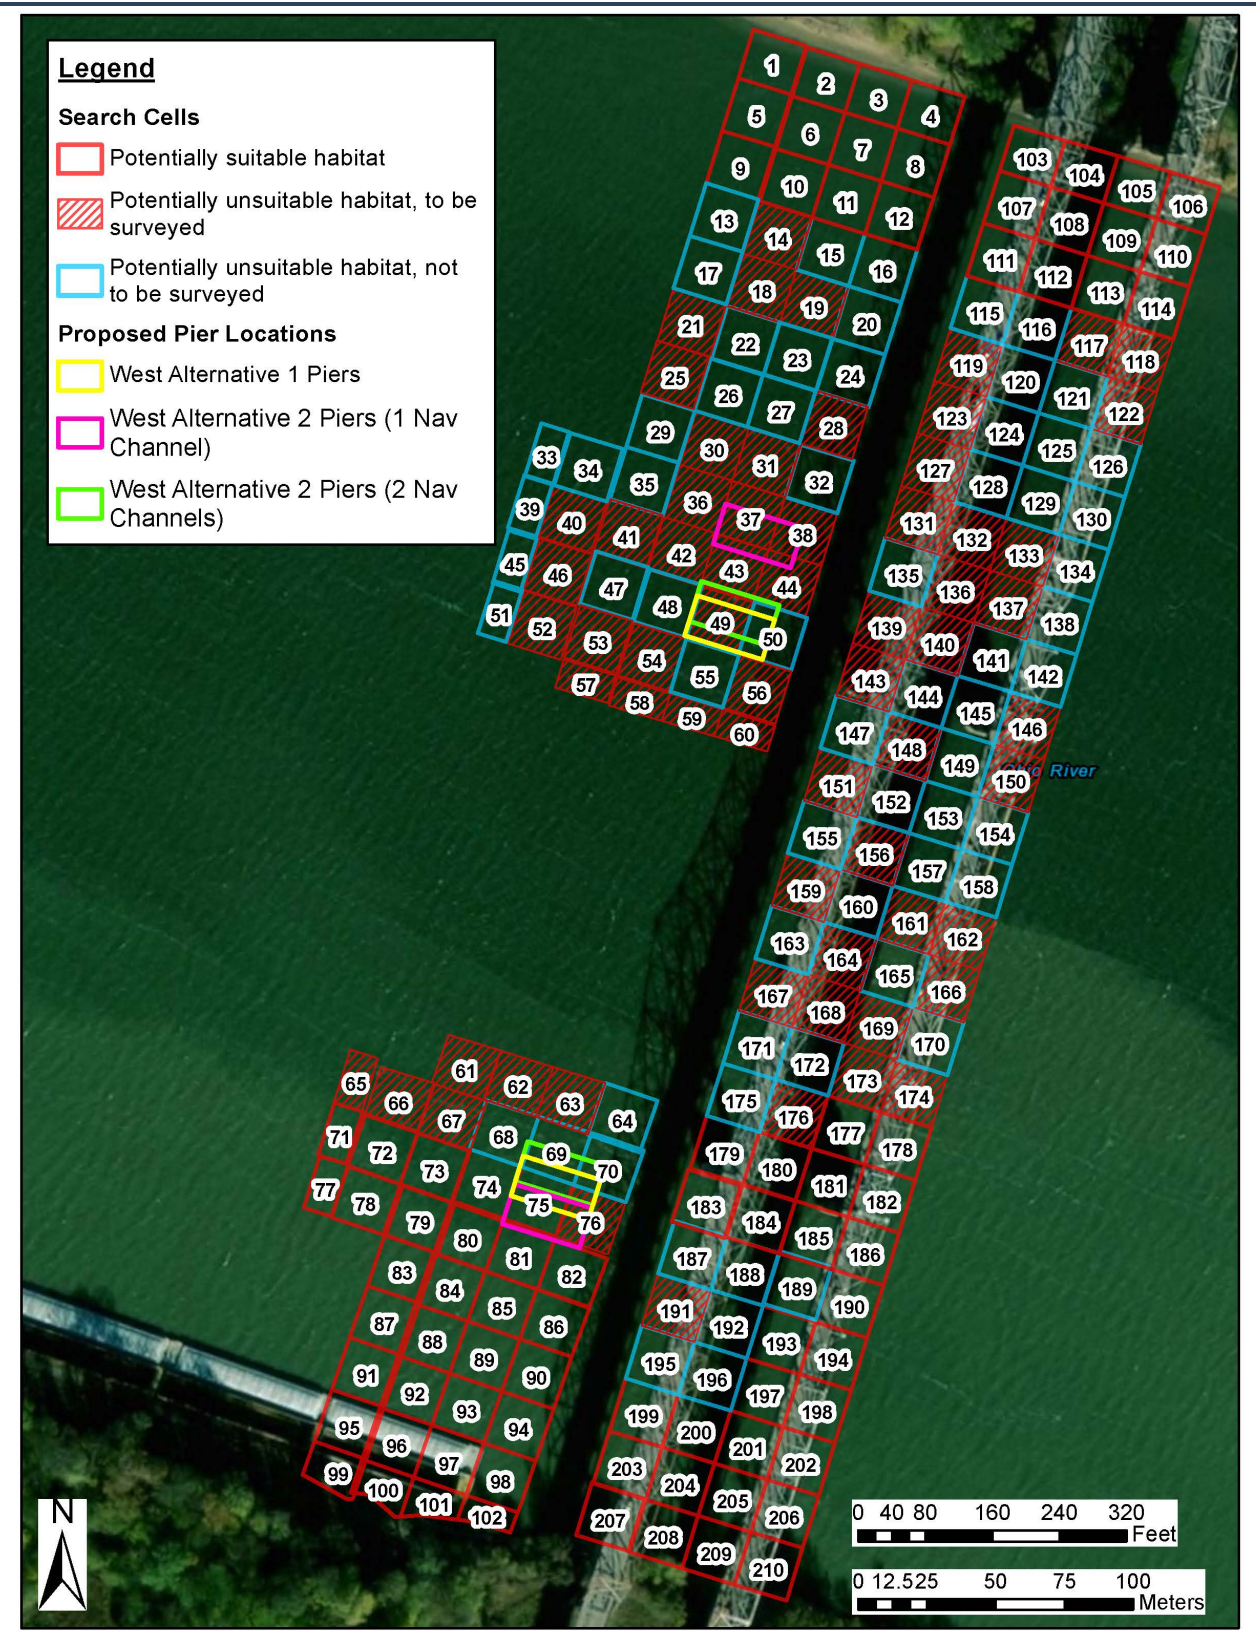
**Figure A-2. West Corridor: Mussel Survey Plan**

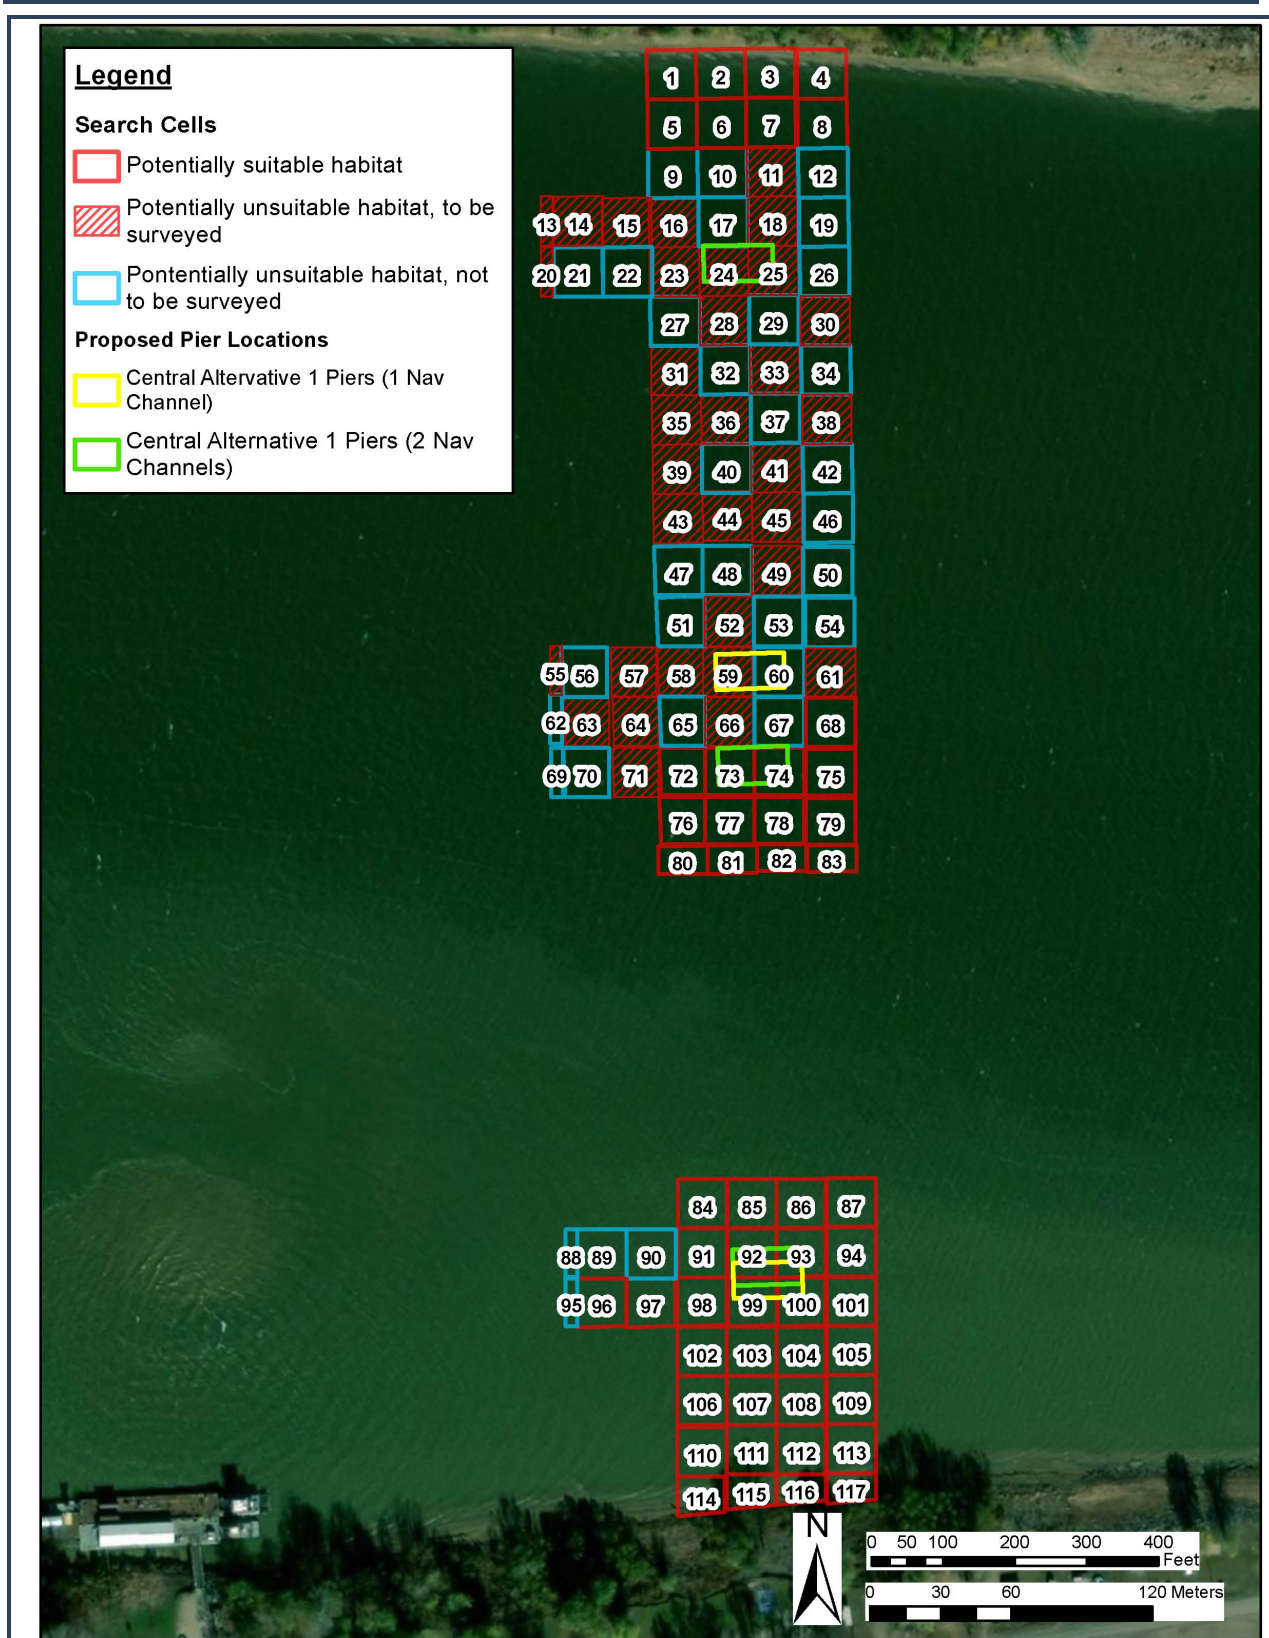
**Figure A-3. Central Corridor: Mussel Survey Plan**

The lone subfossil *Potamilus capax* shell was found on the right descending side of the Central Corridor, approximately 80m from the right descending bank (Cell 19, Figure A-3). The condition of the shell indicates that it could have originated upstream of the Survey Area and been washed downstream. A lone subfossil shell is not enough evidence to state a population is living in the Survey Area. The length scattergram (Figure 3.3.5-1) suggests recruiting populations of most species, with some species not found in abundances high enough to predict. *A. plicata*, *C. nodulata*, *C. pustulosa*, *L. fragilis*, *O. reflexa*, *P. alatus*, and *R. ebena* were collected over a wide range of size classes, which can be interpreted as annually successful reproduction. Others, such as *L. recta*, were collected across a range of size classes but were observed infrequently. This could be a function of small sample size but could also be an indication of sporadic reproduction. Other species, such as *C. tuberculata*, *E. crassidens*, *E. lineolata*, *M. nervosa*, *L. cardium*, and others were collected as large and older individuals only. Reproduction for these species may occur only as infrequent episodes.

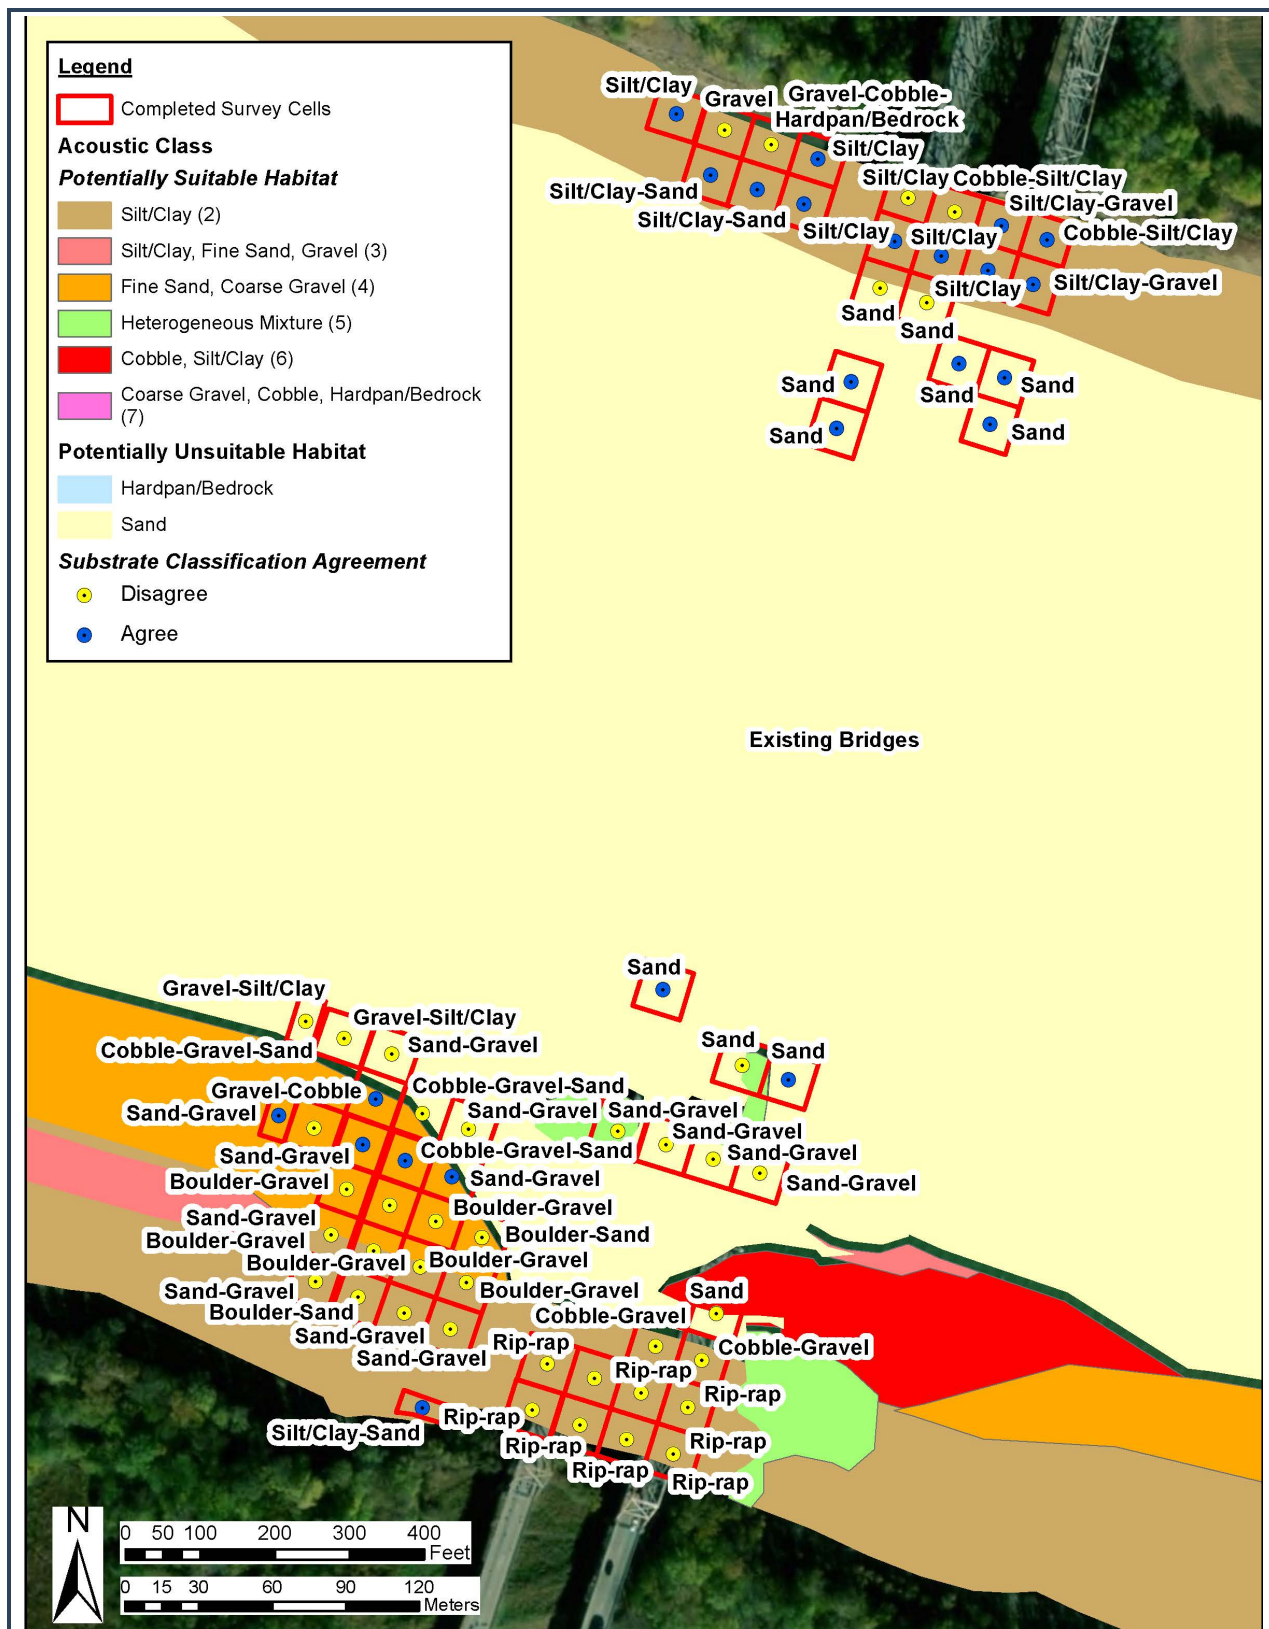
### Figure A-4. West Corridor: Acoustic vs. Field-realized Substrate Classes

Realized substrate differed greatly from the acoustic classes determined by side-scan sonar. As seen in Figures A-4 & A-5, some disagreements between the realized substrate and the acoustic classifications were partial disagreements (sand acoustic realized as a sand/gravel mixture), indicating the 55 percent accuracy is a conservative estimate of acoustic accuracy. It is worth noting that there have been multiple high flow events between the completion of the side-scan sonar substrate classification in November 2017 and the mussel survey in October, 2018. This could have resulted in changes in bedform that would appear as inaccuracy of the side-scan sonar. Seven acoustic classes are too broad to capture real-world substrate variability, however
