# OHIO RIVER CROSSING

## Freshwater Mussel Survey Report

I-69 Ohio River Crossing Project  
Evansville, IN and Henderson, KY

December 8, 2018

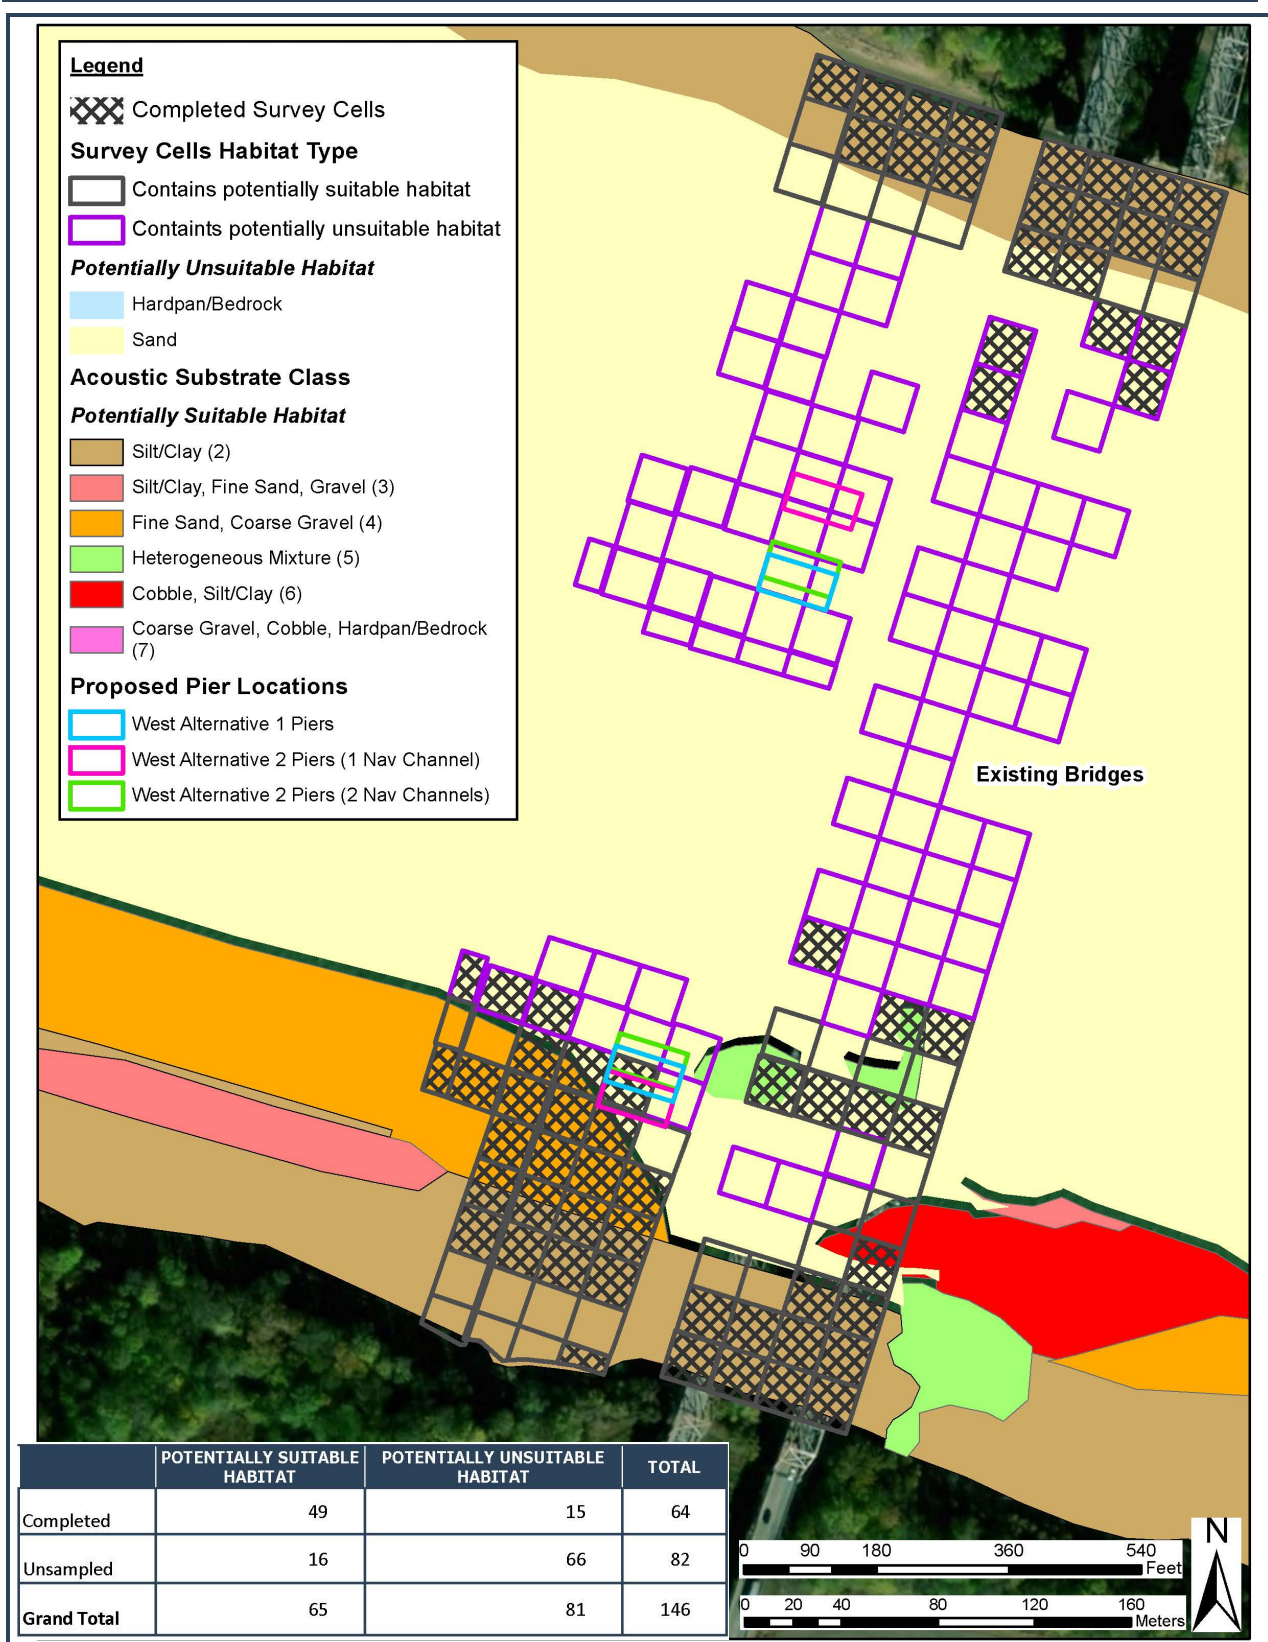
**Figure A-6. West Corridor: Survey Cell Completion**

Approximately 47 percent of scheduled search cells were sampled, including 74% of suitable cells, across the two survey periods (Table 3.2-1). Approximately 52 percent (44/85) of the cells were completed in the Central Corridor, with an additional 7 cell searches resulting in failed attempts, due to fast currents. Some failed cells yielded substrate data or spent mussel shells that are included in later analysis, but are not deemed completed. Cells that were not attempted or completed were deemed “unsampled.” Approximately 44 percent of the scheduled search cells on the West Corridor were completed (64/146). Completed cells can be viewed spatially in Figures A-6 & A-7.

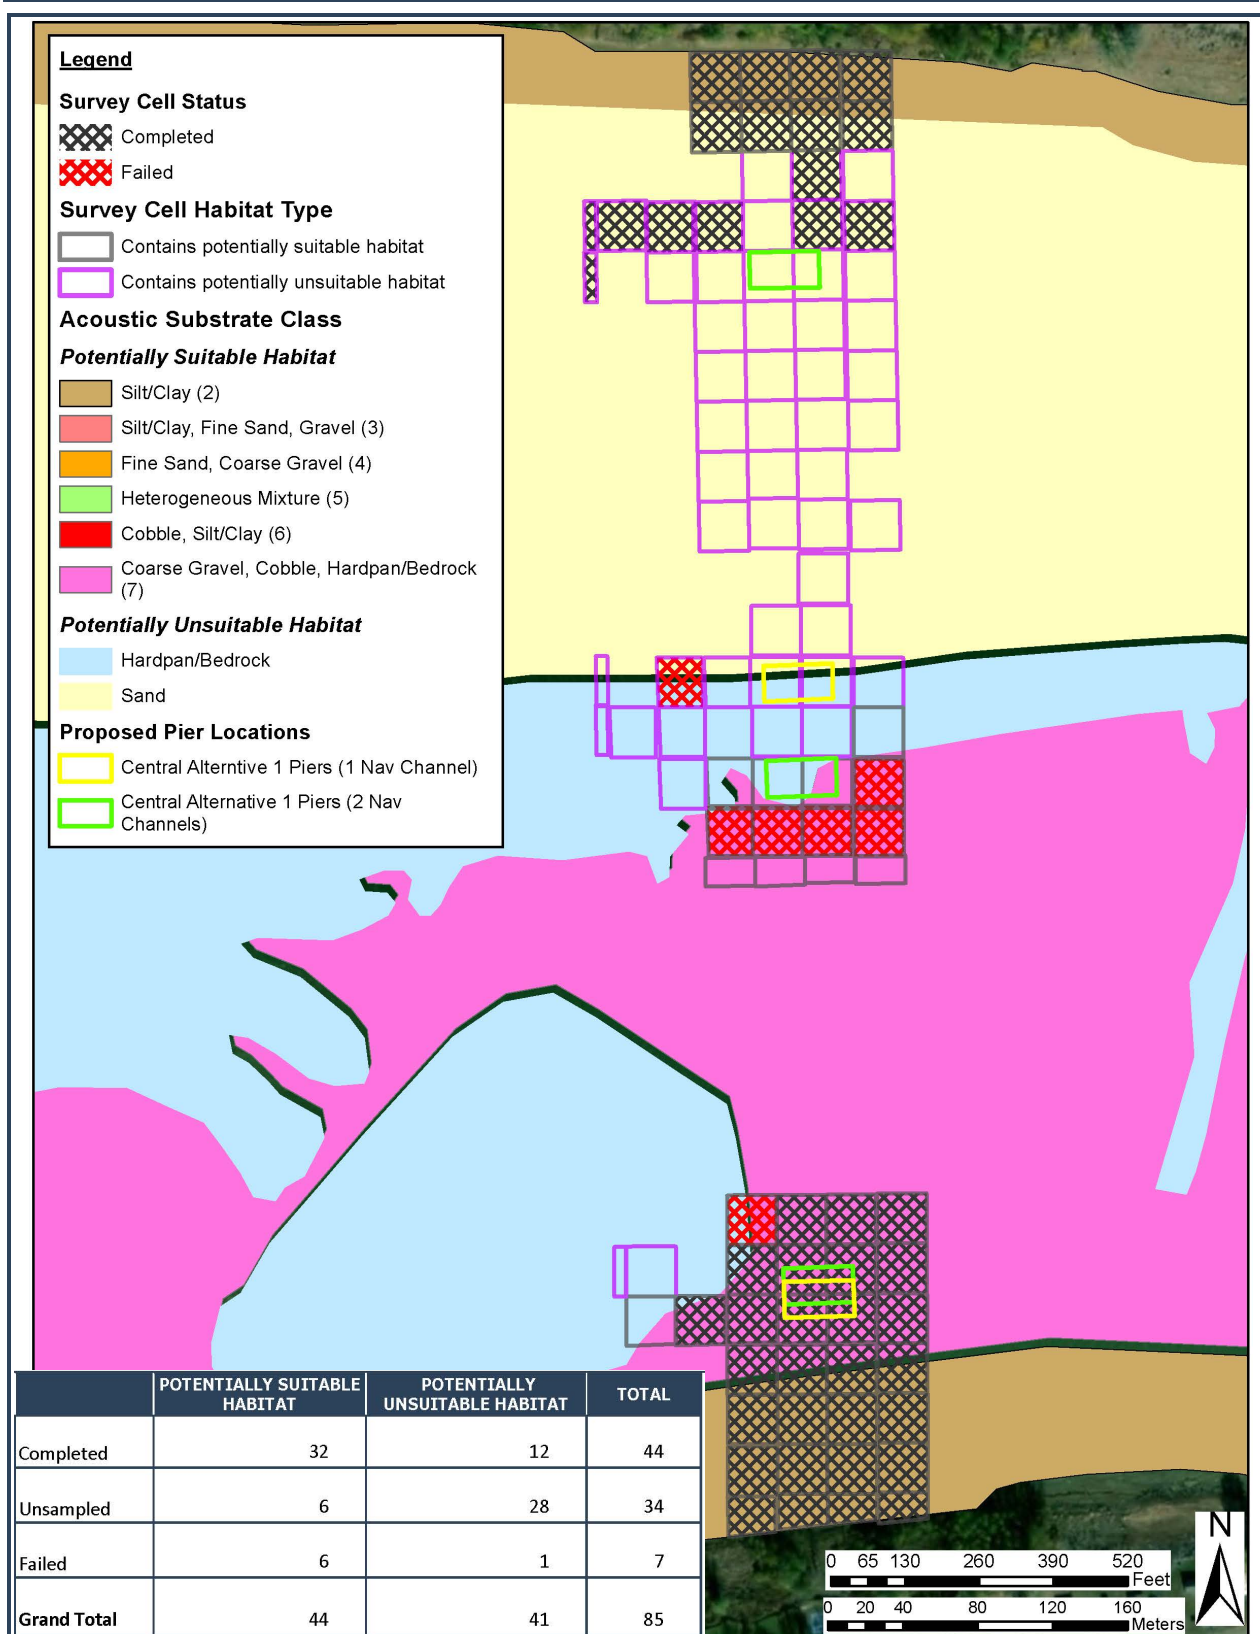
**Figure A-7. Central Corridor: Survey Cell Completion**

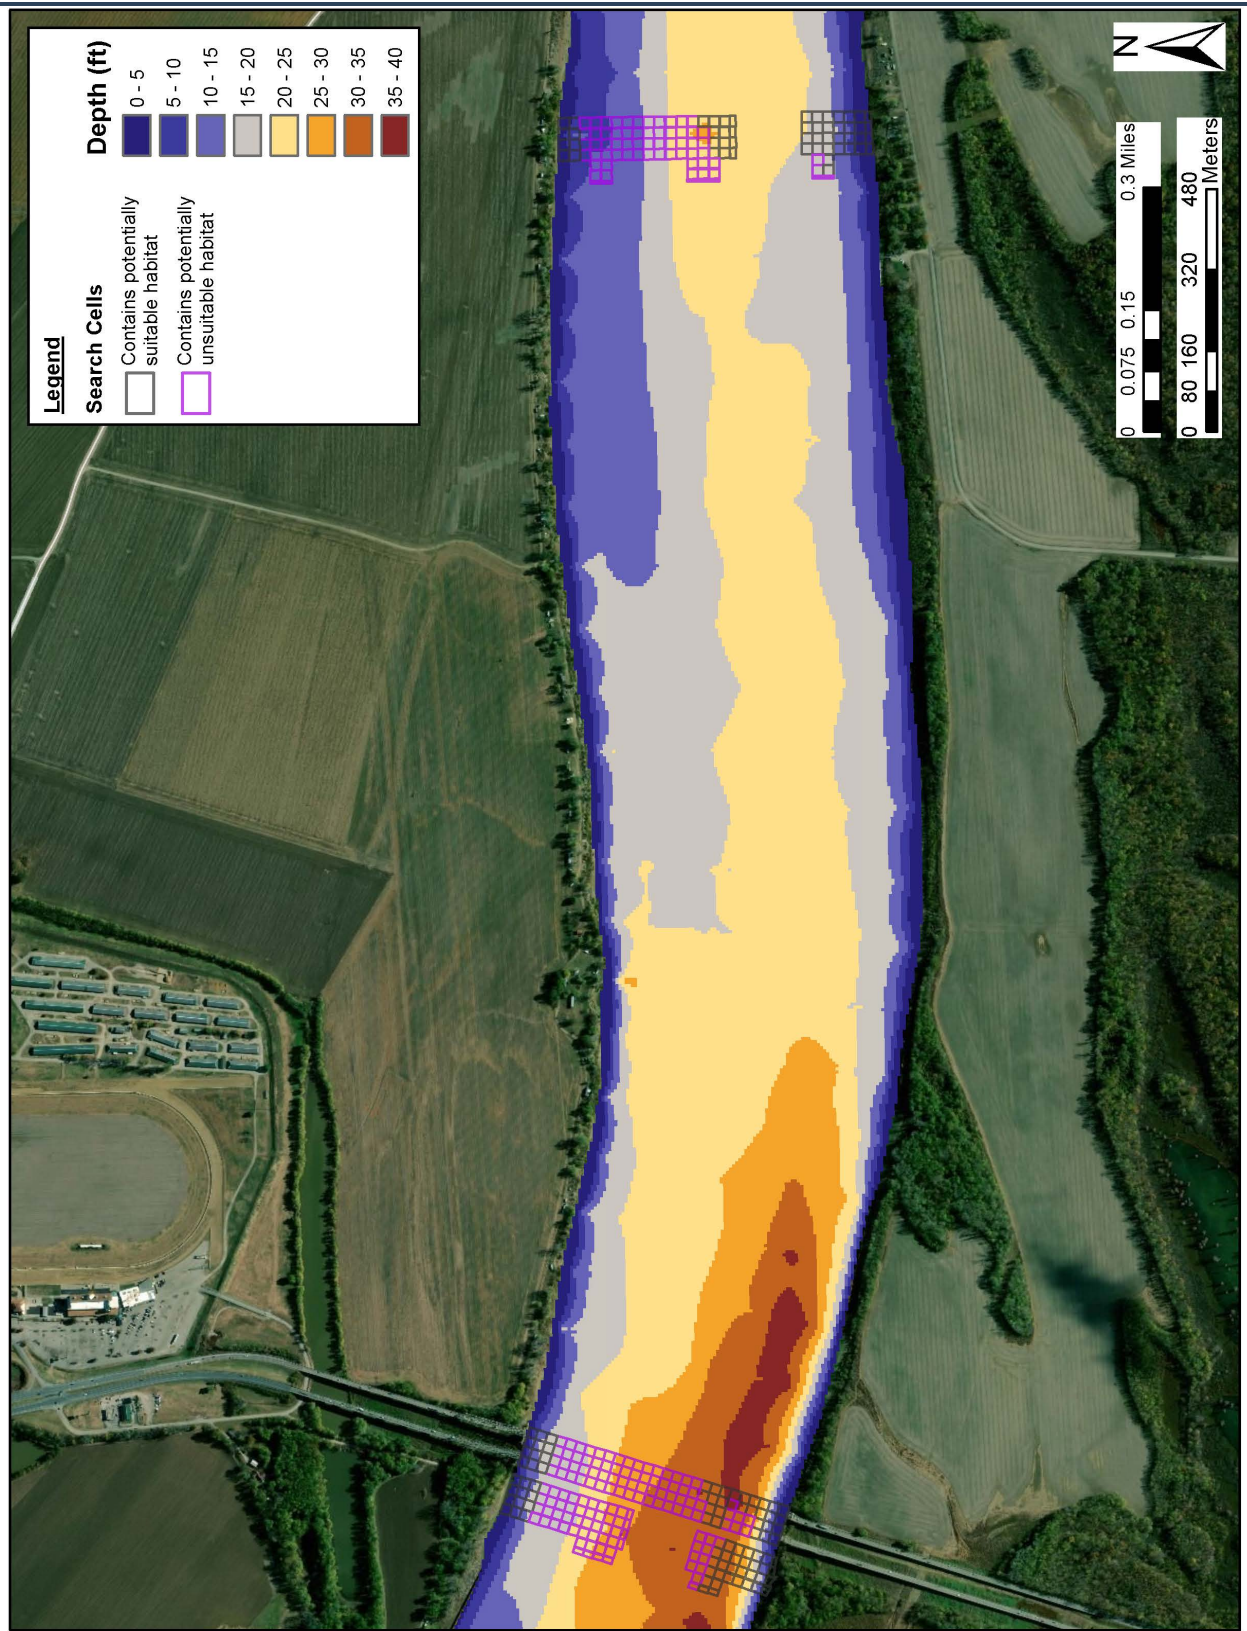
**Figure A-8. Bathymetry Map**

Sampling was skewed towards shallow depths, as realized depths were significantly (~2.4m/8-3.6m/12ft) deeper than ideal conditions (Figure 3.1-2 & 3.2.1-1). Cells towards the thalweg of the river proved problematic as boats were often unable to anchor and maintain position or the combination of unstable substrate and high velocity made it impractical for divers to survey. Additionally, these cells were often in the shipping channel, which made anchoring of the boats for the necessary duration (i.e., > 30 minutes) difficult due to the frequency of barge traffic in the area. Cells were sampled in each depth category except the deepest (11m/35ft-14m/45ft), which only contained 2 cells. Negative values for depth indicated the cells were above water during acoustic surveying. All cells were under water during the mussel survey. Bathymetric data can be viewed in Figure A-8.

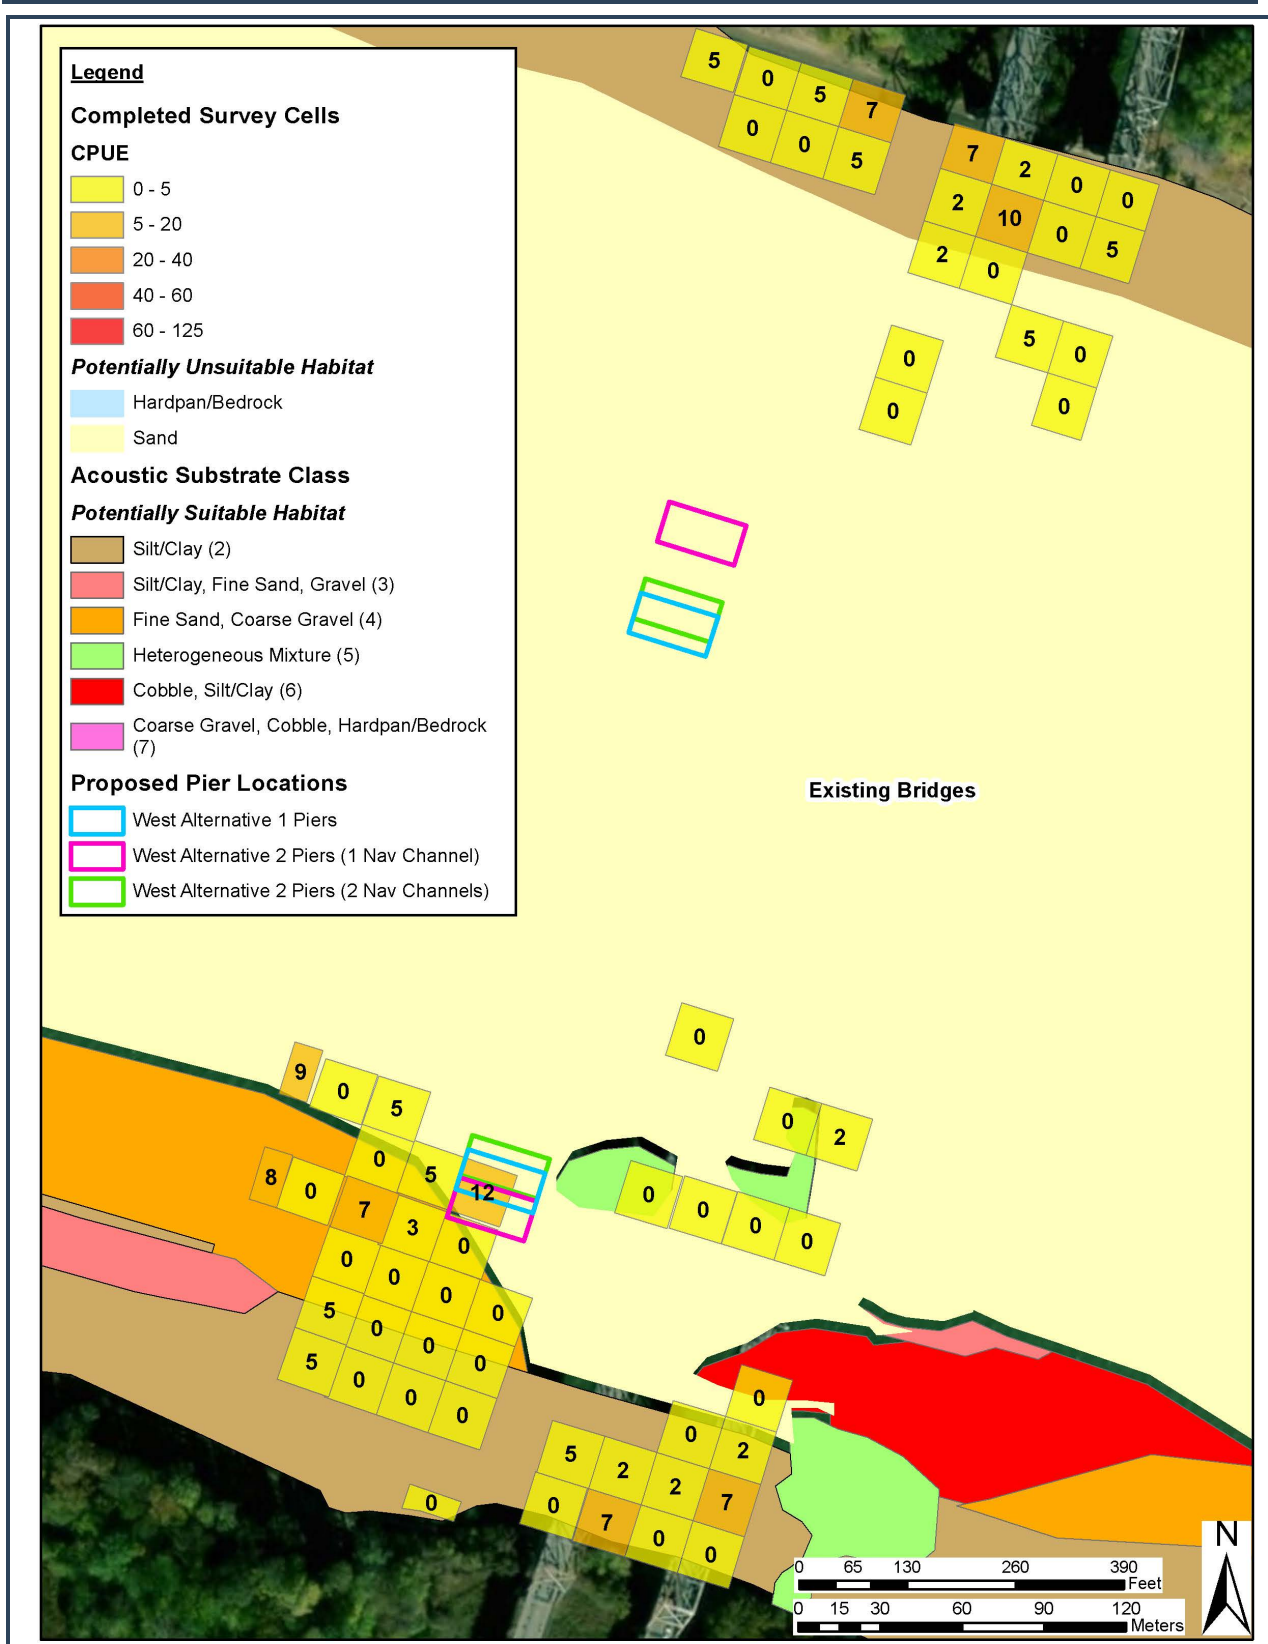
**Figure A-9. West Corridor: Catch per Unit Effort**

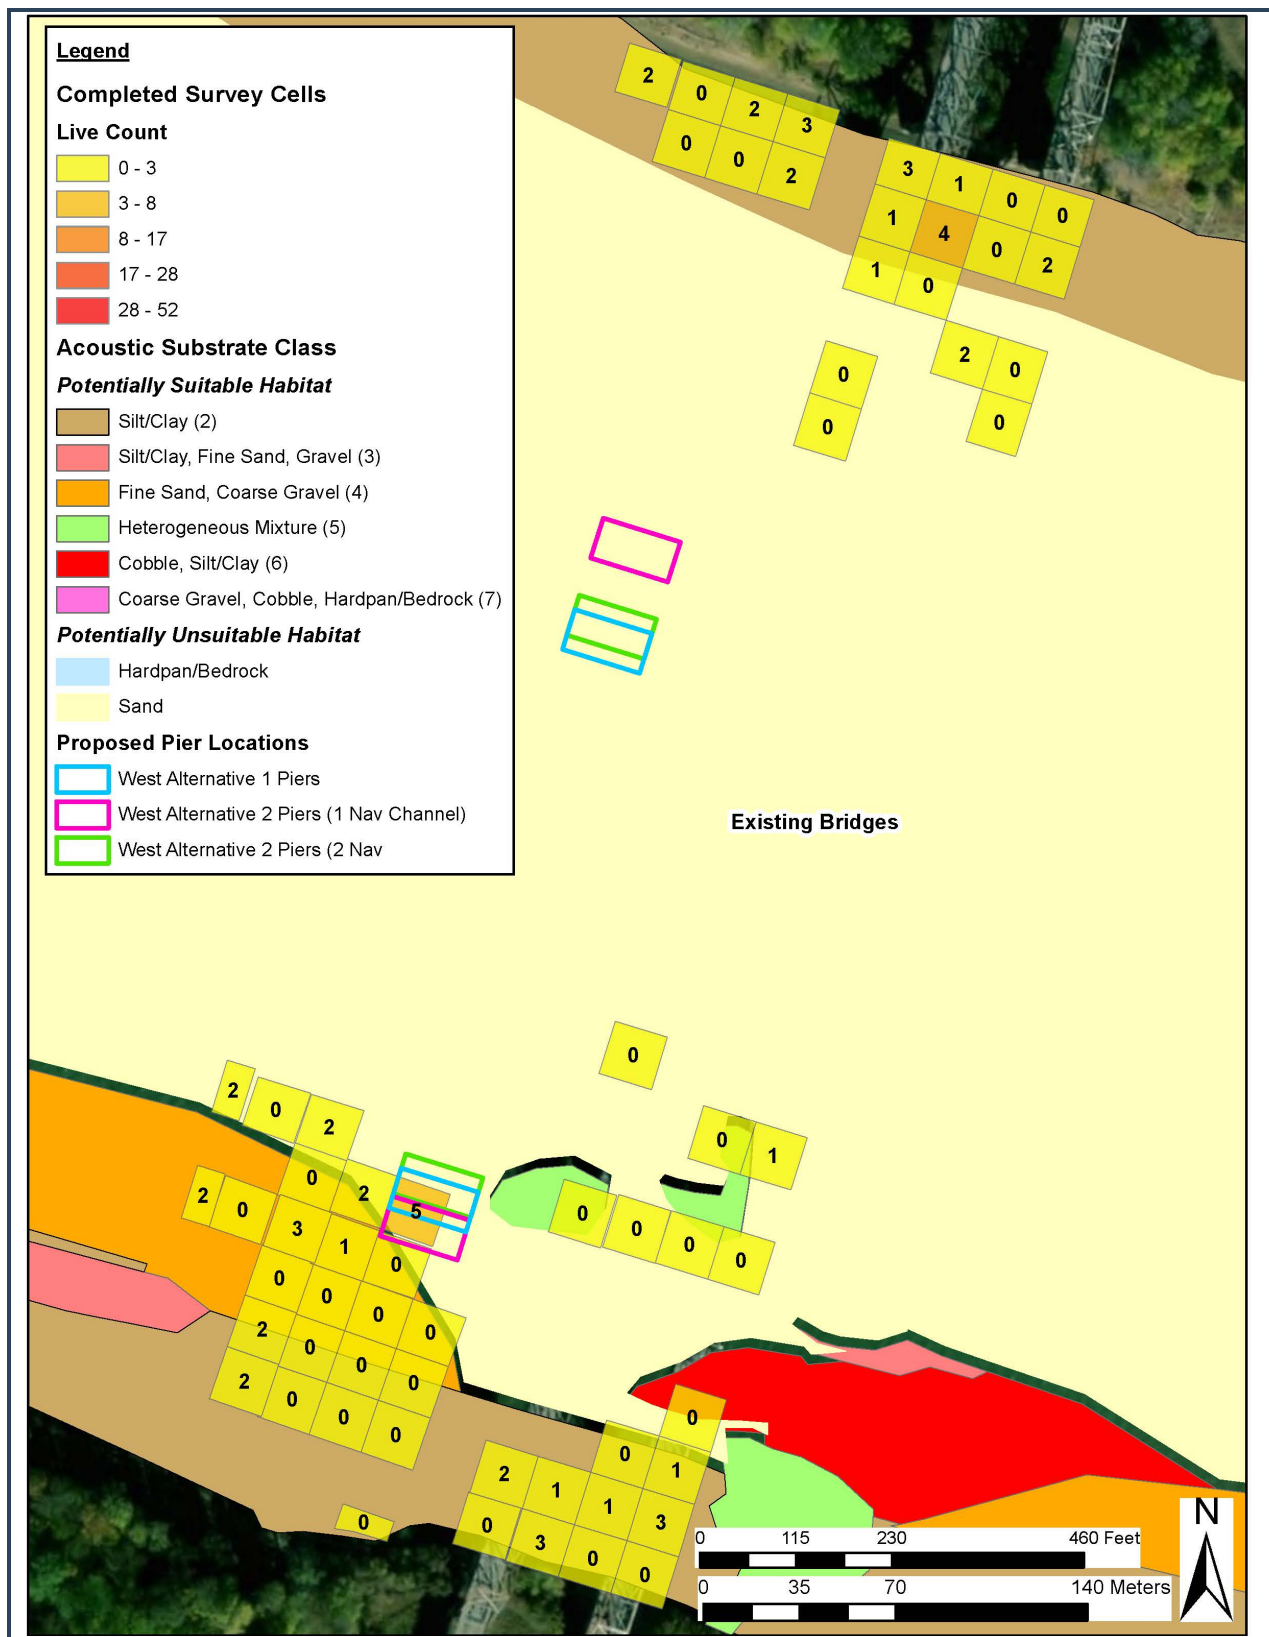
**Figure A-11. West Corridor: Live Mussel Counts**

Only 53 total mussels were found on the Western Corridor, suggesting that it doesn't hold abundant populations of mussels (Figure A-11). The Western Corridor proved to be mostly unsuitable habitat. Cells along the left descending bank that were suggested via acoustic surveying to be silt/clay (suitable) were entirely riprap, yielding few mussels. Some cells along

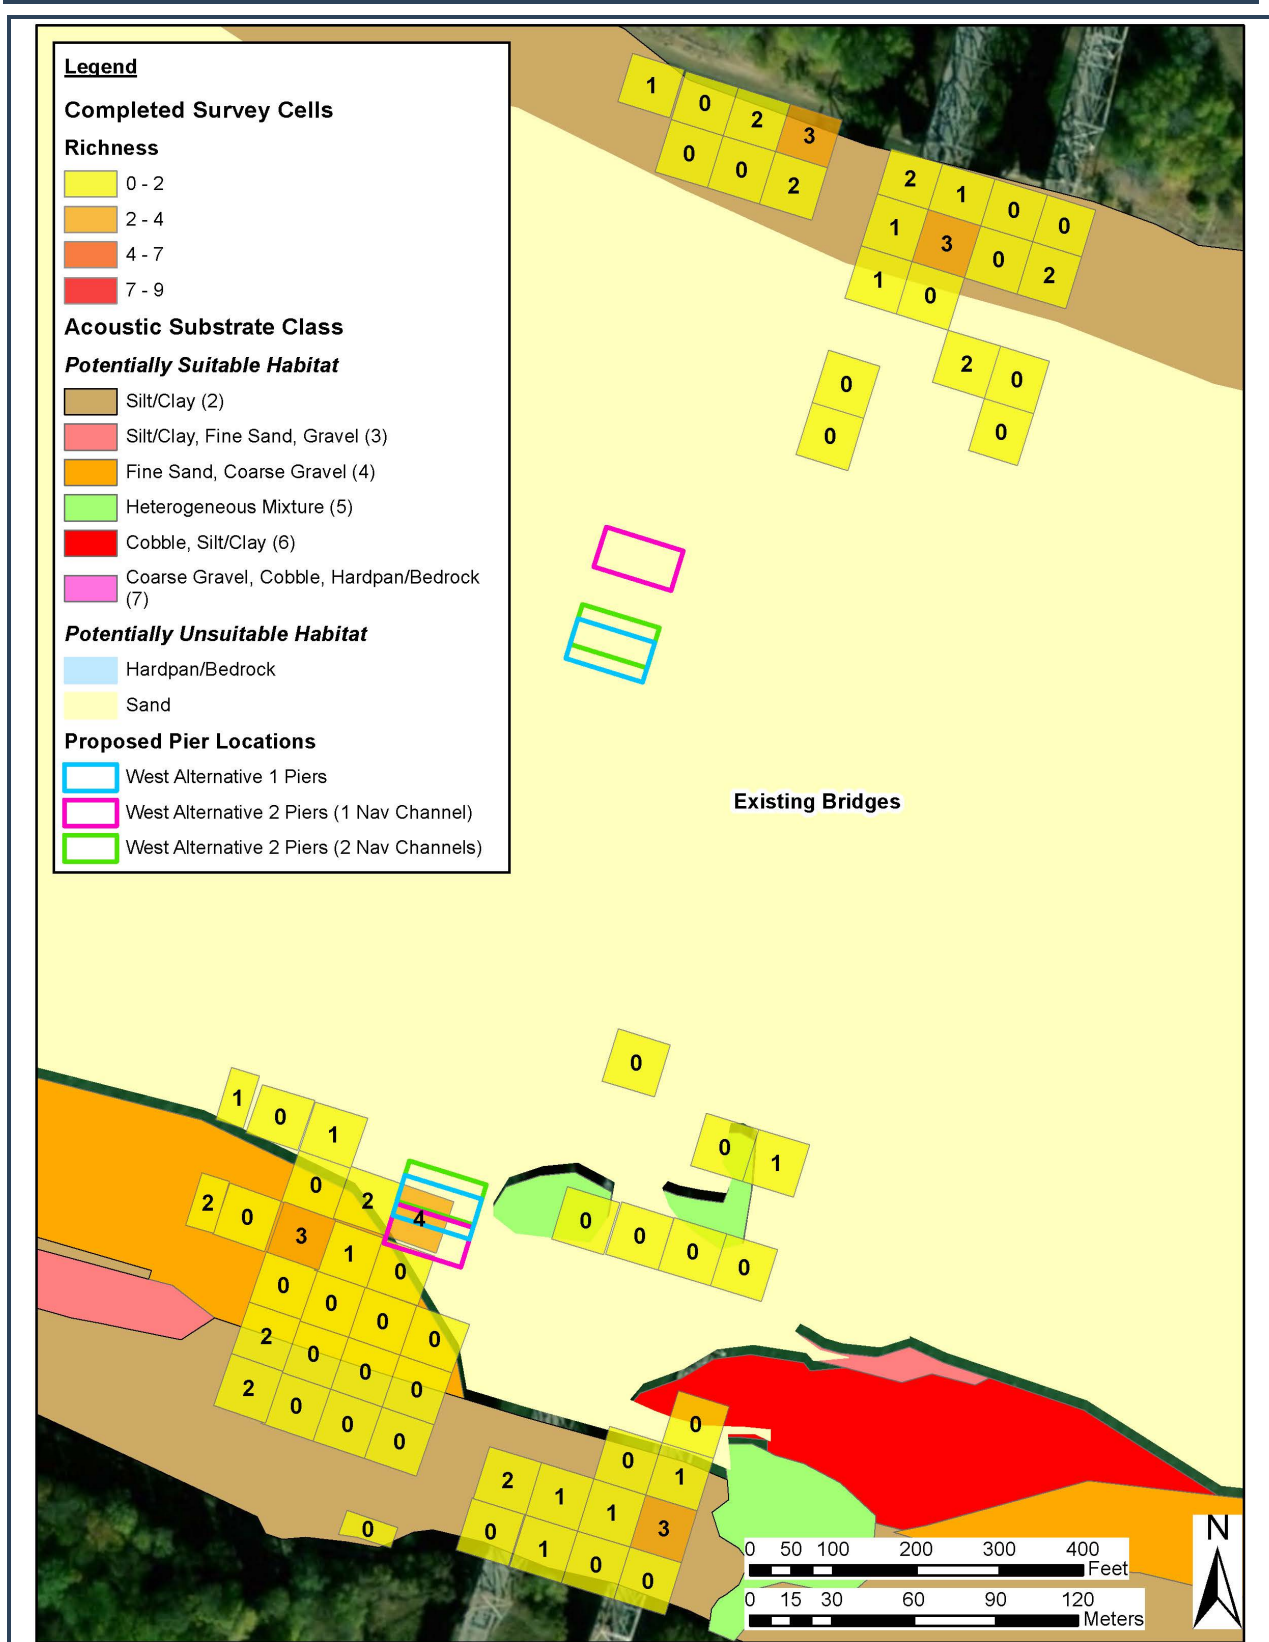
**Figure A-13. West Corridor: Species Richness**

Live mussels were absent at lower frequencies in the Central Corridor (27 present, 18 absent) than in the Western Corridor (27 present, 35 absent) as shown in Figure 3.3.1-1. The frequency distributions for presence/absence in cells did not differ at the 0.05 level but approached statistical significance ( $X^2 = 2.82$ ,  $p = 0.09$ ,  $df = 3$ ). In addition to a higher ratio of presence/absence, catch per unit effort (CPUE, mussels per hour search time) was higher in cells in the Central Corridor (mean = 19.6) compared to the Western Corridor (mean = 2.3) (Table 3.3.1-1). The project overall had an average CPUE of 9.5 mussels per hour. The spatial distribution of CPUE and live mussel count data among survey cells is illustrated in Figures A-9 & A-10 and Figures A-11 & A-12, respectively. Average MacArthur diversity (MacArthur 1972) and species richness were also greater in the Central Corridor compared to the Western Corridor (Table 3.3.1-1). The spatial distribution of richness among survey cells is presented in Figures A-13 & A-14.

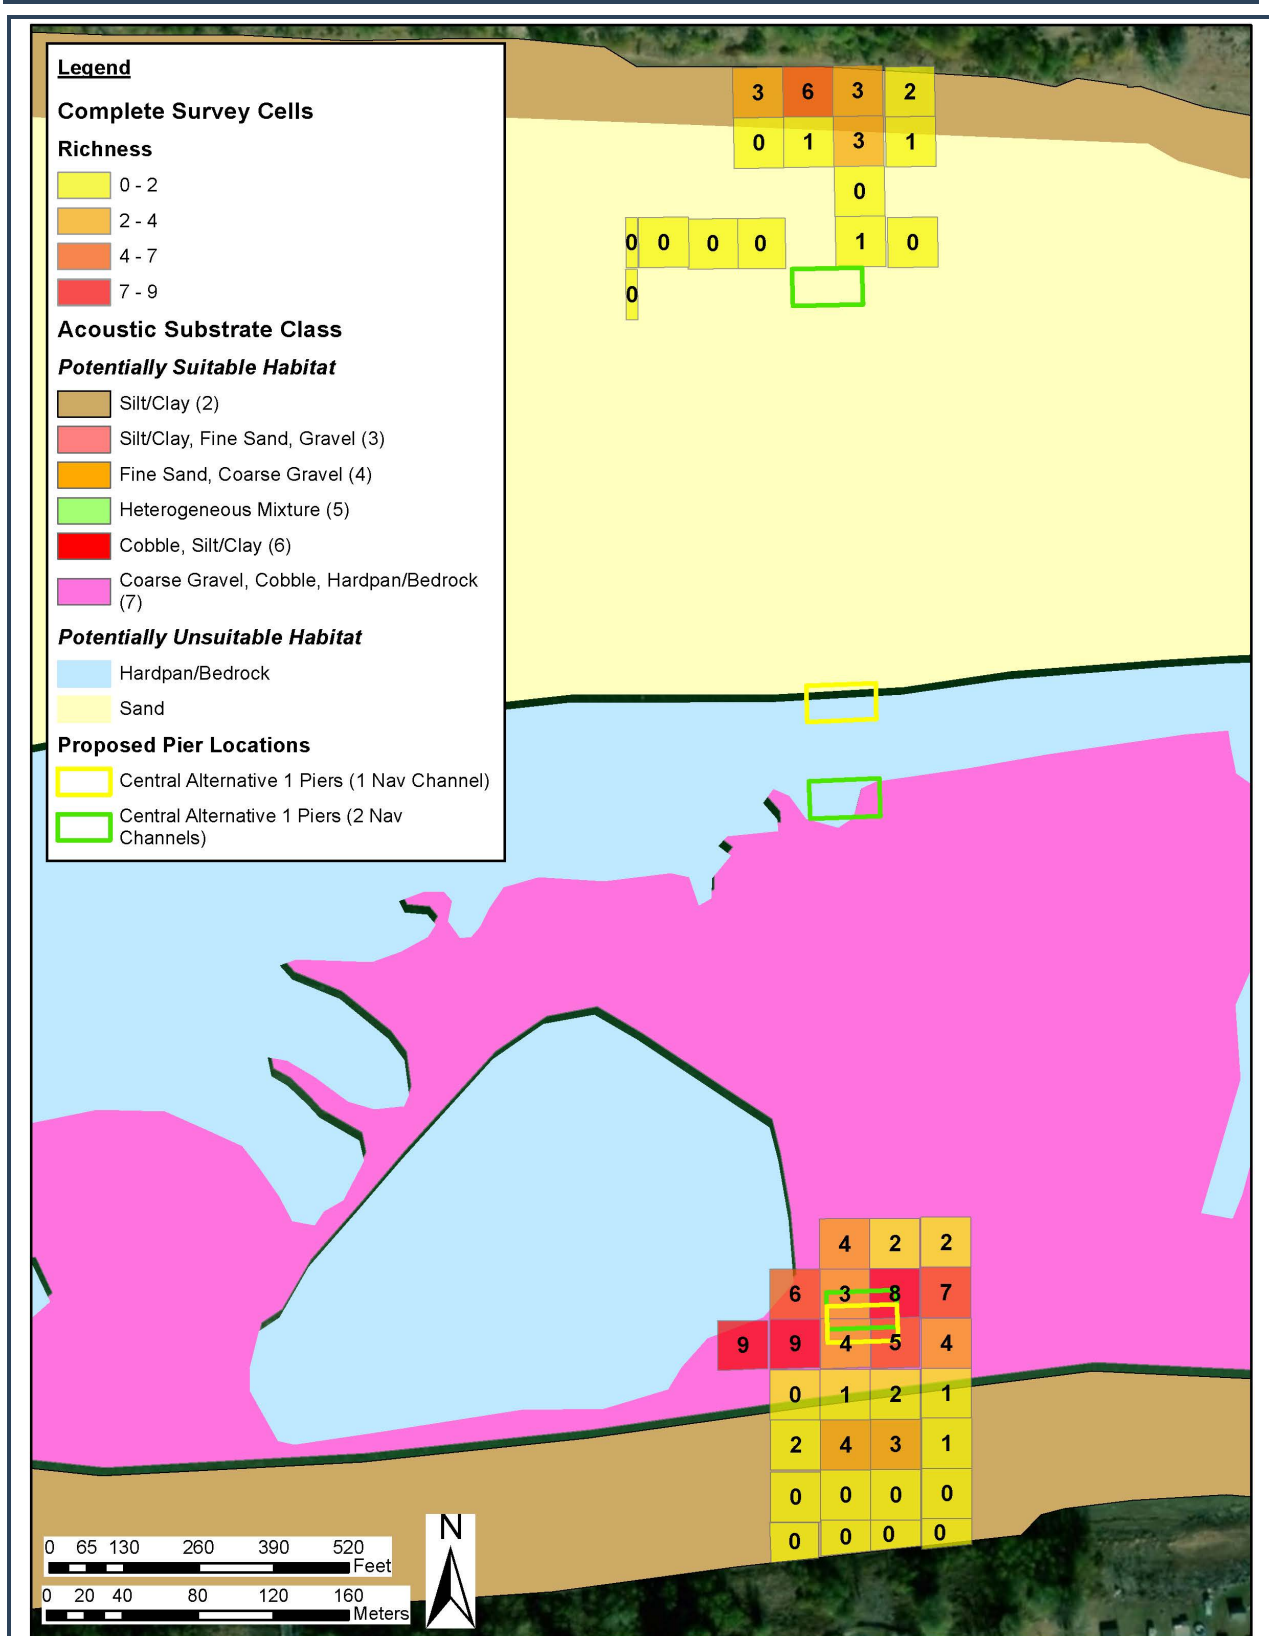
**Figure A-14. Central Corridor: Species Richness**
